# BUILDING SURVEY

## Level 3

**ALLCOTT**  
RESIDENTIAL

Somewhere Street, Anywhere, Everyplace,  
EV1 1WX

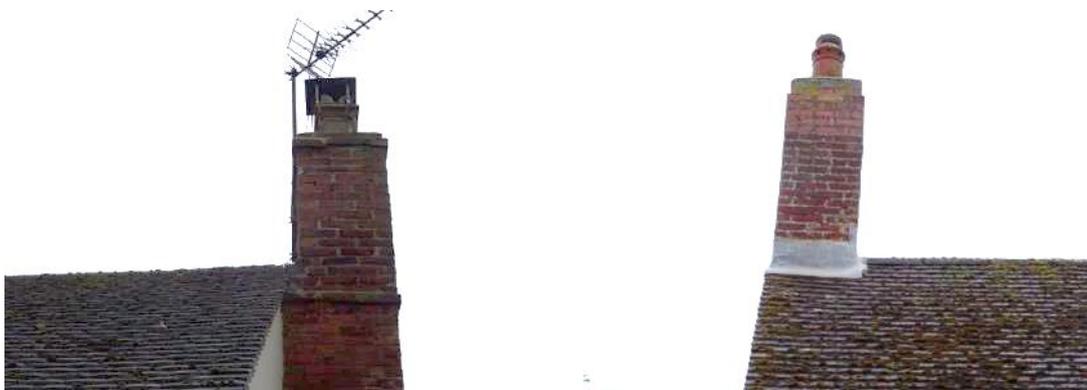
There are chimneystacks to left and right. These are in brick construction with dressed lead flashings to the left and mortar flaunching to the right. Both appear in a satisfactory structural order at the time of survey. There are slight historic deformations though no indications of recent or ongoing significant movement or significant structural compromise. These are therefore considered satisfactory.

The deformations are in line with expectations for a property of this age and construction and there are no indications of recent or ongoing significant movement or significant structural compromise.

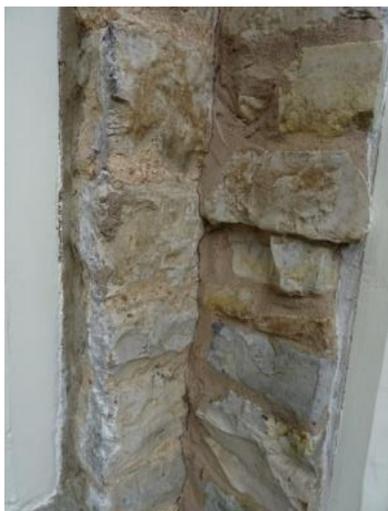
Minor cracking was indicated at the juncture of the entry porch and historic construction.

The porch is a later addition and such cracking is not unusual at the juncture of building phases. There are no indications of significant structural compromise. Our recommendation is limited to localised repointing to maintain the weathertight envelope to the area.

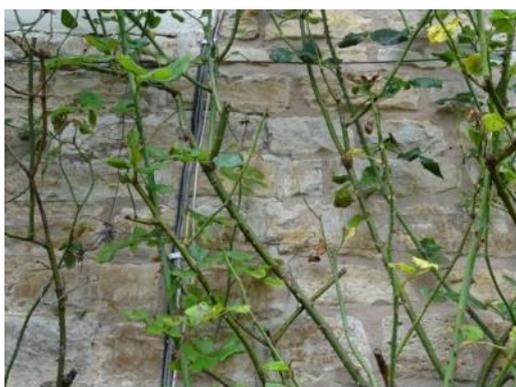
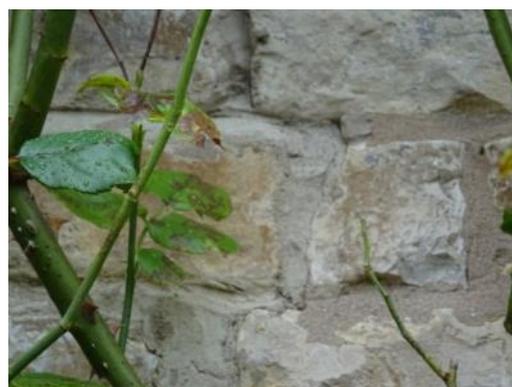
Minor cracking was indicated to the right of the porch at first floor level.

Such minor cracking is not unusual in a property of this age and construction. There are no indications of significant structural compromise. This is considered satisfactory. Repairs are limited to repointing and we recommend the use of a lime based mortar.

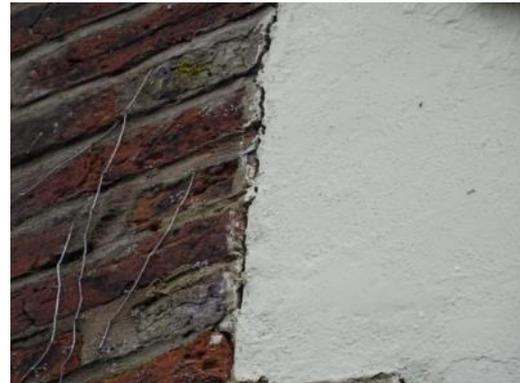
There is minor separation cracking between the chimney and the render finishes reflecting normal seasonal movement.

We have included provisional apportionment for the introduction of a flexible joint detail in this position.

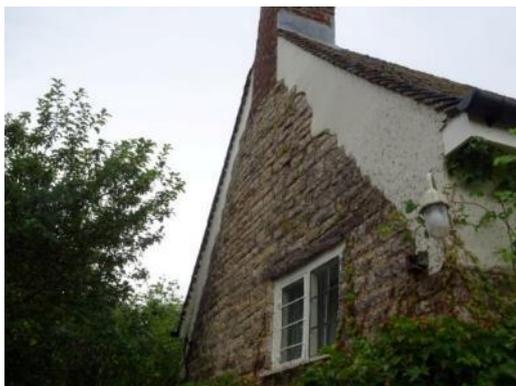
There were indications of historic wall deformations in particular around the base of the chimney and above eaves level.

We are mindful of the propensity of cementitious mortars to disproportionately exhibit cracking. There were no indications of recent or ongoing significant cracking or significant structural compromise. Minor cracking was indicated, but considered to reflect normal seasonal movement and we have included provisional apportionment for repointing repairs locally.

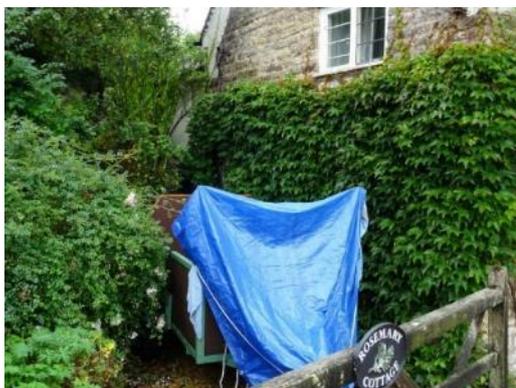
Our inspection at low level was limited by the extent of trailing vegetation against the elevation. The positioning of a trailer to the front of the area and oil tank to the rear restricted access to the area and visual access to the elevation.

Our reporting must be limited in this respect. We recommend the elevation and area are inspected when the vegetation is next cut back or removed together with the completion of any necessary additional remedial repairs identified at that time. No apportionment is included in this respect.

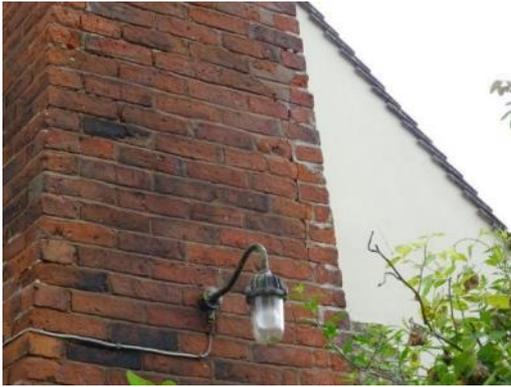
There is minor cracking to the chimney.

We have included provisional apportionment for localised repair.

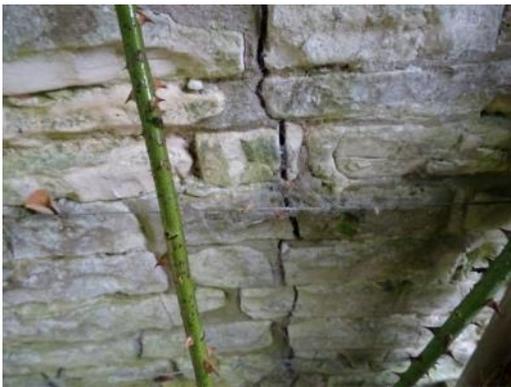
Cracking is indicated to the right to the low-level structure and this was measured in the order of 6mm width.

We have included provisional apportionment for masonry reinforcement and repair in this respect.

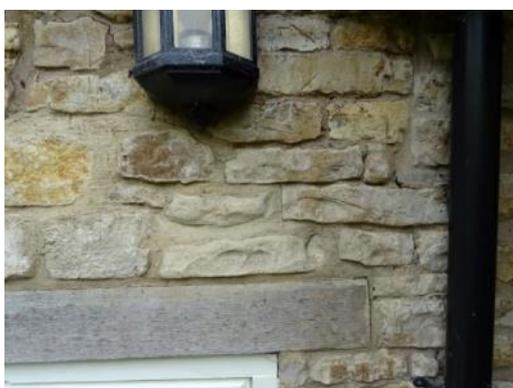
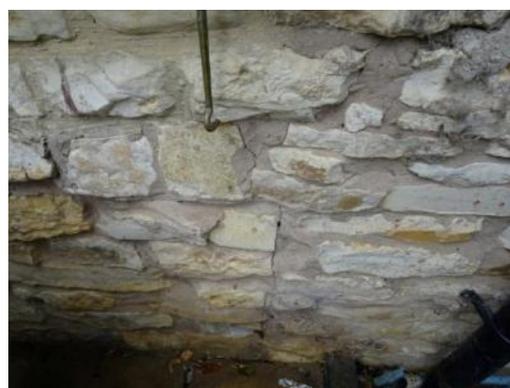
Minor cracking is indicated below the living room right window and there is similar minor cracking above. Both are indicated of historic nature and there are no indications of recent or ongoing significant movement to the walling or significant structural compromise.

Our recommendation is limited to localised masonry reinforcement and repair.

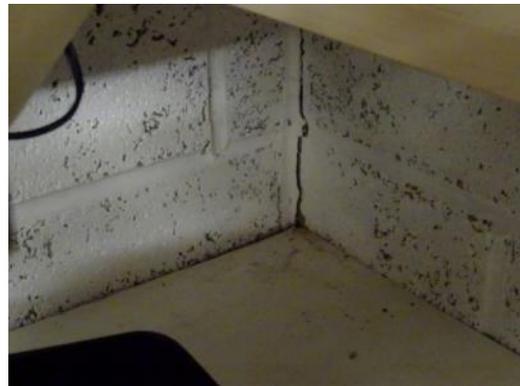
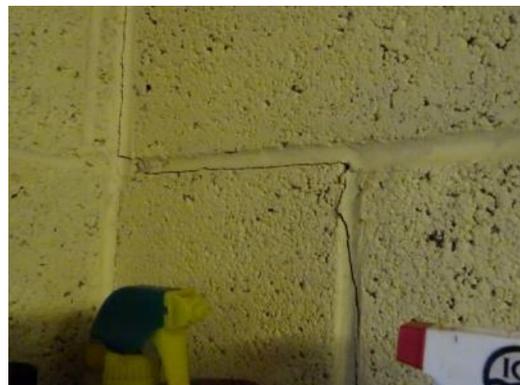
The walling is in blockwork construction. We found no evidence of significant cracking or structural deformation to the main load bearing walls generally. There is a localised issue adjacent to the cracking to the rear. We have included provisional apportionment for localised masonry reinforcement and repair.

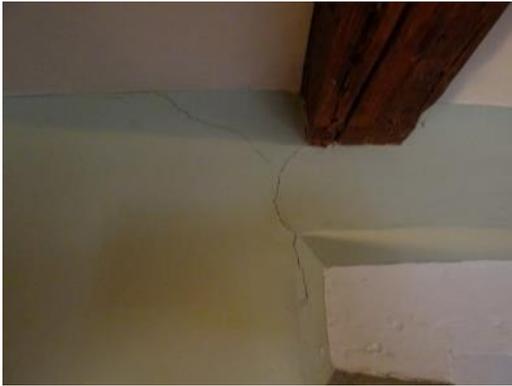
Minor cracking was indicated around the door opening positions. This is in line with expectations for a property of this age and construction. In the absence of any significant structural compromise this is considered satisfactory. Typical detail shown.

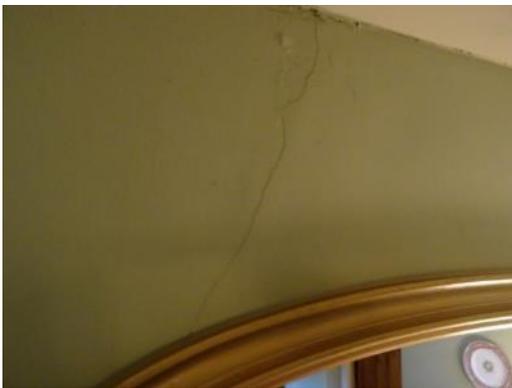
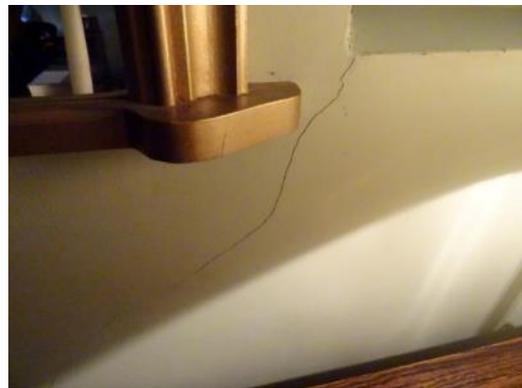
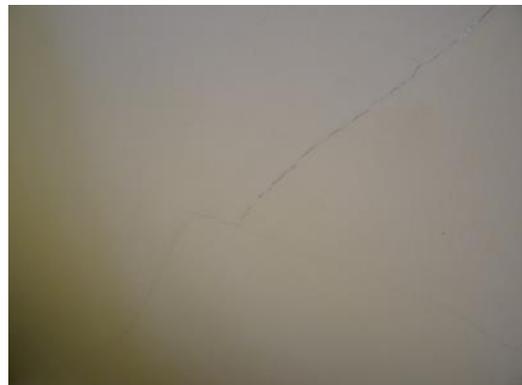
Further minor cracking was indicated to the left rear walls within the inglenook fireplace position. These were measured and confirmed in the order of 0.5mm width and less. Typical detail is shown.

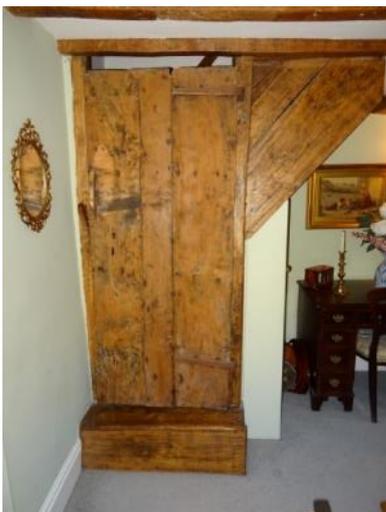
The stair exits from this room. The stair is a historic arrangement and has a door across the base.

Modern Building Regulations do not allow the positioning of doors across the base of stairs though there are no retrospective requirements in this respect and in a historic property this is considered satisfactory.

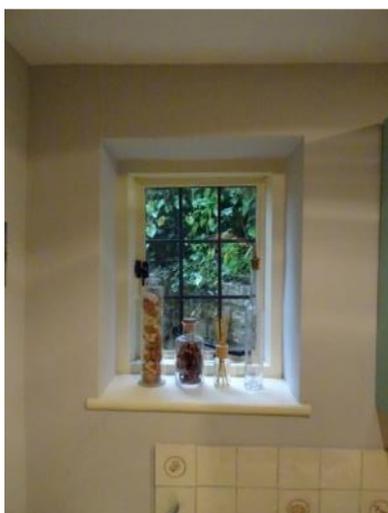
There are indications of historic distortions to both walls and ceiling in line with our findings elsewhere around the property. There are no indications of recent or ongoing movement or significant structural compromise.

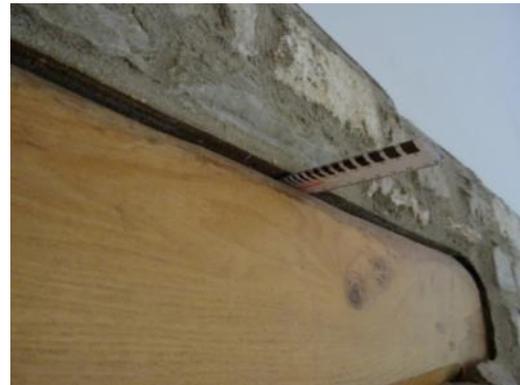
Internal joinery including gloss and varnish finished skirtings, door frames, doors, internal cills and shelving and exposed structural framing generally appear in a satisfactory order. There is some drying back/minor movement around the lintel above the opening to the kitchen. There are no indications of recent or ongoing issue or significant structural compromise and we have included a provisional apportionment for the introduction of slate packing and refinishing to pointing.

There is a blown glazing pane to the rear. We have included provisional apportionment in this respect for replacement.

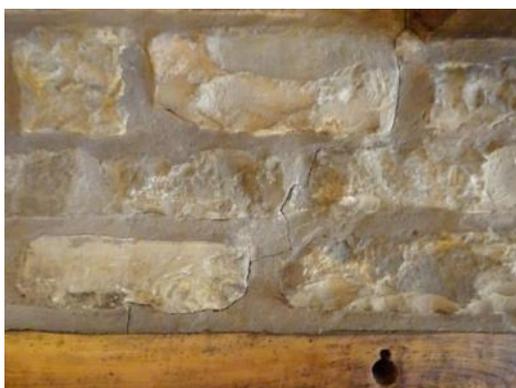
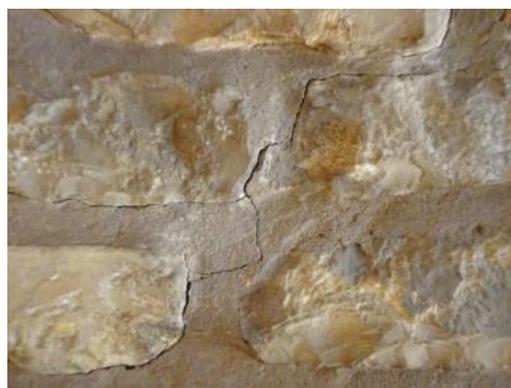
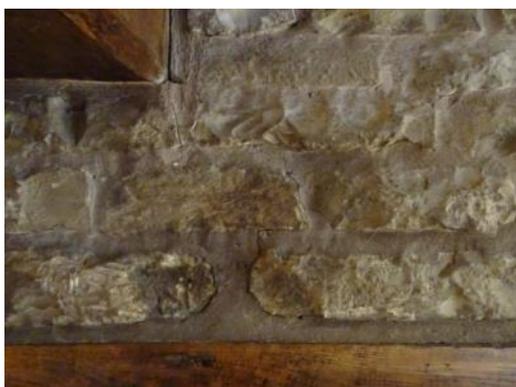
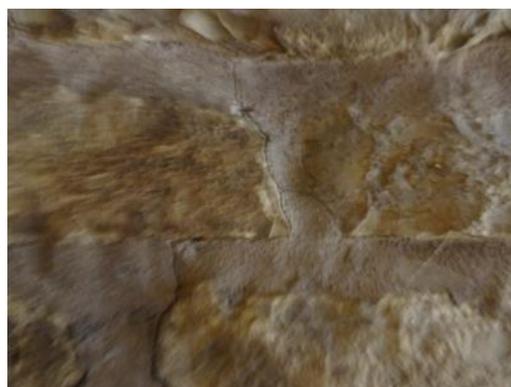
Minor cracking was indicated beneath the principle beam where this bears above the bressummer.

These were indicated of some age. There are no indications of recent or ongoing significant movement or significant structural compromise and these are considered satisfactory.

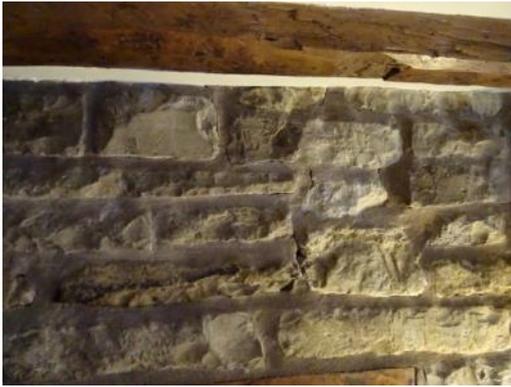
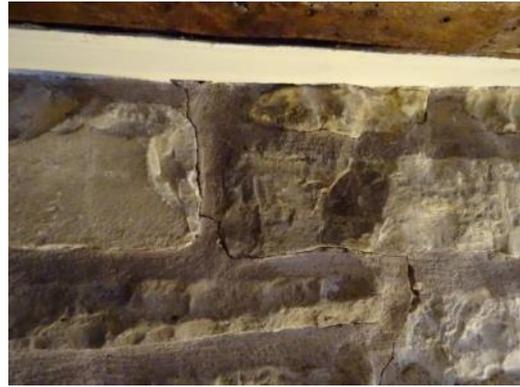
Further minor cracking was indicated to the right of the fireplace position just below ceiling level.

Again there were no indications of recent or ongoing significant movement or significant structural compromise and this is considered satisfactory.

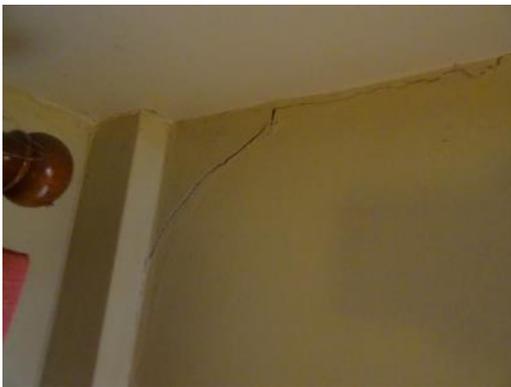
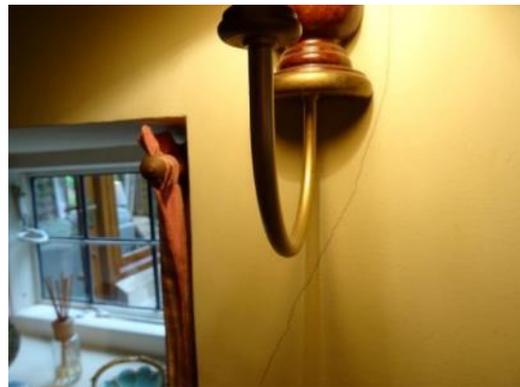
Minor cracking was also indicated around the splayed window position to the rear right corner of the room. The cracking was indicated in the order of 1mm width or less.

In the absence of any significant structural compromise this is considered cosmetic and normal for a property of this age and construction. There were no works arising from our reporting in this respect.

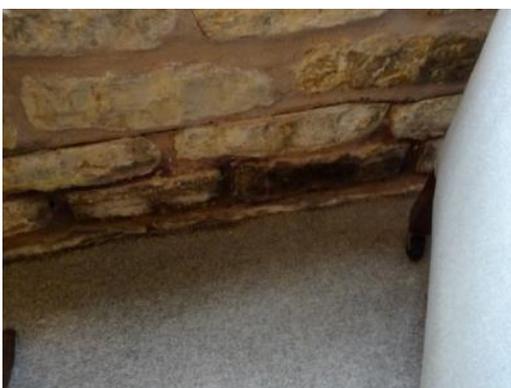
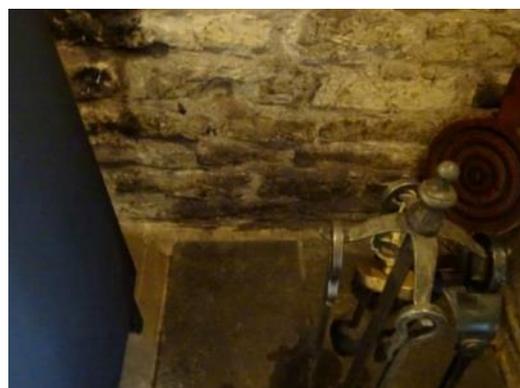
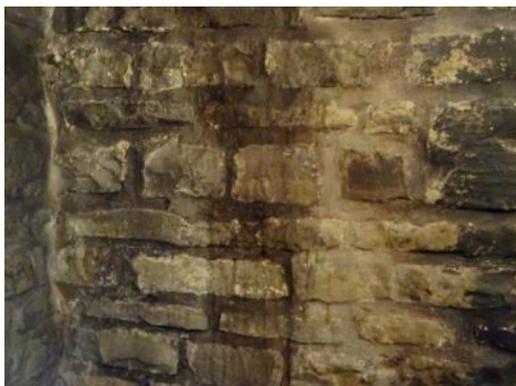
There is some staining to the walling at low level to the front below the window position and within the chimney recess.

These are often indicative of water staining/water ingress. These were checked with a moisture meter and there were no indications of significant elevated moisture levels at the time of survey. Slightly elevated moisture levels were indicated in line with expectations for a property of this age and construction. This is normal within historic construction.

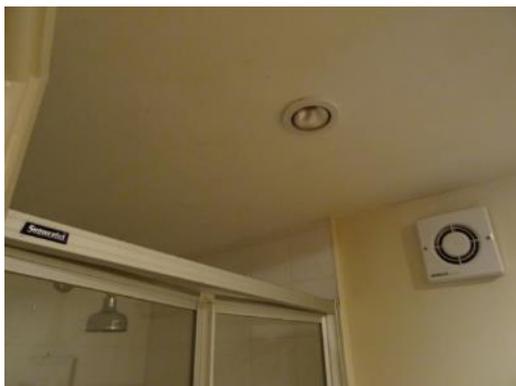
The area is lit by inset ceiling lighting. This does not appear to be ingress protection rated and we are aware of the proximity of the lighting to the shower enclosure. We have included a provisional apportionment for replacement of the light fitting nearest to the shower with an IP67 rated fitting.

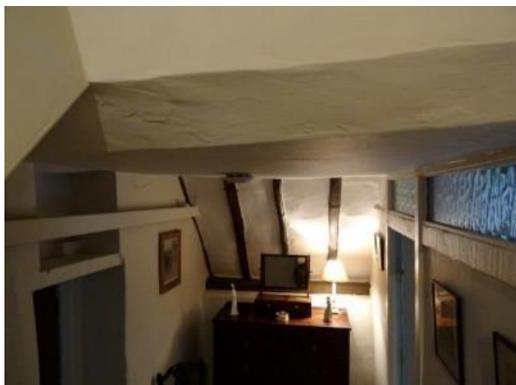
The historic ceilings show evidence of deformation in line with expectations for a property of this age and construction. There are no indications of recent or ongoing deformation or significant cracking or structural compromise.

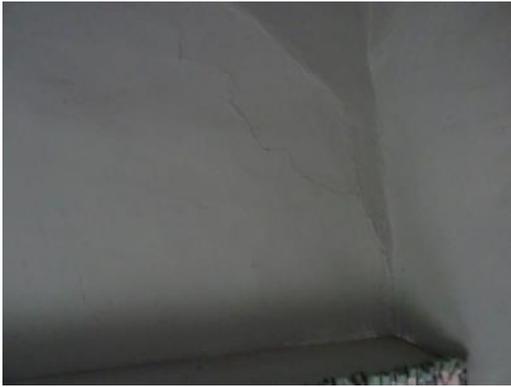
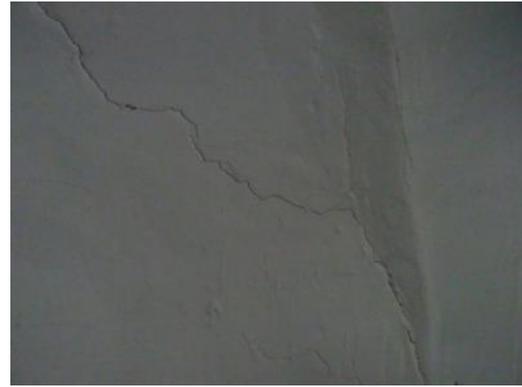
The walls have received both direct plaster and board and skim finishes. The historic walling shows some distortion reflecting the age and construction of the property and minor cracking was indicated above the window position though not considered of significant structural consequence and as a cosmetic repair should be made good at next redecoration.

The cracking was indicated in the order of 0.4mm width and less.
