BUILDING SURVEY

Level 3

ALLCOTT
RESIDENTIAL

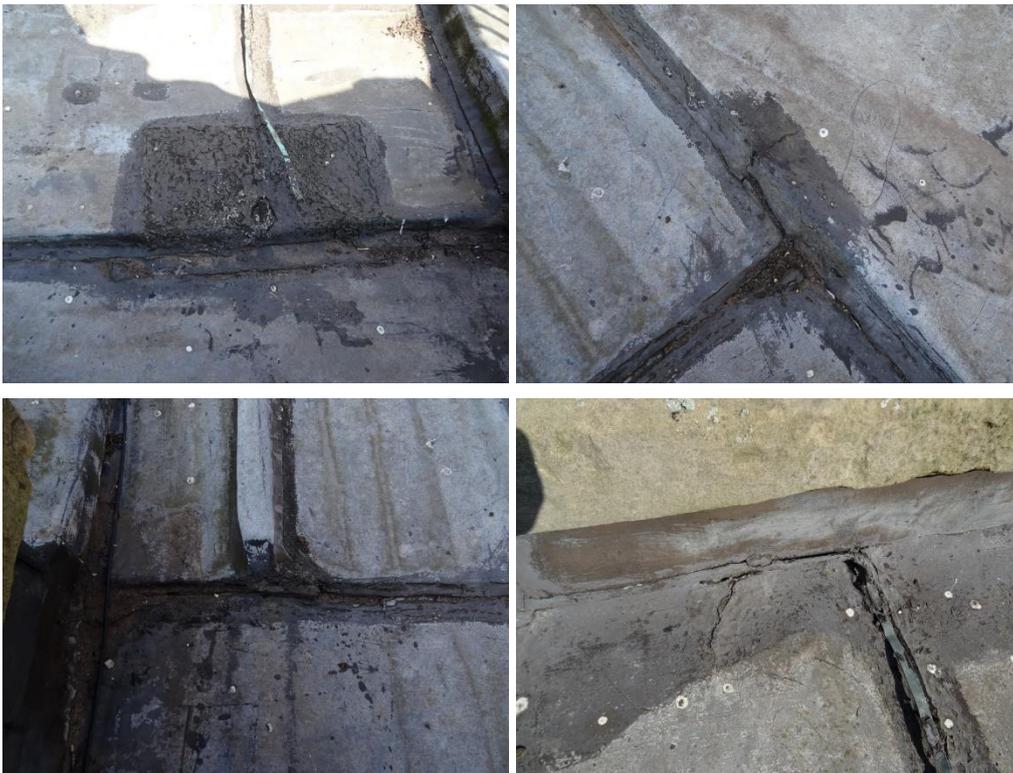
The tower platform capping is formed with dressed lead sheet and this is indicated of some significant age by the graffiti inscriptions.

There are several repairs already carried out and notably there are several splits to the leadwork indicating this is approaching the end of its serviceable life. Whilst acknowledging that the graffiti provides a significant contribution to the social history of the property suitable weather protection must be provided by the leadwork and we recommend that the leadwork capping is planned for replacement within the next 5-10 years as a long term maintenance repair. At that time we recommend the leadwork is inspected and sections retaining where notable graffiti is found. As a longer term maintenance repair no apportionment is included within this reporting for works.

Temporary repairs should be carried out pending replacement of the lead roofing. We have included a provisional apportionment for temporary repairs.

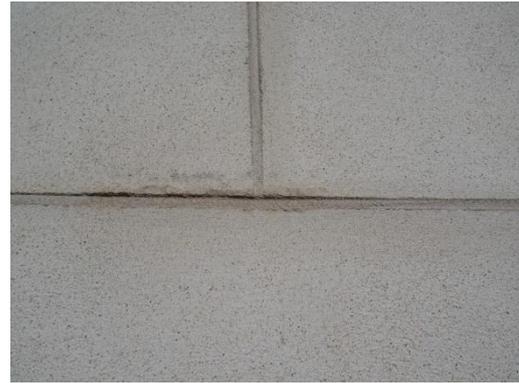
The elevation is in load bearing construction indicated in solid wall construction and of some age. The elevation is finished in a ruled Ashlar effect into render finishes.

We were unable to confirm the render type from a non-intrusive visual inspection and must limit our reporting in this respect. We highlight that cementitious renders can limit the natural absorption and desorption of moisture through the walling and this can lead to moisture transfer internally. The render finishes are indicated a relatively modern work and we recommend enquiries via your Solicitors or the current owners to confirm whether cementitious or lime based materials have been used. If this cannot be confirmed via enquiries then we recommend specialist inspection by a suitably qualified building conservation contractor to establish the type of mortar and its strength. Whilst there were no indications internally of any obvious or significant moisture penetration the type of mortar and potential damage this may cause together with any interim work requirements can prove expensive and we recommend the issue is resolved prior to any commitment to purchase to best protect your future financial interests.

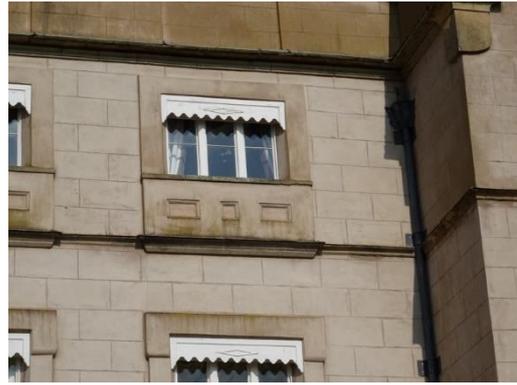
There are minor wall deformations historically.

These are again common in a construction of this age and type and in the absence of any evidence of recent or ongoing movement or significant structural compromise are considered satisfactory.

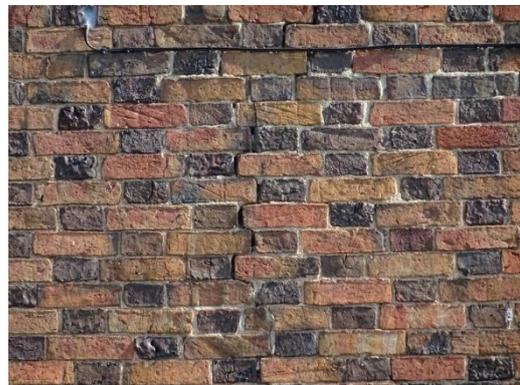
There is minor historic cracking indicated by the age between the ground floor and first floor window surrounds.

We have included a provisional apportionment for brickwork reinforcement and repair to re-establish brick bond locally.

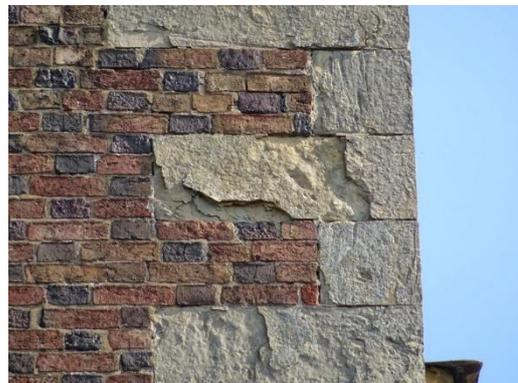
Typical detail shown.

There is again shaling and spalling to stonework.

In line with our advices above this should be programmed as an ongoing maintenance issue with no apportionment included for future repairs.

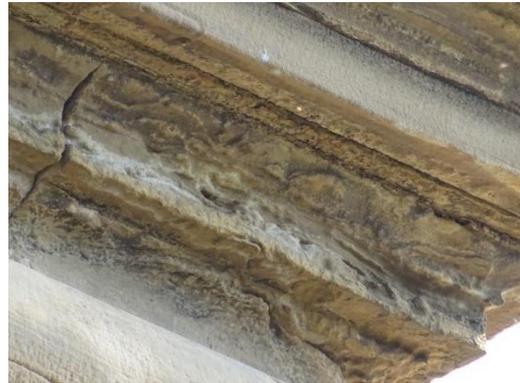
The stonework corbel table and architectural detailing continue across this wall section. These generally appear in a satisfactory order notwithstanding stonework erosion and decay in line with expectations for a property of this age and construction.

These are considered satisfactory in a construction of this age and type. There were no indications of significant loose, detached or unstable materials.

Localised repointing was noted and we have included provisional apportionment in this respect.

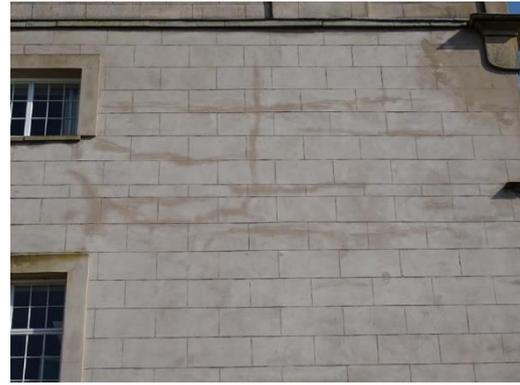
Across the elevation notable through the render finishes there are a series of lines indicative of minor substrate cracking.

There are no indications of significant structural compromise, the extent of cracking might readily be anticipatable in a construction of this age and type, though for example to a brickwork substrate this might be barely noticeable. There were no indications of significant structural compromise. This is considered satisfactory in a property of this age and construction and may reflect previous repairs prior to render refinishing.

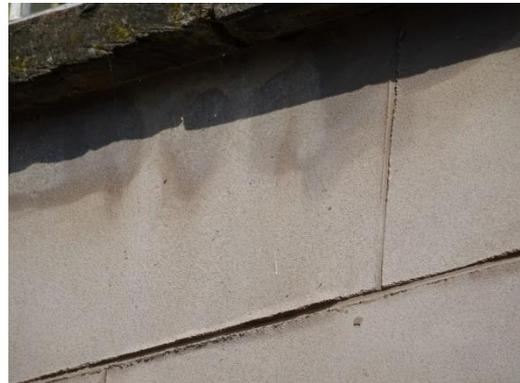
There is minor cracking below the first floor window position.

None were indicative of any significant structural compromise and as external weather tightness repairs should be addressed at the next external works cycle. No apportionment is included in this respect.

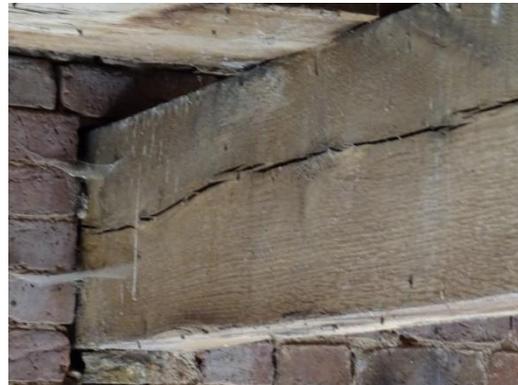
Evidence of a previous infestation was noted to the exposed timbers where we cannot confirm that the infestation is dormant. Unless a recent treatment certificate is available, we would advise that a specialist company is instructed to inspect the timbers and treat as necessary.

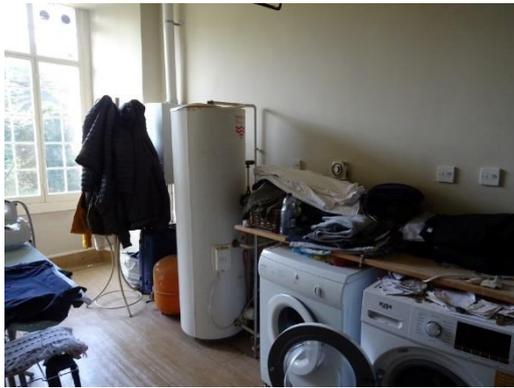
The walls and ceilings are plastered finished with emulsion. Slight board cracking was noted to the ceiling which was of no structural concern and requires filling prior to decoration.

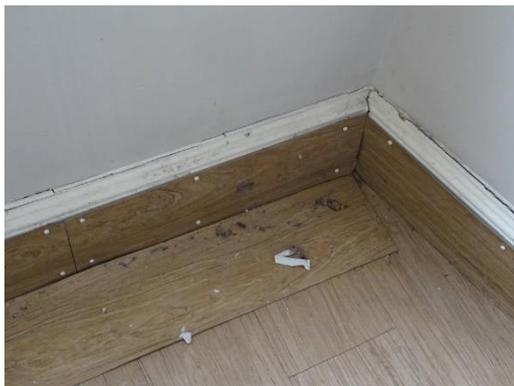
The skirtings were noted to have slightly warped therefore will require localised repairs and securing back to the wall.

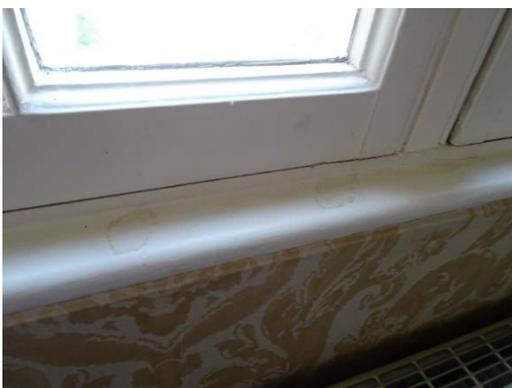
Localised damage was noted to various panes which will require replacing.

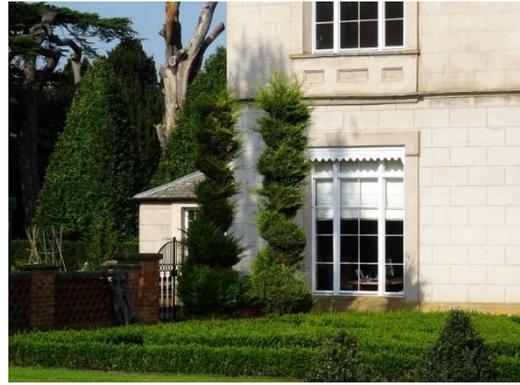
These do not appear to be adversely affecting the property or its foundations at the present time though have the potential to do so if left unchecked. We recommend these are managed and maintained to reduce future foundation movement risks.

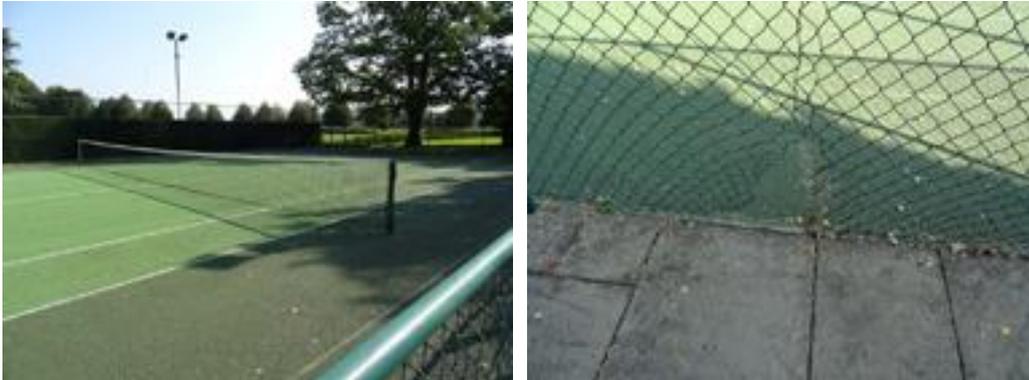
Concrete paving slabs have been laid adjacent to the tennis court which are relatively level however would benefit from general maintenance in the form of removing the vegetation between the joints.

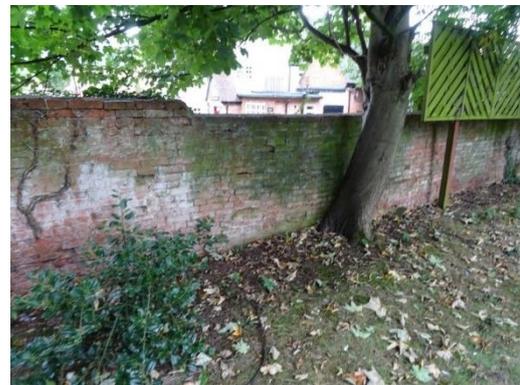
Whilst there were no indications of significant structural compromise repair is required and we have included a provisional apportionment in this respect.
