BUILDING SURVEY

Level 3

This service is delivered in accordance with the Home Survey Standard (1st edition) RICS Professional Statement and is equivalent to Level 3.

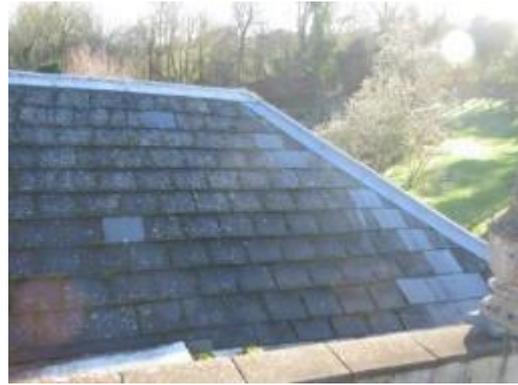
A parapet gutter is formed at the base of the front roof slope. This is provided with a sheet lead lining. The gutter lining is weather stained and there is some vegetation growth and debris to the parapet gutter. We would recommend that the vegetation growth and debris are cleared away to allow effective discharge of the rainwater. The parapet gutter lining appears to be sound and no evidence of water ingress internally was noted, but it is considered likely that some repair works may be required in the medium term.

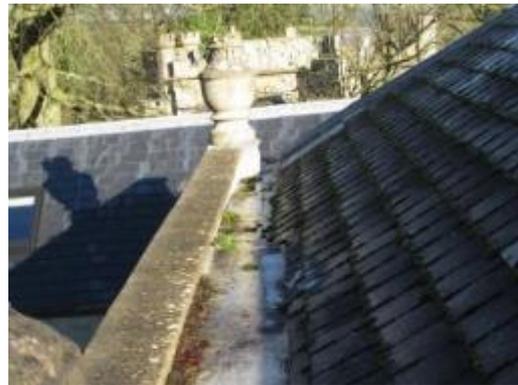
The parapet wall is constructed in solid masonry with a concrete coping over. Some minor areas of defective pointing were noted to the coping, but these are not considered to be significant and can be remedied during the normal course of cyclical maintenance works. The masonry is weather stained, but the parapet wall is otherwise sound.

Two decorative stone urns are provided to the parapet wall. Some mechanical damage was noted to the urn to the left-hand side. We would recommend that this is repaired to minimise the possibility of further erosion and damage to the stonework.

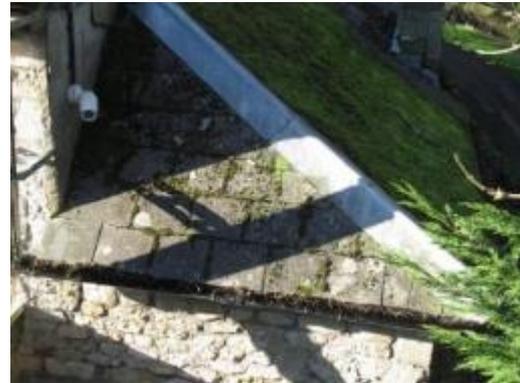
The roof is constructed as previously described. The ridge and hip lines are level. The ridge and hip cappings are weather stained, but are otherwise sound. The roof slope is flat. The roof covering is weather stained and is supporting a very significant quantity of moss growth. We would recommend that the moss growth is cleared off to avoid a build-up of debris within the gutters. The roof covering was largely obscured by the moss growth, but it is anticipated to be in a similar condition to the other main roof slopes. It is likely that

some maintenance and repair works will be required in the short to medium term. We would recommend that consideration be given to renewing the roof covering in the medium to long term.

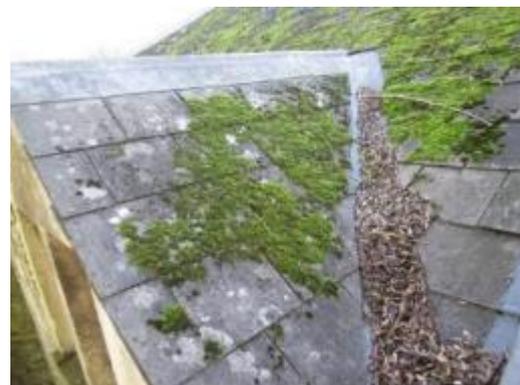
A parapet gutter is formed at the base of the main roof slope. The gutter is provided with a sheet lead lining. This was almost completely obscured by debris at the time of our inspection and we cannot therefore comment on its condition. No evidence of water ingress internally was noted. We would recommend that the debris is cleared away to allow effective discharge of the rainwater and a detailed inspection of the gutter.

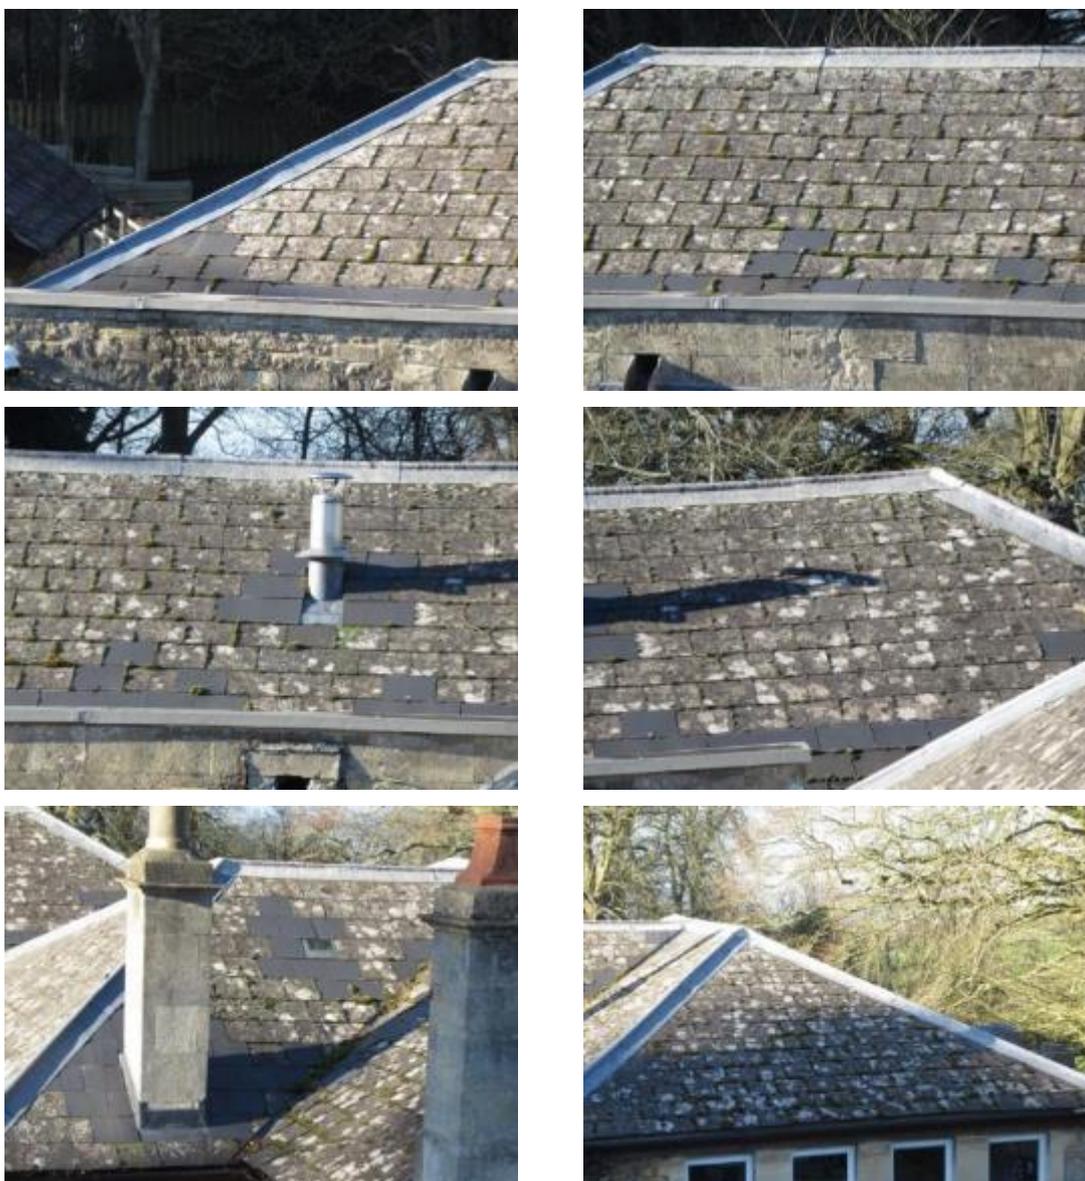
The main roof areas are constructed as previously described. Some slight deflection was noted to the ridge line of the main roof, but this was not excessive and is not unusual in properties of this age and type of construction. The ridge and hip cappings are weather stained, but are otherwise sound. Some slight deflection was noted to the main rear roof slope. This was not excessive and is not unusual in properties of this age and type of construction. The finish to the roof covering is denatured and weather stained and the roof coverings are supporting a quantity of moss growth. We would recommend that this is cleared off periodically to avoid a build-up of debris within the gutters. There is evidence of numerous previous repairs to the roof slopes in isolated locations, particularly to the centre rear roof slope. The roof coverings are sound and weathertight presently, but it is anticipated that ongoing repair and maintenance works will be required in the short to medium term. We would recommend that consideration be given to renewing the roof coverings completely in the medium to long term.

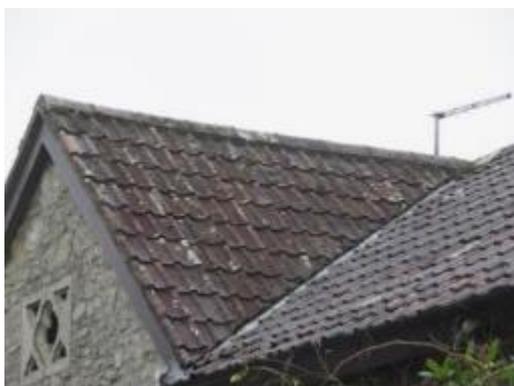
A valley gutter is formed at the intersection of the roof to the bay with the main roof slope. This is provided with a sheet lead lining. The valley gutter lining is weather stained and a small quantity of debris was noted within the valley gutter, but it is otherwise sound and no evidence of water ingress internally was noted. We would recommend that the valley gutter is cleared out to allow effective discharge of the rainwater.

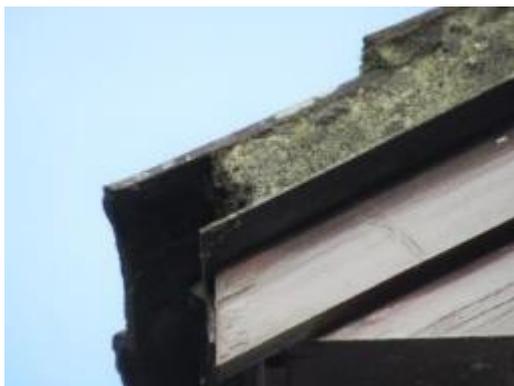
The fascias, verge boards, and soffits are timber. The decorations to the external joinery, particularly to the verge boards and dormers, are in fair condition only with areas of flaking and otherwise defective paintwork. We would recommend that all of the external joinery is prepared and redecorated.

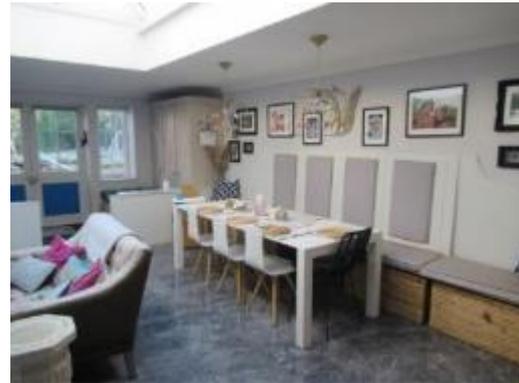
The ceiling and walls are plastered and painted. A decorative coving detail has been provided to the perimeter of the ceiling. Some slight damp staining was noted to the coving above the right-hand side external wall and some corrosion was noted to the angle beads to the head of the window reveals. It appears that there has previously been some water ingress in this location.

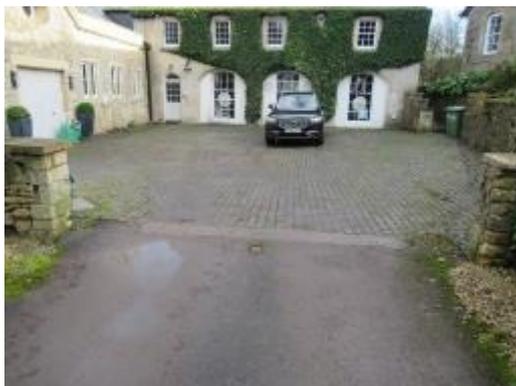
There is a courtyard to the front of the Coach House. This is surfaced with clay stable block type paviours. An Aco type drainage channel is provided to the right-hand side of the paved area. It is anticipated that this is connected into the surface water drainage system. The surface of the paving undulates noticeably. This is likely to be a consequence of some settlement of the sub-base due to the vehicular traffic over the courtyard. This is not considered to be significant, but some local repairs will be required in the short to medium term.

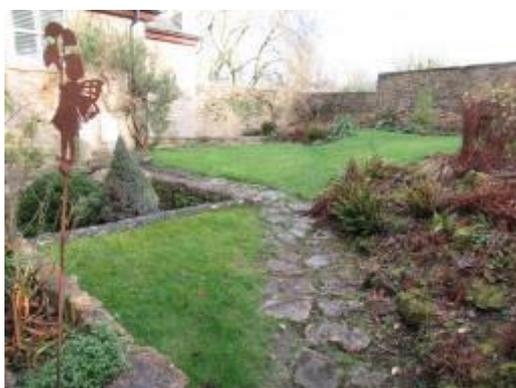
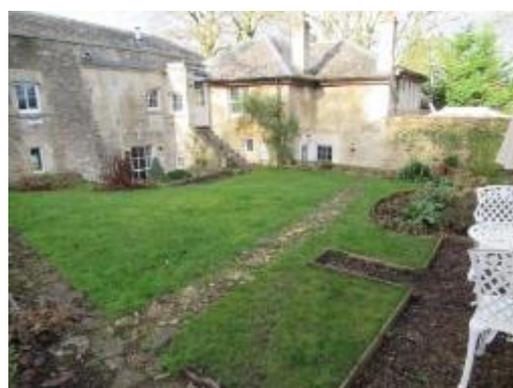
The rear garden is bounded by the wall of the Walled Garden. This is constructed in solid masonry with random rubble stonework and a stone coping over. A number of areas of loose, displaced, and otherwise defective stonework were noted and there are a number of areas of defective pointing. We would recommend that any areas of loose, displaced and defective stonework are repaired and re-bedded as required and that any areas of defective pointing are raked out and repointed.

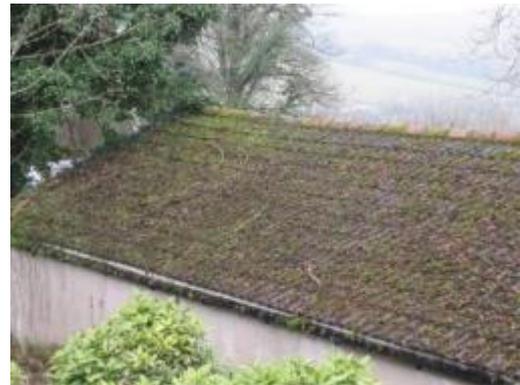
The gutter is half round PVCu with a circular downpipe. A brush leaf guard is fitted. The rainwater goods are soiled and weather stained and the downpipe is displaced presently. This is allowing rainwater to discharge over the face of the external masonry which will lead to water penetration internally in time. We would recommend that the rainwater goods are cleared out, cleaned down, and overhauled with any leaking joints made good as necessary and the displaced downpipe reinstated.

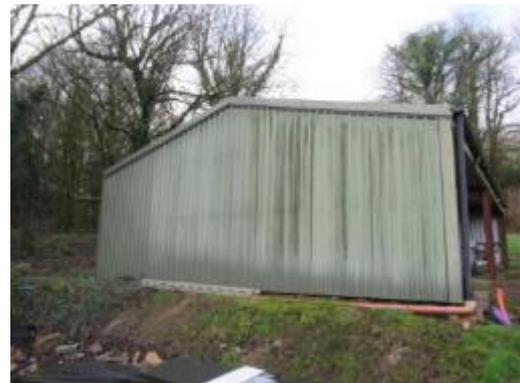
The verge capping to the right-hand side elevation is damaged as previously described. We would recommend that the damaged sections of capping are replaced.

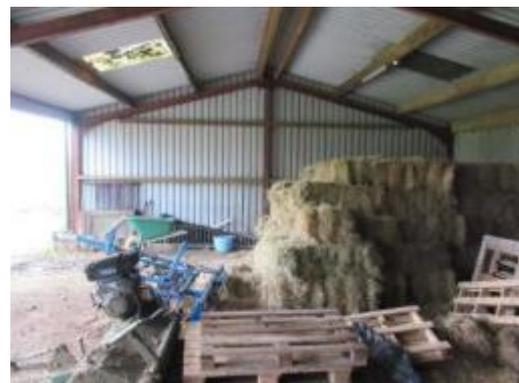
The cladding rails and purlins are timber. As noted above, there is evidence of water ingress internally through the fixings to the roof cladding panels and there is some water staining to a number of the purlins. The purlins and cladding rails are sound and serviceable presently, but if the water ingress to the roof covering is not addressed in the near future this will lead to decay to the purlins and a loss of structural strength.

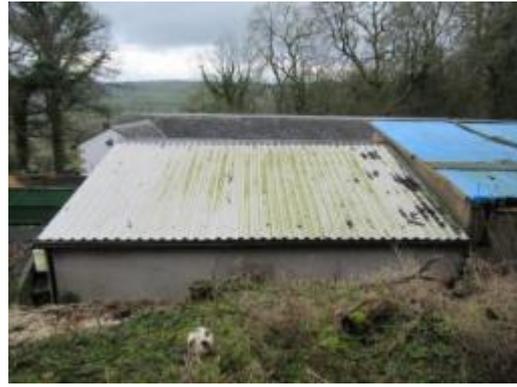
The gutter is half round PVCu with a circular downpipe that discharges onto the adjacent ground. The rainwater goods are soiled and weather stained and there is evidence of some slight leaks to the joints in a number of locations. We would recommend that the rainwater goods are cleared out, cleaned down, and overhauled with any leaking joints made good as necessary.
