# BUILDING SURVEY

## Level 3

**ALLCOTT**  
RESIDENTIAL

Somewhere Street, Anywhere, Everyplace,  
EV1 1WX

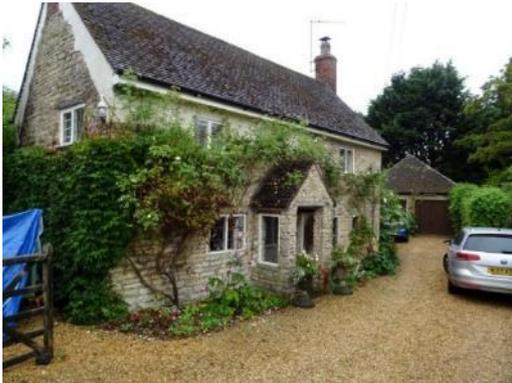
Our inspection to the elevation was limited by trailing vegetation and our reporting must be limited in this respect. We recommend the elevation is reinspected when the vegetation is next cut back or removed, together with the completion of any necessary additional remedial repairs identified at that time. No apportionment is included in this respect.

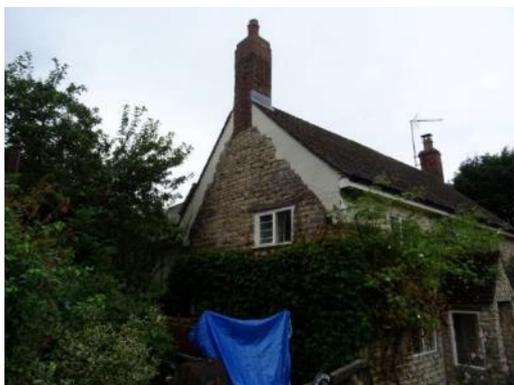
#### **Left Elevation**

The left most chimney described to the front elevation again presents to the left gable and this is as previously described with no significant additional issue indicated.

The roof edge detail is formed with an oversailing concrete tile edging with mortar bedding to the wall head. This generally appears in satisfactory order.

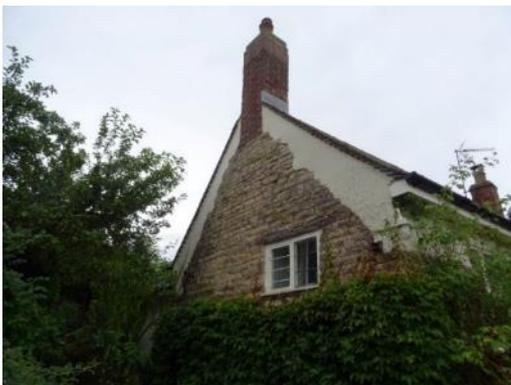
There were indications of historic wall deformations in particular around the base of the chimney and above eaves level.

We are mindful of the propensity of cementitious mortars to disproportionately exhibit cracking. There were no indications of recent or ongoing significant cracking or significant structural compromise. Minor cracking was indicated, but considered to reflect normal seasonal movement and we have included provisional apportionment for repointing repairs locally.

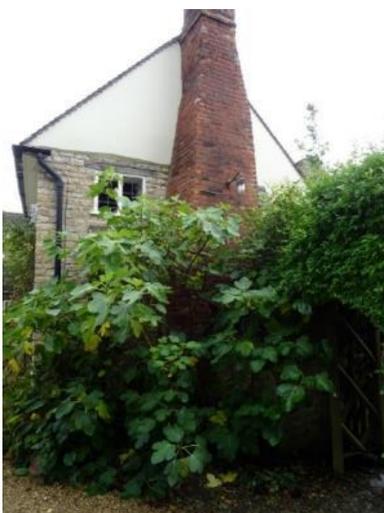
There is minor cracking to the chimney.

The chimney shows evidence of distortion historically. This is not unusual in a property of this age and construction. There are no indications of recent or ongoing significant movement or significant structural compromise and this is considered satisfactory.

We have included provisional apportionment for localised repair.

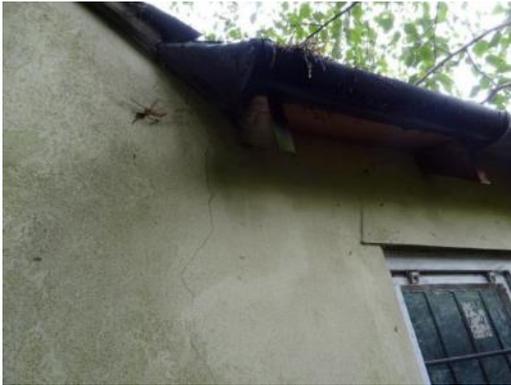
We found no evidence of significant cracking or structural deformation to the main load bearing walls generally. Minor cracking was indicated above both front vehicular doors and below the position at the junction of building units to the rear.

There are no indications of significant structural compromise. Our recommendation is limited to localised repair. We have included provisional apportionment in this respect.

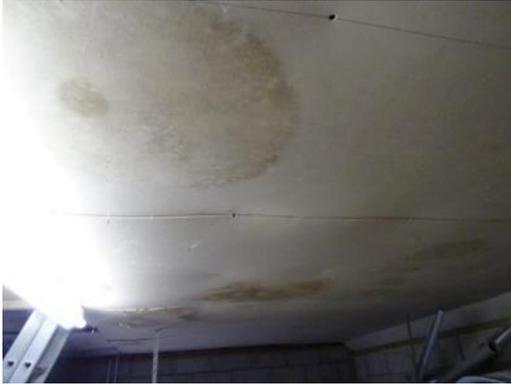
Inspection from below shows various areas of water damage and these were confirmed active when tested with the use of a moisture meter.

There were no obvious indications of significant compromise to the roof membrane and the source of moisture is unclear. We are however mindful of the significant extent of the owners' possessions to the area and must limit our reporting in this respect.

We recommend further inspection following clearance of the owners' possessions together with the completion of any necessary additional remedial repairs identified at that time. Our apportionment is included in this respect.

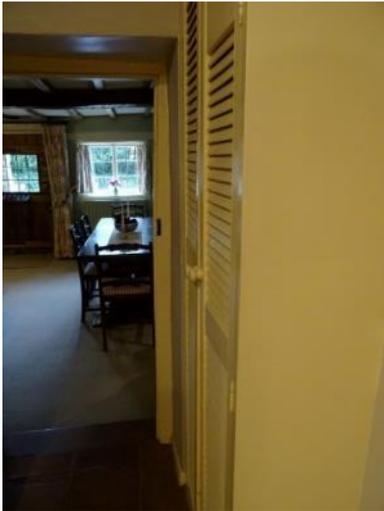
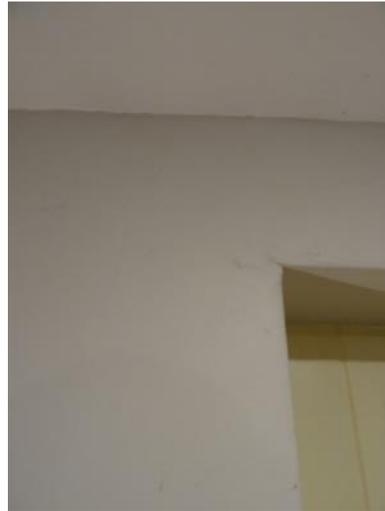
Minor cracking was indicated to the flanking wall to the range opening. The cracking was measured in the order of 0.6mm width and less. Notably the cracking is indicated to the exterior of the area but not internally, suggesting this may be historic. In the absence of any significant structural compromise this is considered cosmetic and should be made good at the next redecoration.

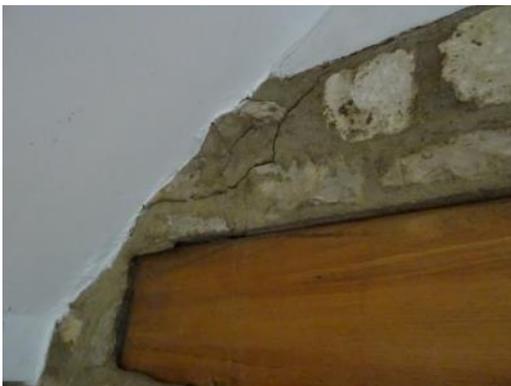
Internal joinery including gloss and varnish finished skirtings, door frames, doors, internal cills and shelving and exposed structural framing generally appear in a satisfactory order. There is some drying back/minor movement around the lintel above the opening to the kitchen. There are no indications of recent or ongoing issue or significant structural compromise and we have included a provisional apportionment for the introduction of slate packing and refinishing to pointing.

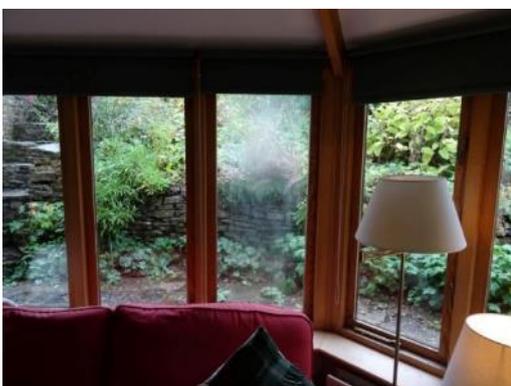
There is a blown glazing pane to the rear. We have included provisional apportionment in this respect for replacement.

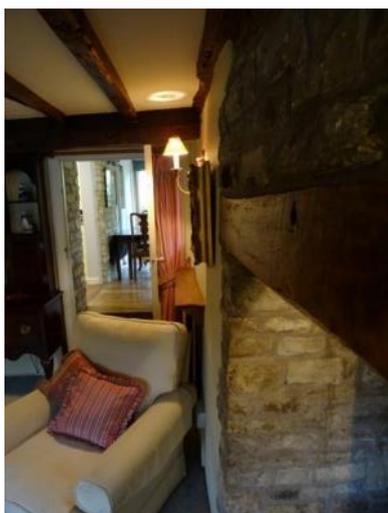
Minor cracking was indicated beneath the principle beam where this bears above the bressummer.

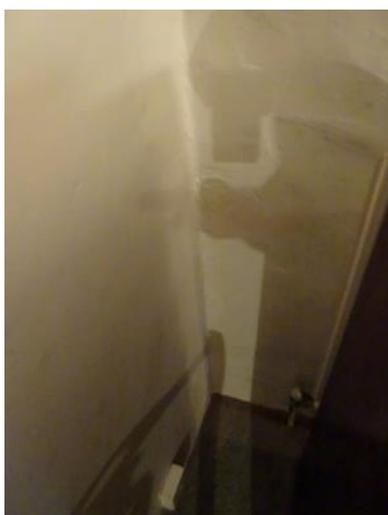
Minor cracking was indicated at the junction between direct plaster and lath and plaster finishes to the right wall adjacent to the doorway position.

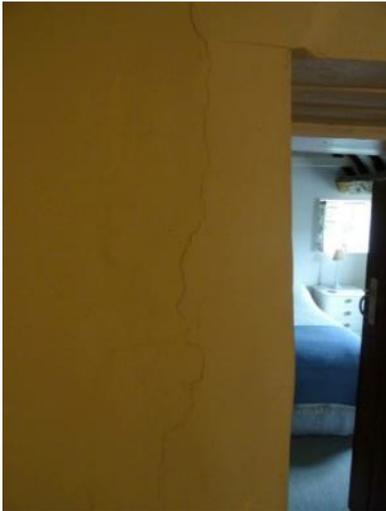
The cracking was indicated in the order of 0.35mm width and less and considered cosmetic.

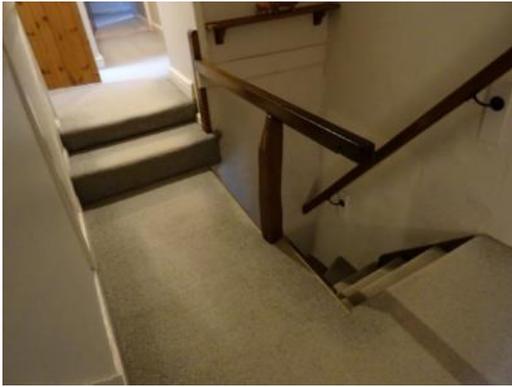
The internal joinery including gloss and varnish finished skirtings, architraves, door frames, doors, shleving and exposed historic and structural timberwork, stair handrailing and balustrading generally appear in a satisfactory condition. The balustrade would not meet the requirements of the modern Building Regulations there are no retrospective compliances required and this is considered satisfactory.

You may wish to consider introducing additional balustrading elements to improve safety though there are no requirements arising from our reporting in this respect and no apportionment included in this respect.

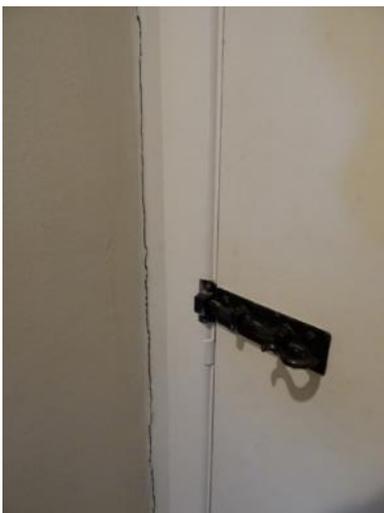
There is minor cracking between the walls at the juncture by the hot water cylinder cupboard. This is not considered of significant structural consequence neither being load bearing and as a cosmetic repair should be made good at next redecoration. Typical detail shown.

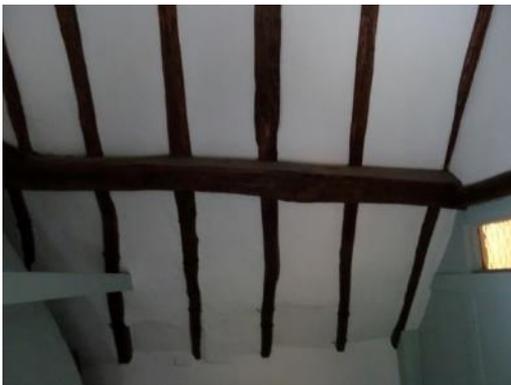
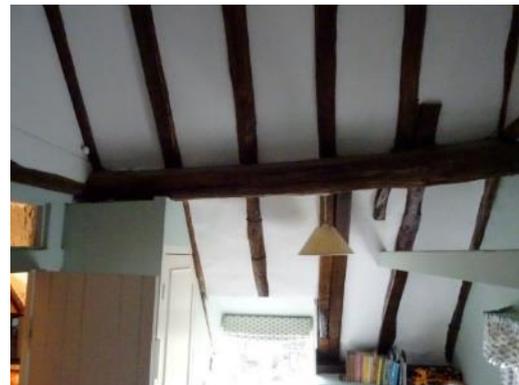
The walls have received both direct plaster and board and skim finishes. The historic walling shows some distortion reflecting the age and construction of the property and minor cracking was indicated above the window position though not considered of significant structural consequence and as a cosmetic repair should be made good at next redecoration.

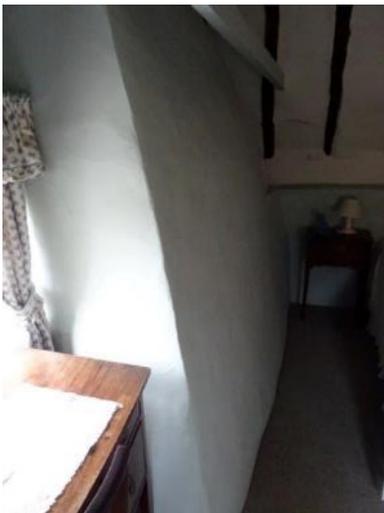
There is a significant batter to the chimney hood above the inglenook below. This is normal in a property of this age and construction and considered satisfactory. Minor cracking was indicated to the hood walling. This was not considered significant structural and as a cosmetic repair should be made good at next redecoration.

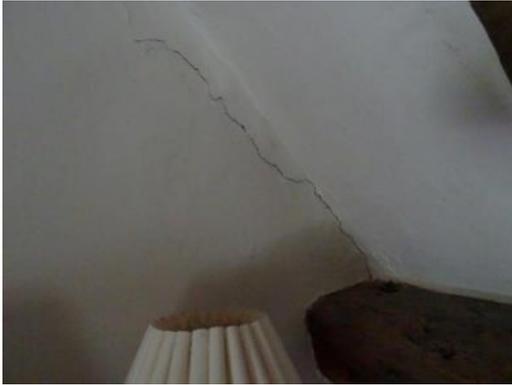
Minor cracking was indicated at the juncture between wall and ceiling finishes.

This is to be anticipated in a property of this age and construction reflecting normal seasonal movement. There are no indications of significant structural compromise and this is considered satisfactory.

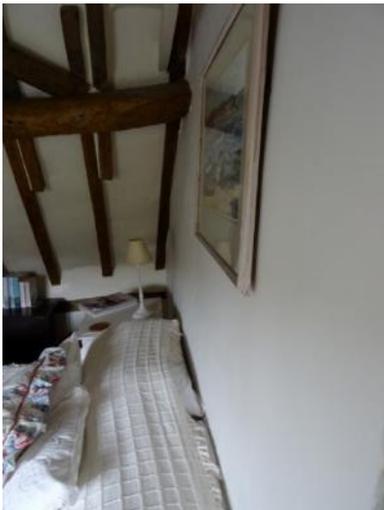
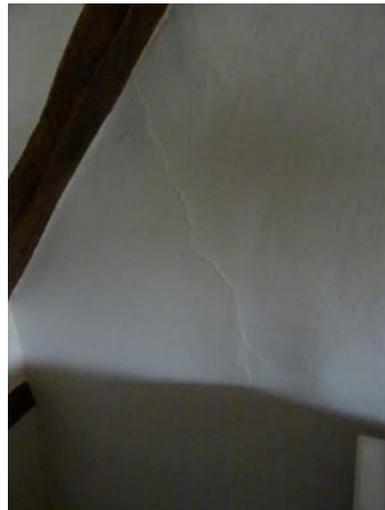
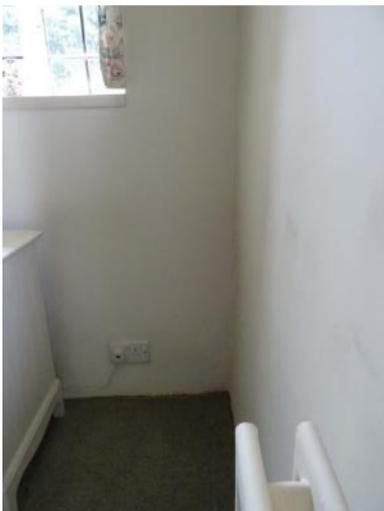
Historic cracking was indicated to the right wall and in addition there were historic deformations to the walling.

These are in line with expectations for a property of this age and construction. There are no indications of recent or ongoing significant movement or significant structural compromise and these are considered satisfactory.

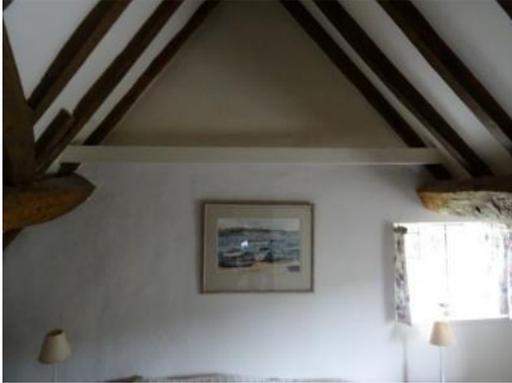
There is a timber strapping detail between the front and rear roof slopes similar to that to the front left room.

There were no indications of subsequent recent or ongoing movement or significant structural compromise.

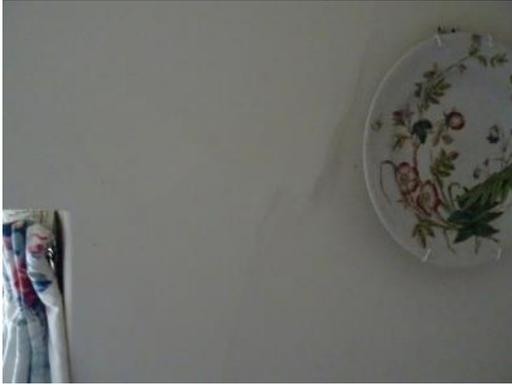
There was minor cracking to the walling though not considered significant structurally and as a cosmetic repair should be made good at next redecoration.

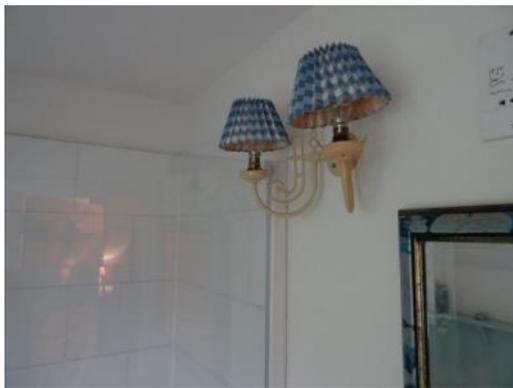
The area is lit by a standard wall mounted fitting which is positioned adjacent to the bath/shower area and above the wash hand basin. We recommend its replacement with an IP44 rated fitted shortly following purchase.

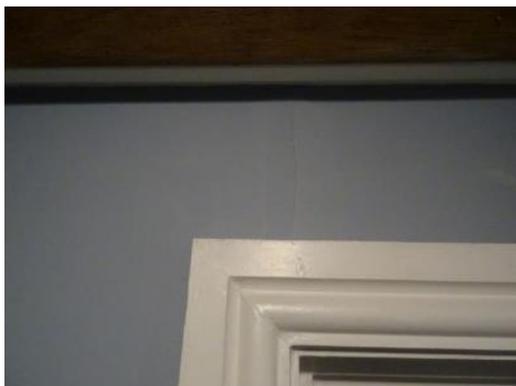
Minor cracking was indicated above the door position. This is not considered of significant structural consequence and as a cosmetic repair should be made good at next redecoration.

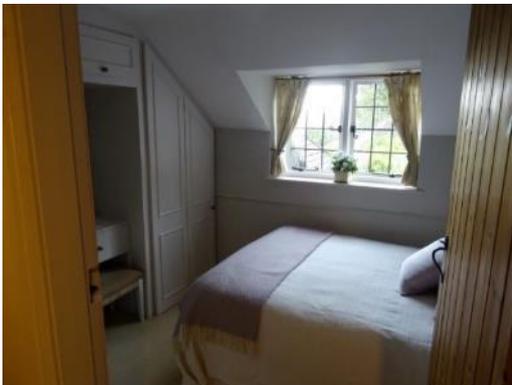
### **Middle Right Bedroom**

The ceiling is formed in plaster finishes including to underdrawn sections. We found no evidence of significant cracking or structural deformation. There are historic deformations to the wall plate level in line with expectations for a property of this age and construction. There were no indications of recent or ongoing movement or significant structural compromise. This is considered satisfactory.

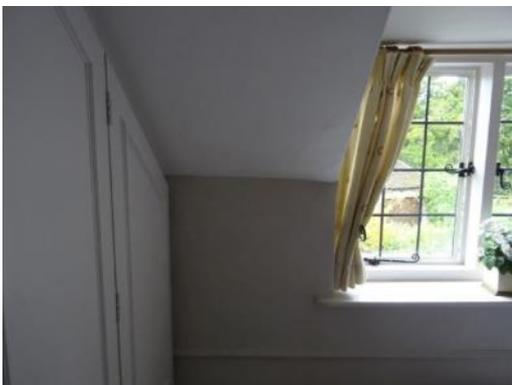
The walls have received direct plaster and board and skim finishes and generally appear in a satisfactory condition with no evidence of significant cracking or wear and tear. Hairline

cracking was indicated. This is not considered significant structurally and as a cosmetic repair should be made good at next redecoration.

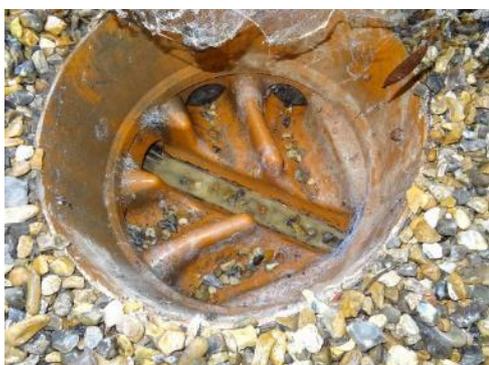
### **Drainage**

The drains run to a modern septic tank via a modern polycarbonate pipe system which was clear of blockages at the time of our inspection.

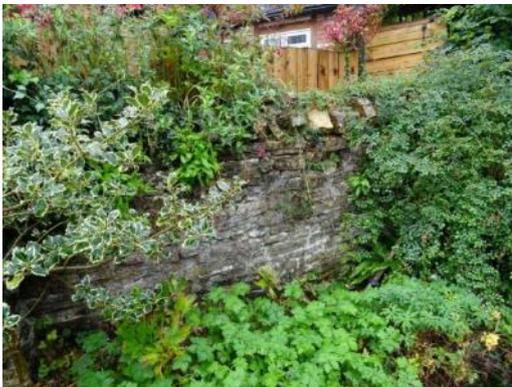
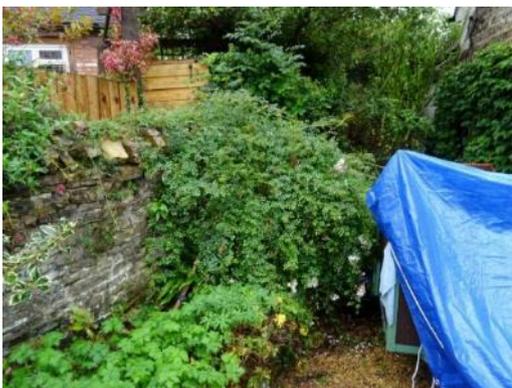
To the left there is a stone wall between this and the adjoining property. There is some outward lean to the wall from the adjoining property and the wall levels within the adjoining garden are indicated raised.

The extent of wall lean could not be fully identified at the time of survey given the extent of vegetation growth against the walling from the garden planting.

We recommend the walling is reinspected when the vegetation is next cut back or removed together with the completion of any necessary additional remedial repairs identified at that time. No apportionment is included in this respect.

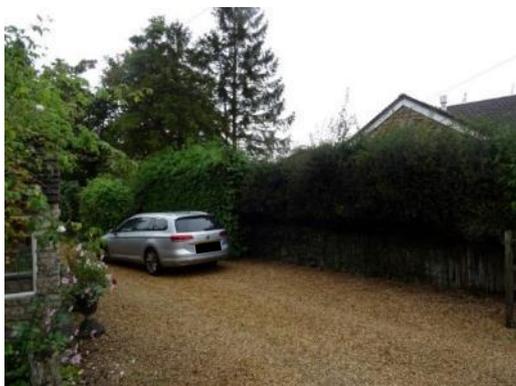
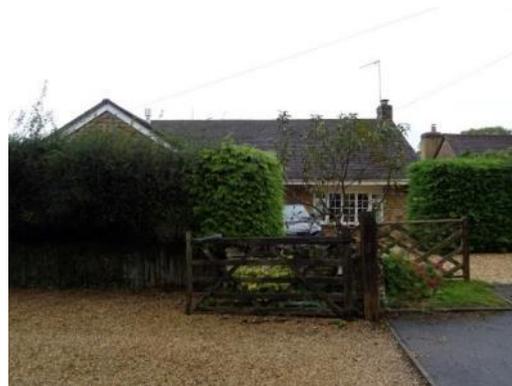
There are maturing tree growths including coniferous growths to this and the adjoining property. We recommend these are managed and maintained to reduce future foundation movement risks. Where the vegetation is positioned within the adjoining property this should be via undertakings sought through your Solicitor from the adjoining owners that the vegetation will be managed and maintained to reduce future foundation movement risks.

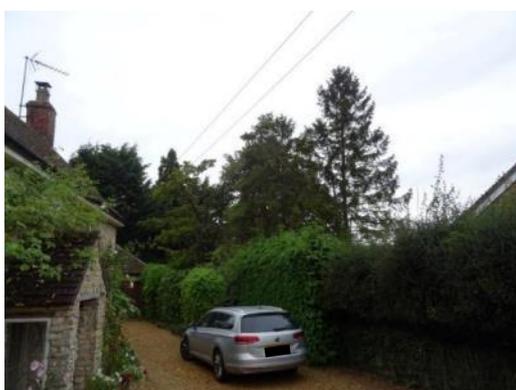
There are further trees within the adjoining ownership to the front. Again we recommend the seeking of undertakings via your Solicitor that these will be managed and maintained to reduce future foundation movement risks.

There were no indications of significant structural movement associated with the tree and hedge plantings at the time of survey.

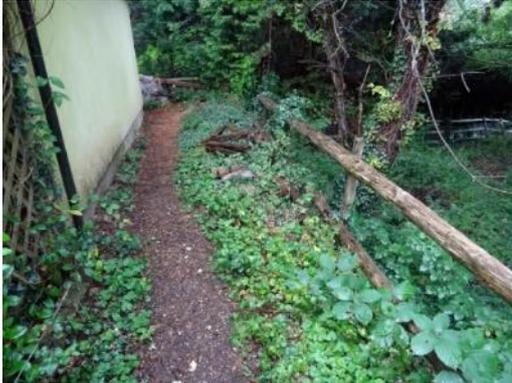
Beyond the footpath there is a retaining wall providing support to the property over that below to the front.

We recommend obtaining confirmation via your Solicitor of any rights of support to and from the property in this respect.

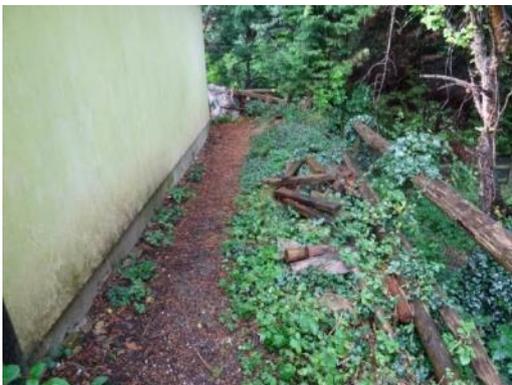
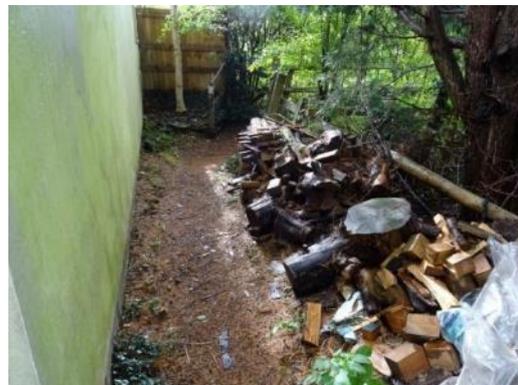
The area alongside contains various logs and timber materials together with some building materials. We recommend these are kept clear if the land is shown within the ownership of the property or removed if this is shown out with the property. Your Solicitor should confirm the precise boundary positions around the property together with ownership, access arrangements, entitlements, obligations and any maintenance repair liabilities.

Similarly in addition to the rights of support enquiry is recommended to your Solicitor we also recommend obtaining confirmation of any liabilities to demarcate or limit the change in levels and any responsibilities to provide guarding for same.

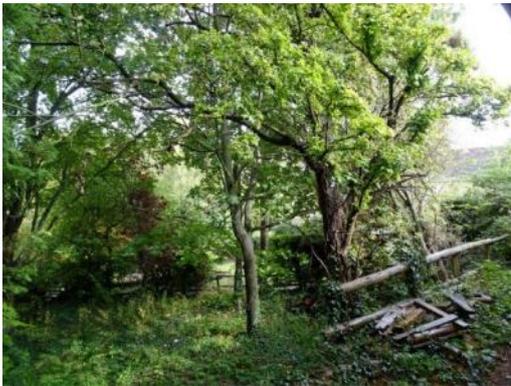
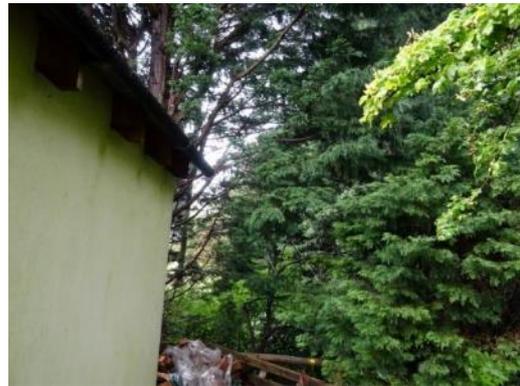
Beyond the indicative boundary fencing there are mature tree growths.

In line with our advices above we recommend a seeking of undertakings from adjoining owners that these will be managed and maintained to reduce future foundation movement risks.

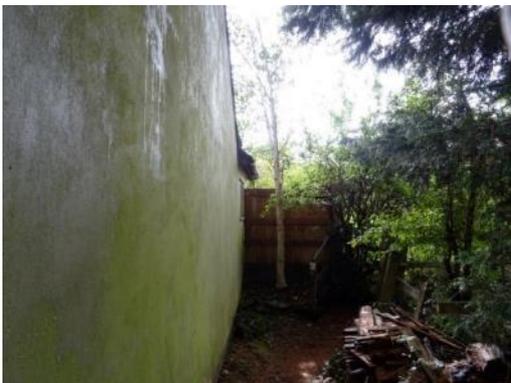
There is a maturing growth immediately to the rear of the garage which is indicated with the property. This should be managed and maintained to reduce future foundation movement risks or preferably removed.

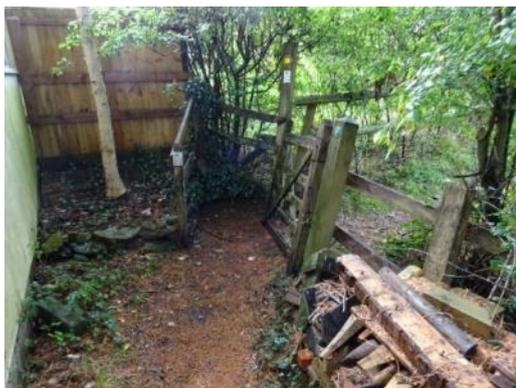
The rear indicative boundary is in timber fencing with a gate inset. These are significant decayed. In line with the recommendations above we recommend obtaining confirmation via your Solicitor of ownership and any maintenance repair liabilities.

No apportionment has been included at this stage pending clarification of liabilities.

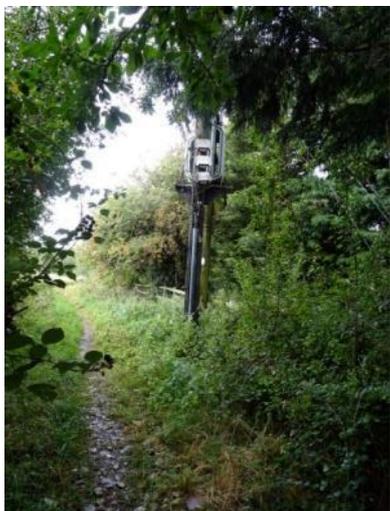
Beyond the garden and alongside the pathway to the rear there is an overhead electric cabling installation and transformer. This is mentioned for reference purposes.

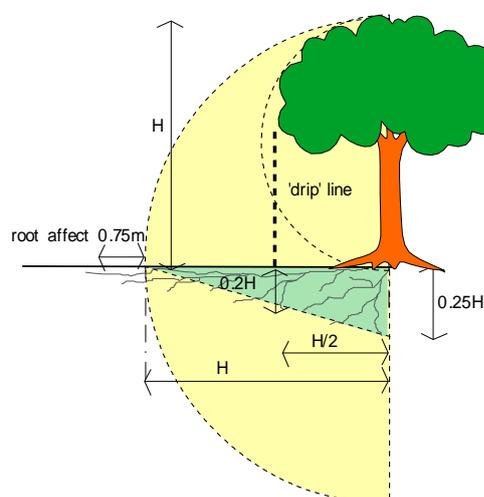
Of particular concern in the apple tree close to the right hand gable which we have advised be reduced in the immediate term.

Typical proportions of an Apple tree. Note the potential root zone.
