BUILDING SURVEY

Level 3

ALLCOTT
RESIDENTIAL

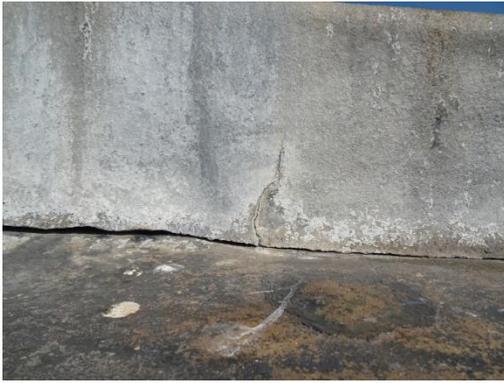
The tower platform capping is formed with dressed lead sheet and this is indicated of some significant age by the graffiti inscriptions.

There are several repairs already carried out and notably there are several splits to the leadwork indicating this is approaching the end of its serviceable life. Whilst acknowledging that the graffiti provides a significant contribution to the social history of the property suitable weather protection must be provided by the leadwork and we recommend that the leadwork capping is planned for replacement within the next 5-10 years as a long term maintenance repair. At that time we recommend the leadwork is inspected and sections retaining where notable graffiti is found. As a longer term maintenance repair no apportionment is included within this reporting for works.

Temporary repairs should be carried out pending replacement of the lead roofing. We have included a provisional apportionment for temporary repairs.

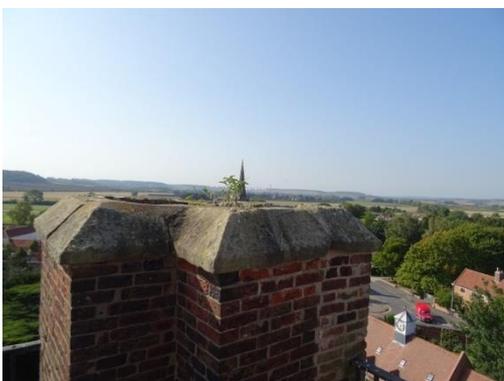
The tower crenellations include chimney flues. There is some vegetation growth and this should be carefully removed and the chimney provided with a ventilated capping if no longer in use. As a maintenance issue no apportionment is included in this respect.

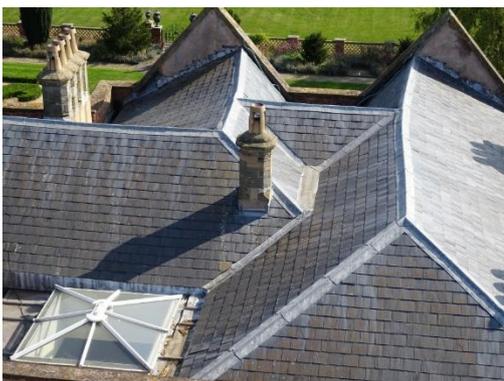
Localised slatework issues were indicated and repair is recommended.

Typical detail shown.

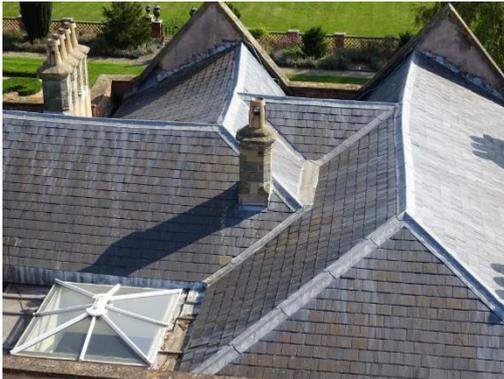
Historic roof deformations were noted from our high level tower vantage. These are common in buildings of this age and type. In the absence of any significant recent movement or significant structural compromise these are considered satisfactory.

Typical detail shown

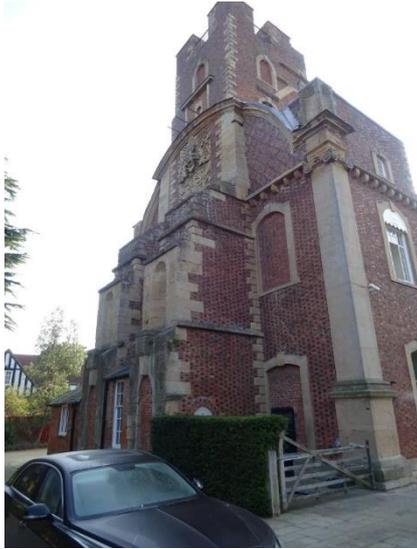
No inspection of the roofing to the rear left adjacent to the tower was possible. Our reporting is limited in this respect. We reiterate our advices above for inspection when high level access is next available together with the completion of any necessary additional remedial repairs identified at that time.

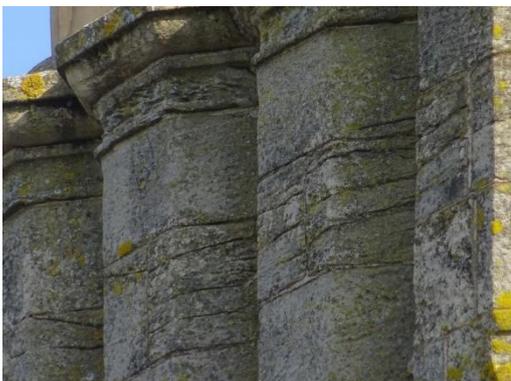
The stacks are all of similar or like type and generally appear in satisfactory order with no obvious or significant issues indicated. There are stone bedding plane lines to the chimney faces which appear across the flues.

These are indicative of the natural stone formation and in the absence of any significant issue or compromise are considered satisfactory.

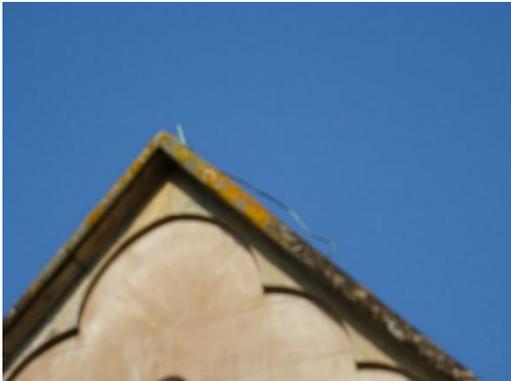
There are roof edge projecting gables in stonework with stone hood mouldings. There were no indications of significant cracking, structural deformation, delamination, splits or displacement. There are lightning conductor terminals to the head of each gablet. These generally appear in satisfactory order. There is some detachment of the lightning conductor tape to the front right and we have included provisional apportionment in this respect for high level attendance, inspection and repair.

We are not aware of any inspection or testing arrangements for the lightning conductor system or any recent results and we must limit our reporting in this respect. We recommend enquiries via your Solicitor or the current owner to confirm any recent test results together with confirmation that any required works arising have been completed or any additional insurers requirements arising have been completed. Alternatively if this is not available inspection and testing of the lightning conductor system should be completed by a suitably qualified engineer shortly following purchase.

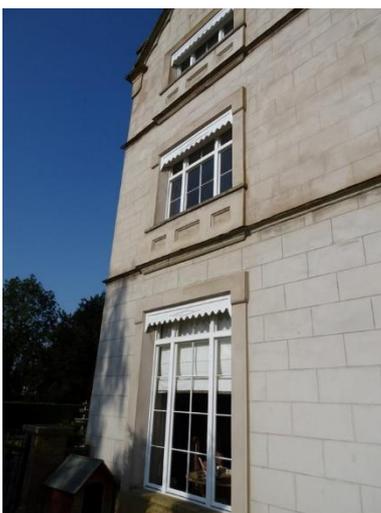
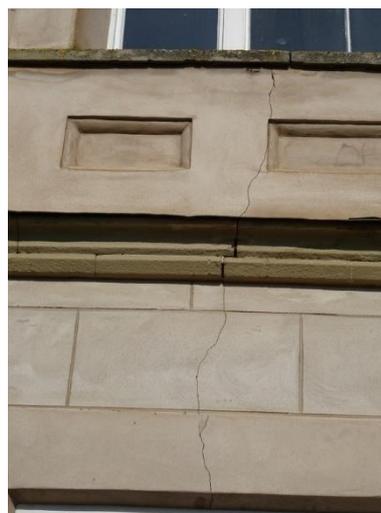
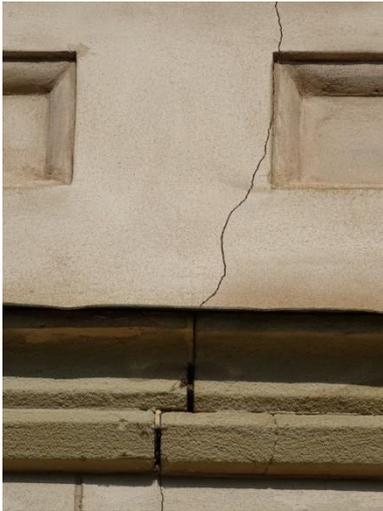
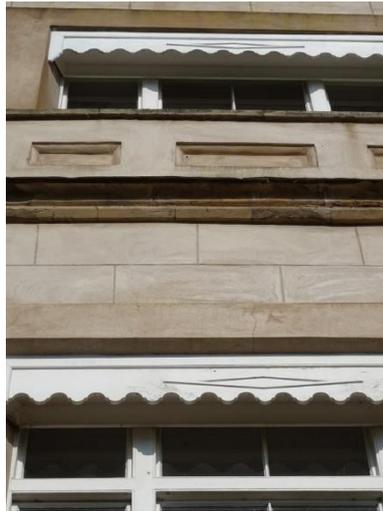
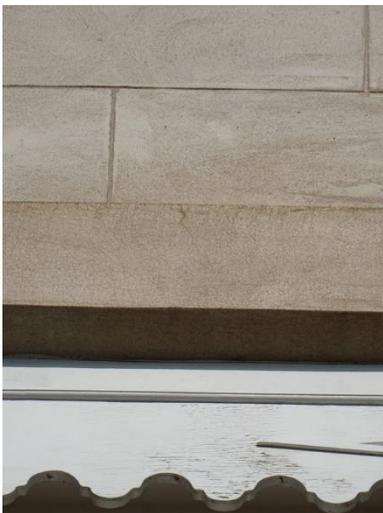
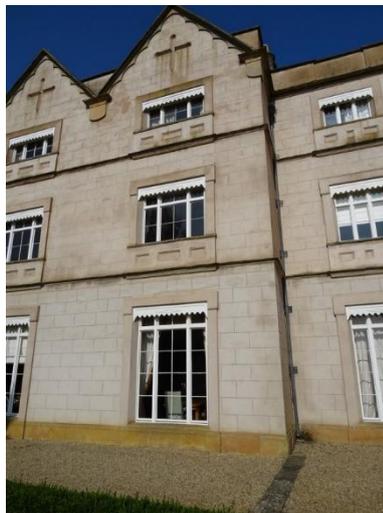
Minor cracking was noted to various areas.

The cracking is typical of a property of this age and construction and raised no significant structural concerns. We are mindful that cementitious mortars/renders are rigid and brittle by contrast with lime based mortars and have a propensity to crack disproportionately under normal seasonal movement conditions. We reiterate our advice for obtaining confirmation as to whether cementitious mortars have been utilised. We however considered there to be no significant structural compromise arising.

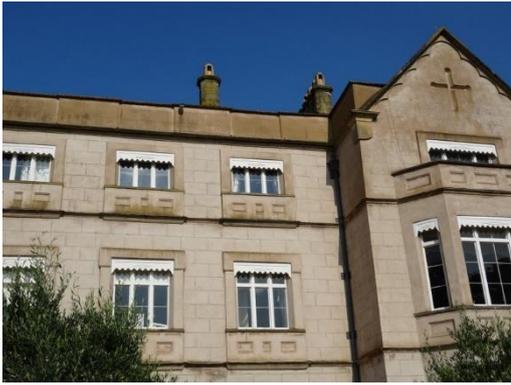
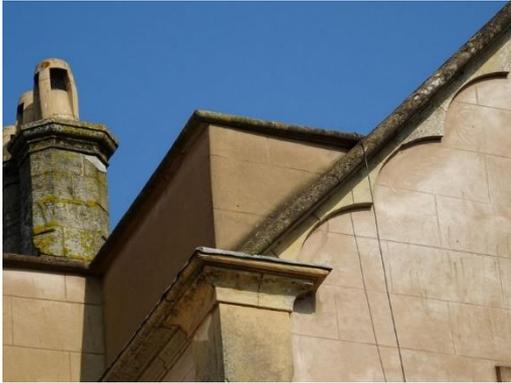
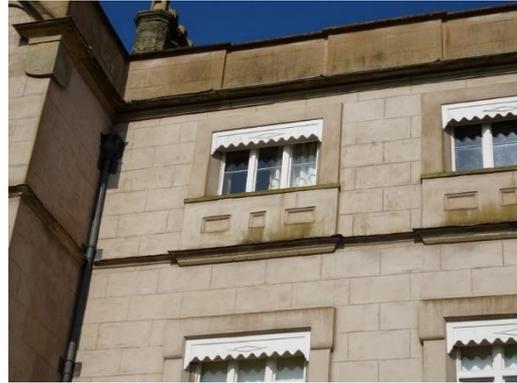
There are minor wall deformations historically.

These are again common in a construction of this age and type and in the absence of any evidence of recent or ongoing movement or significant structural compromise are considered satisfactory.

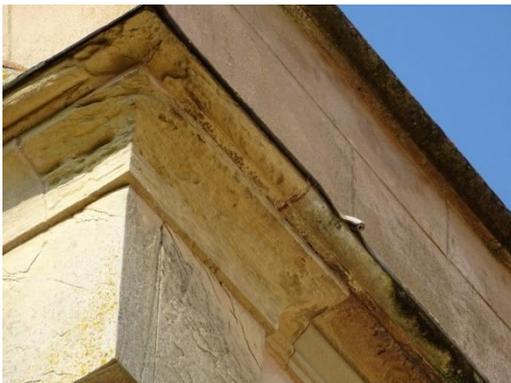
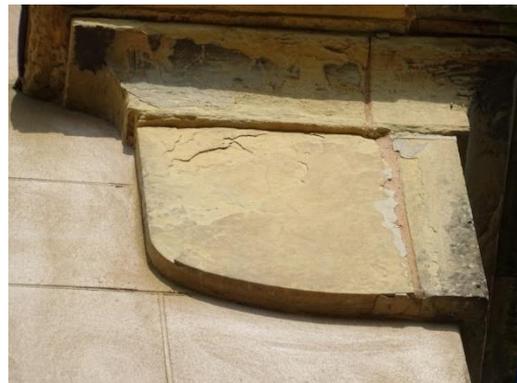
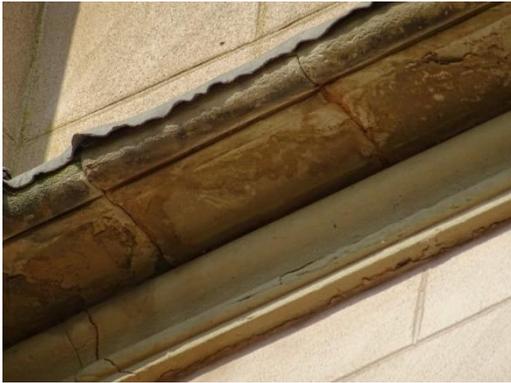
The stonework architectural detailing generally appears in a satisfactory order. There is some evidence of delamination and shaling.

There are no indications of significant or widespread threat of falling materials at the time of survey though localised minor delaminations were indicated and should be addressed as maintenance repairs as required.

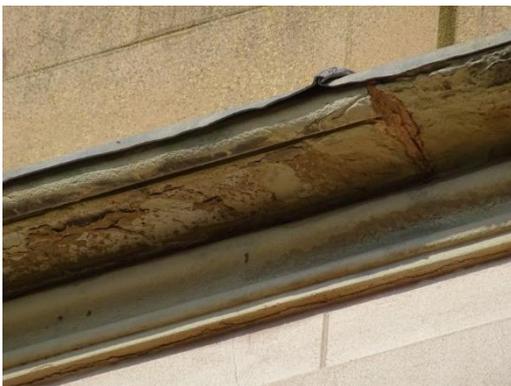
There is a localised area with delaminated stonework to the left of the central range at high level to the underside of the stone band detail.

We have included provisional apportionment for high level access and careful removal at this stage to limit the risk of materials falling onto those below.

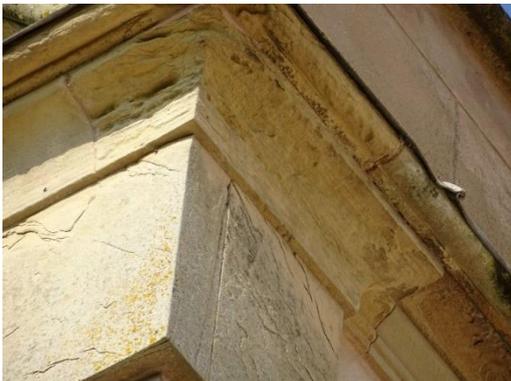
There is significant erosion of the historic stonework banding.

This is considered to represent the patina of the building and is not seen as any significant structural defect or other defect. No apportionment is included in this respect. If required this can be repaired by the running in of plastic lime mortar repairs by a stonework specialist though in the absence of any requirements arising from this reporting no apportionment is included in this respect. This is quite normal in a property of this age and construction.

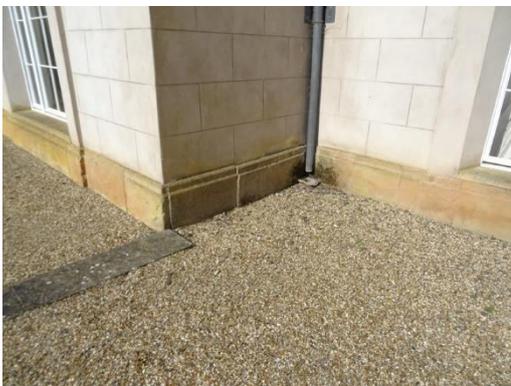
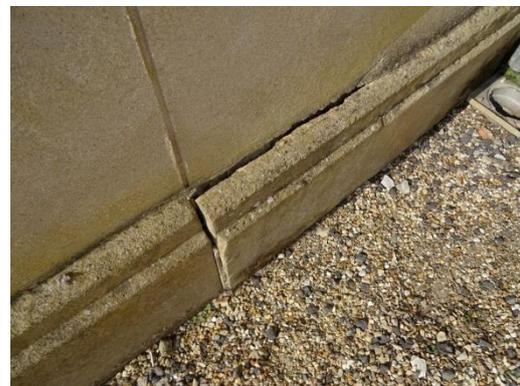
To the base of the wall there is a stone plinth facing. This generally appears in satisfactory order though with a displaced section to the left.

We have included provisional apportionment in this respect for release and refitting.

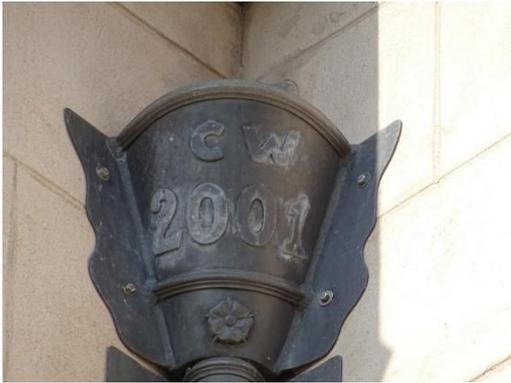
To the internal angles there are lead hoppers and fall pipes. The hoppers are dated 2001 and this may provide guidance for your solicitors enquiries as to dating the render finishes with which the dating would appear broadly consistent.

Otherwise the fall piping and hoppers generally appear in a satisfactory condition with no evidence of significant leakage or overflowing.

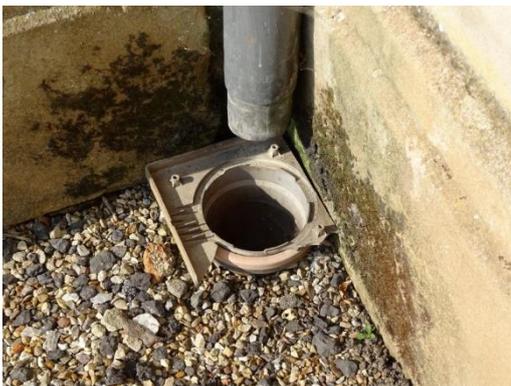
To the left however the fall piping stops short of the gutter arrangement below and we recommend this is extended into the gutter to ensure proper discharge of rainwater away from the property and its foundations and to reduce future property movement risks.

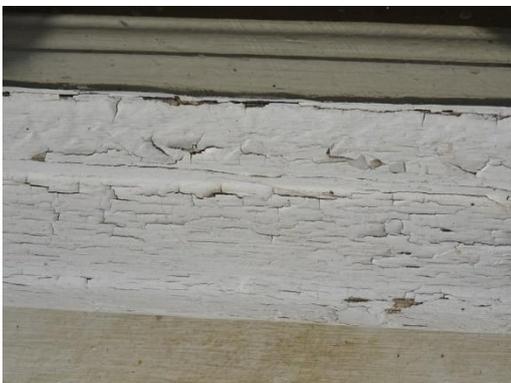
The door and window installations are in timber incorporating single glazing. They generally appear in a satisfactory condition. There is some external redecoration required to extend the serviceable life of the materials and we recommend this is programmed as a maintenance repair.

As a maintenance issue no apportionment is included in this respect.

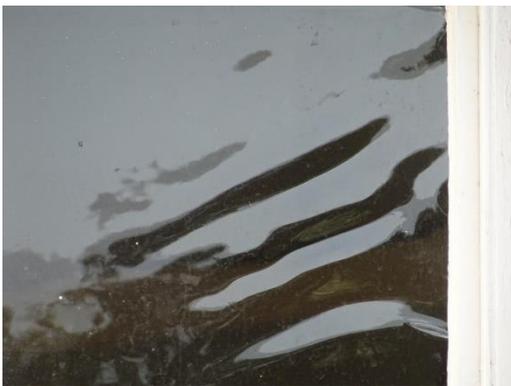
To various windows the glazing is indicated of some age. Over time glazing will distort and slump slightly. This is mentioned for reference purposes and in line with expectations for a construction of this age and type.

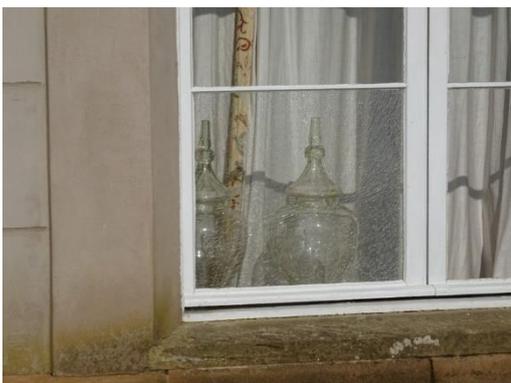
There is a broken glazing pane to the central door set.

We have included provisional apportionment for replacement including safety glazing given the low level position.

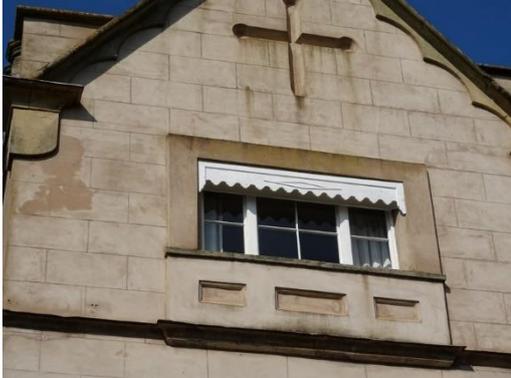
The support arrangements above the door and window openings are concealed within the render finishes. Notwithstanding minor cracking in line with expectations for a property of this age and construction we found no significant damage, decay, deformation or structural failure indicated.

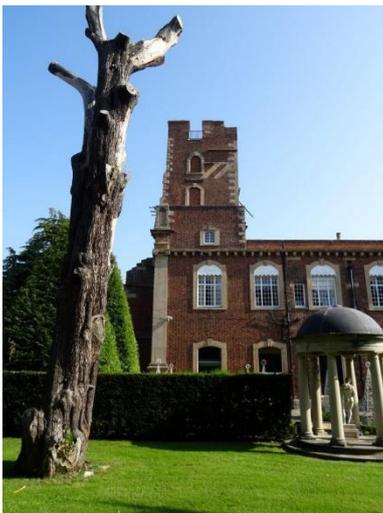
The elevation is dominated by the high level tower to the rear left corner. This is in a load bearing brickwork construction indicated in solid wall construction with stone architectural mouldings. The tower has a slight rearward distortion reflected at all levels.

There were no indications of significant structural compromise or recent or ongoing significant structural movement to the tower construction.

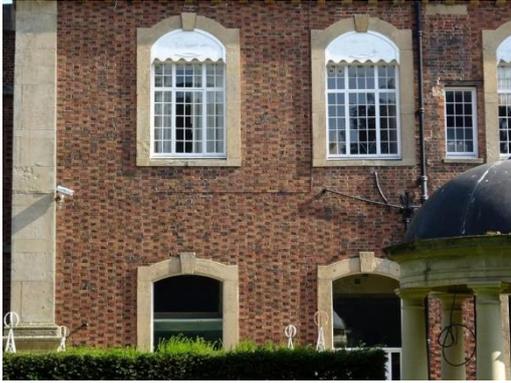
The brickwork coursing similarly is indicative of a historic slight movement toward this rear left-hand corner.

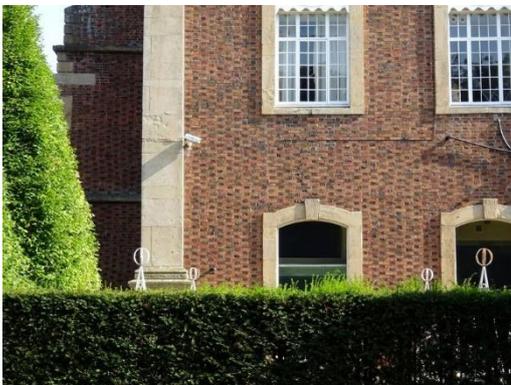
There is minor historic cracking indicated by the age between the ground floor and first floor window surrounds.

We have included a provisional apportionment for brickwork reinforcement and repair to re-establish brick bond locally.

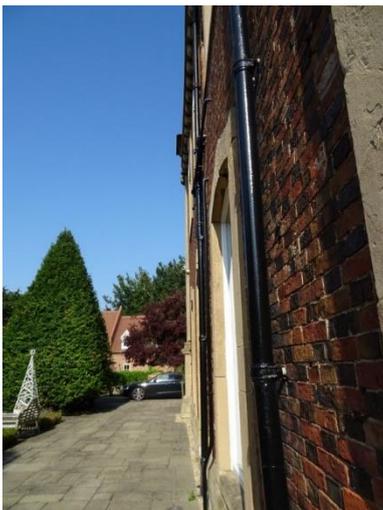
There is some slight outward movement of the wall head.

This is common in a property of this age and construction.

In the absence of any recent or ongoing significant movement or significant structural compromise these are considered satisfactory in a property of this age and construction.

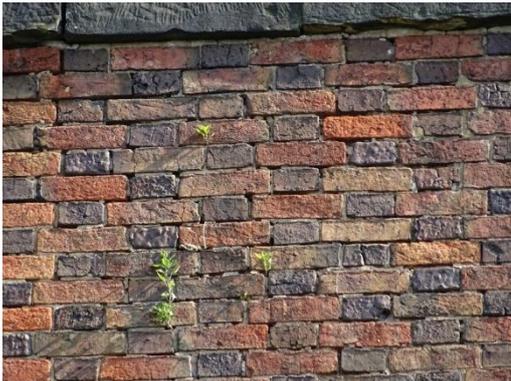
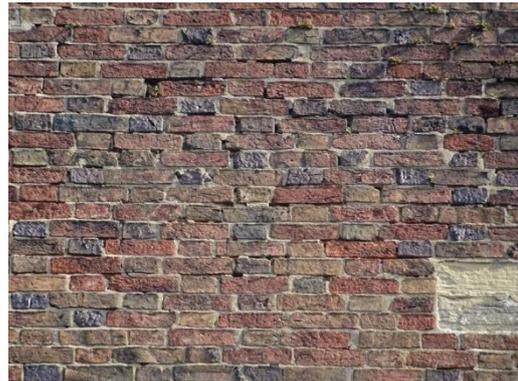
There are various areas of repointing required to the elevation and localised areas of minor crack repair. We have included a provisional apportionment in this respect.

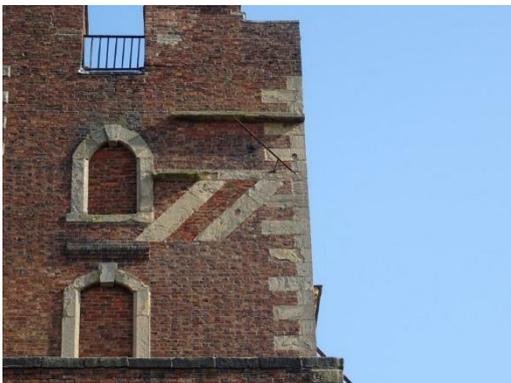
Typical detail shown.

There is again shaling and spalling to stonework.

We have included a provisional apportionment for removal of detached stonework lenses at this stage to reduce safety risks to those using the building below.

In line with our advices above this should be programmed as an ongoing maintenance issue with no apportionment included for future repairs.

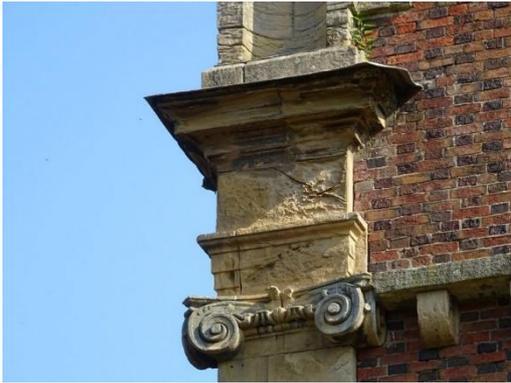
Otherwise the gradual powdering/erosion is considered a maintenance issue with no apportionment included in this respect. Typical detail shown.

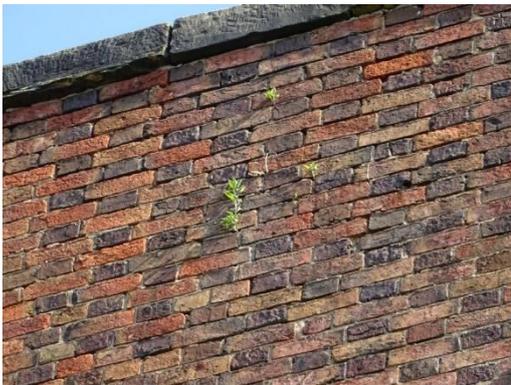
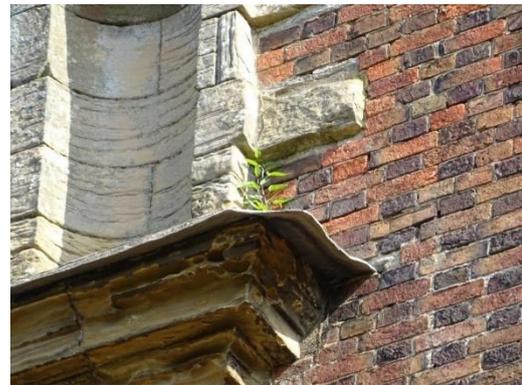
There is some vegetation growth establishing at high level within the brickwork.

As a maintenance issue this should be addressed as part of the normal maintenance cycle. No apportionment is included in this respect.

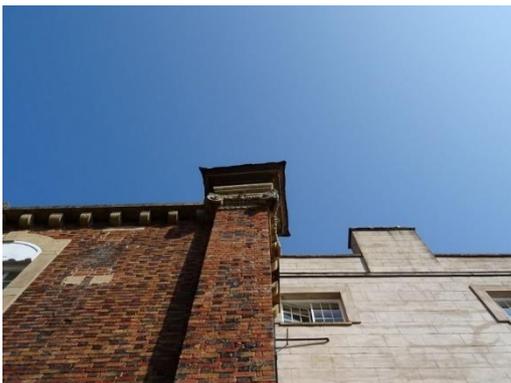
Notably there is some rotation of the brickwork and the cap detailing to the front left corner of the brickwork range.

This is common in a property of this age and construction and does not represent any significant structural compromise and is considered satisfactory in a property of this age and construction.

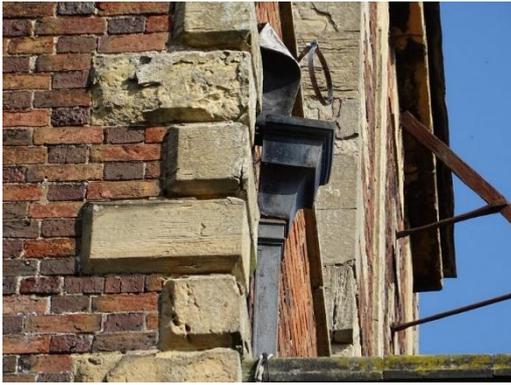
To the front facing walling to the tower at lower level there is some detachment of the gutter hopper. We have included provisional apportionment in this respect.

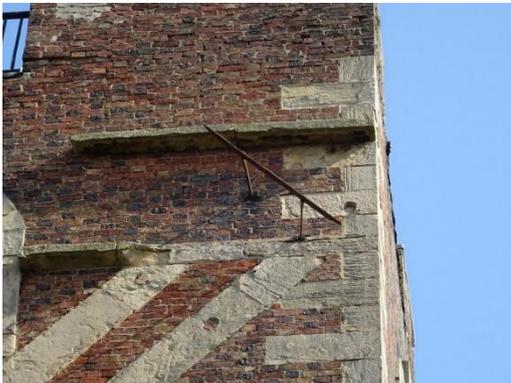
There is a metal rail type installation affixed to the tower. Its function could not be confirmed and this could not be inspected from our ground level vantage. We must limit our reporting in this respect. We recommend this is inspected at high level when access is next available together with an appraisal for removal should significant decay be indicated.

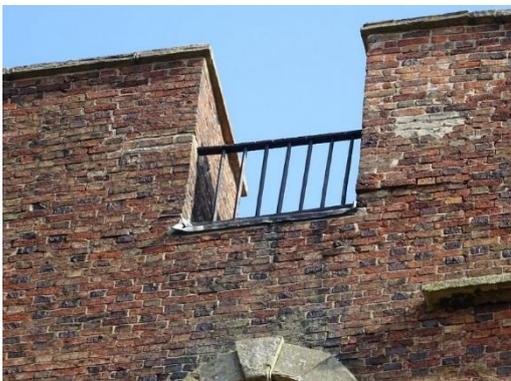
Inset between the brick crenelations to the tower belvedere there is metal balustrade railing indicated. This is indicated of some age and certainly would not meet modern safety standards. There is no requirement for retrospective compliance with modern building standards however the railing provides edge guarding/fall restraint at a significant height and we have included provisional apportionment for improvements in this respect.

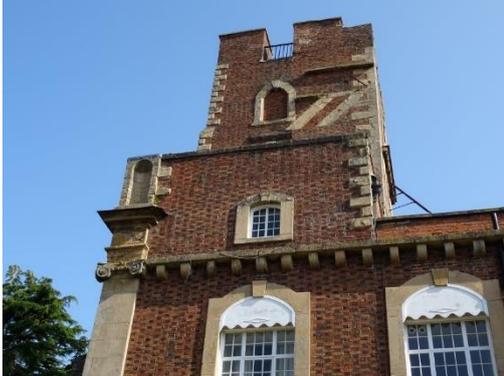
No inspection of the second floor roofing was possible to the rear left corner of the building and notably this extends above the height of our camera pole access. Our reporting must be limited

in this respect. Our further reporting will continue from the tower vantage where access is available though otherwise we recommend this roofing is inspected when high level access is next available together with the completion of any necessary remedial repairs identified at that time.

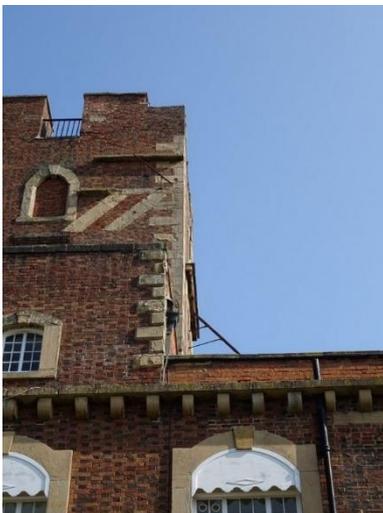
To the inner facing tower face there are further significant historic distortions noted to the walling again reflecting the age and construction of the building.

There were no indications of recent or ongoing significant movement or significant structural compromise and this is considered satisfactory in a property of this age and construction.

We recommend the historic deformations are monitored as part of any quinquennial inspection regime.

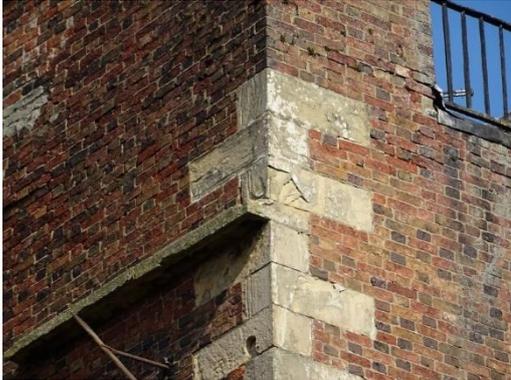
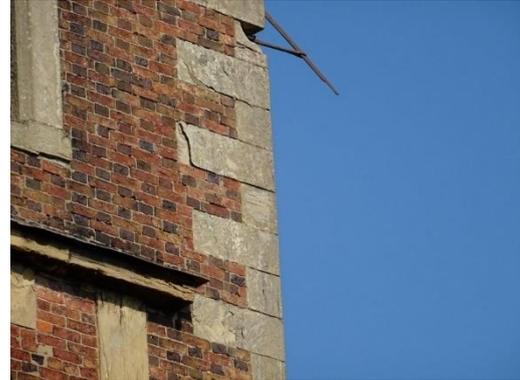
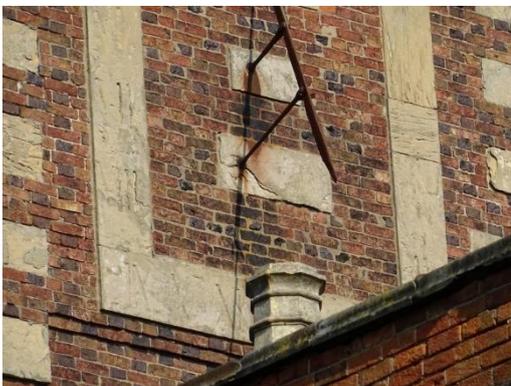
There are spalling stonework lenses and in places these are indicated as significant.

Attendance is required and we have included provisional apportionment for attendance by a suitably experienced stonemason and for high level access to safely remove/stabilise these.

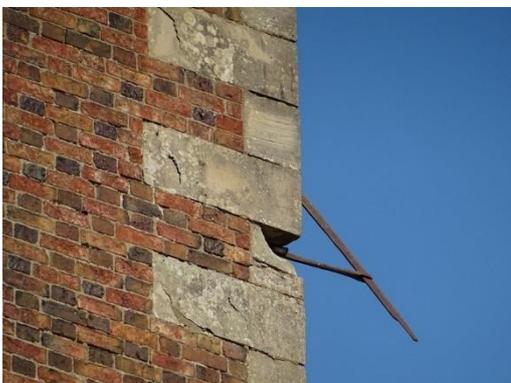
Notably to the front right corner of the tower there is a significant stone section displacement and this is indicated around a socket to inset ironwork.

To the front right corner of the tower the displaced stonework indicated from rust jacking was again noted. We reiterate our advices above for localised repair.

We highlight the need for maintenance redecoration of external metalwork where embedded to avoid the risks of rust jacking and such issue. We have included provisional apportionment for

the building up of plastic lime repairs around copper armatures to reduce the risks or further decay.

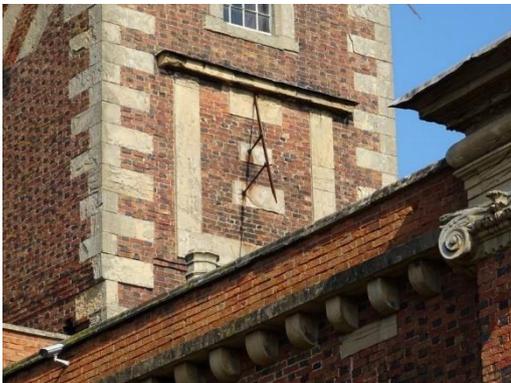
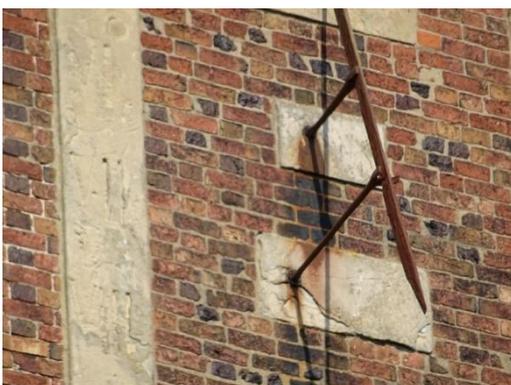
There is a cast iron gnomon serving the wall sundial arrangement.

We reiterate our advice above for external decorative repair to reduce the risks of rust jacking. Some surface runoff/solute staining was noted to the stonework facings around the fixing positions. This is mentioned for reference purposes only.

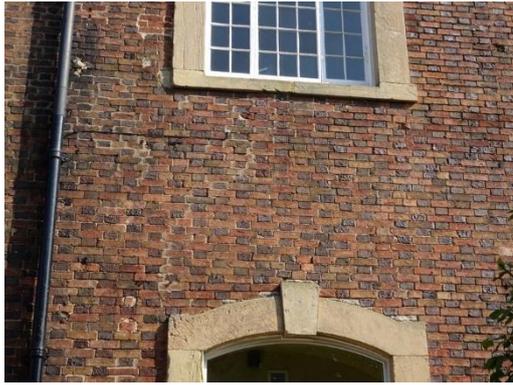
At lower level and to the centre of the building the walling is similarly in load bearing construction finished externally with brick finishes and stone architectural detailing. There were no indications of significant cracking. Minor historic cracking was noted in line with expectations for a property of this age and construction and this has been subject to historic repair.

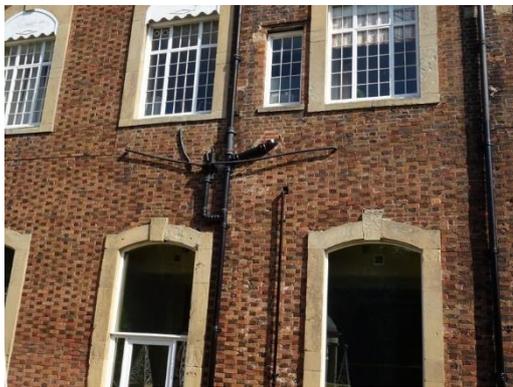
There is some undulation to the brickwork coursing lines reflecting minor historic movement in line with expectations for a construction of this age and type.

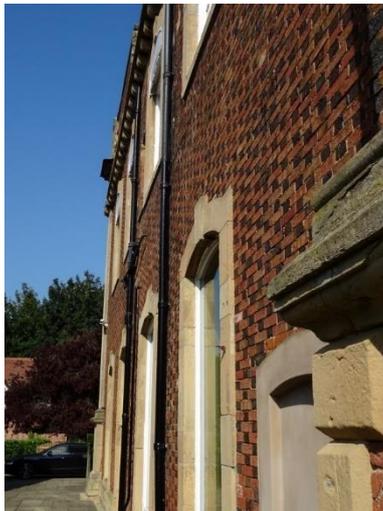
There is also, in line with our advices above, some historic deformation toward the wall head position.

We found no evidence of significant cracking or structural deformation or structural compromise to the main load bearing walls. The issues identified are in line with expectations for a property of this age and construction and raise no significant concerns.

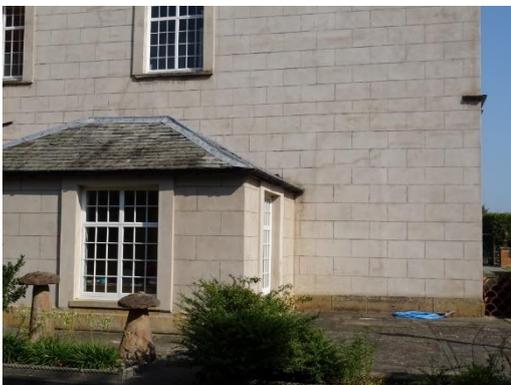
To the front left corner of the building the external walls are again indicated in load bearing construction, reverting to ruled Ashlar effect render finishing. There are some distortions to the Ashlar ruling but this may reflect the setting out detail when this was finished. There were no indications of significant structural deformation.

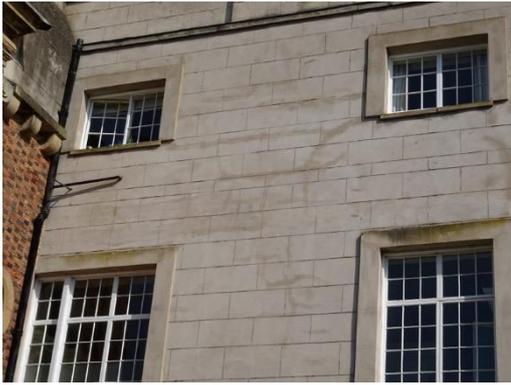
Across the elevation notable through the render finishes there are a series of lines indicative of minor substrate cracking.

There are no indications of significant structural compromise, the extent of cracking might readily be anticipatable in a construction of this age and type, though for example to a brickwork substrate this might be barely noticeable. There were no indications of significant structural compromise. This is considered satisfactory in a property of this age and construction and may reflect previous repairs prior to render refinishing.

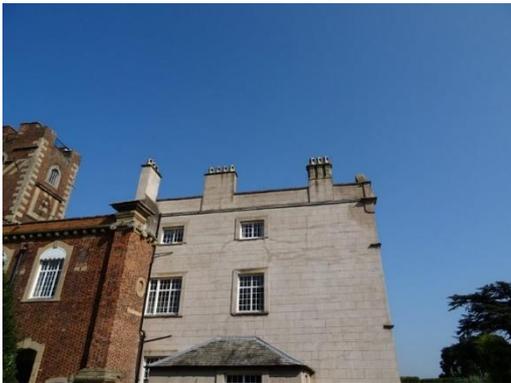
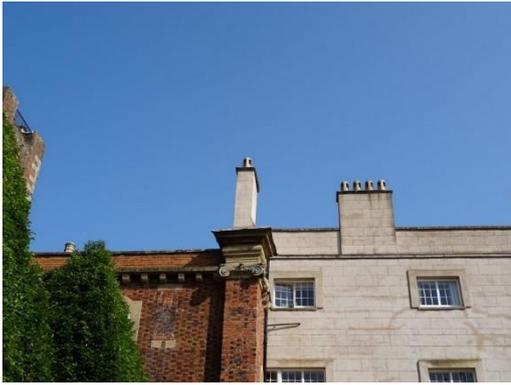
At high level above this front left corner to the building there are again multiple chimneystacks including those described previously to the front though with further stack arrangements heading rearward.

These generally appear in a satisfactory structural order notwithstanding some slight historic minor lean which is common in a property of this age and construction. In the absence of any recent or ongoing significant movement or significant structural compromise this is considered satisfactory.

We were unable to inspect the flues or flue terminals atop the chimneystacks or the flue terminal projecting above the central left area from a ground level vantage and must limit our reporting in this respect. We recommend these are inspected when high level access is next available together with the completion of any necessary additional remedial repairs identified at that time. No apportionment is included in this respect.

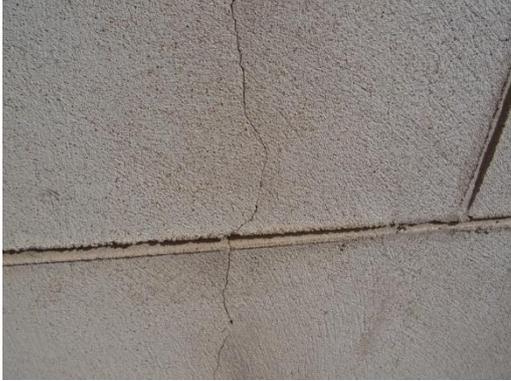
There are minor cracks to the render finishes, not indicative of any significant structural compromise and which as weather tightness repairs should be made good at the next external works cycle.

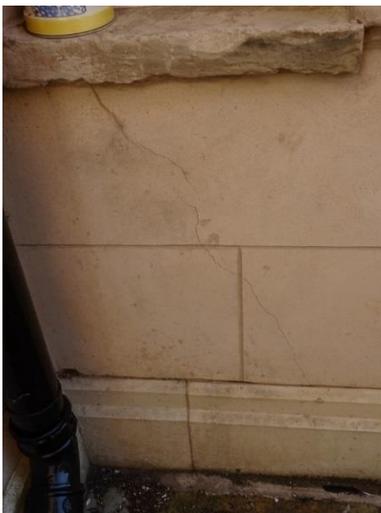
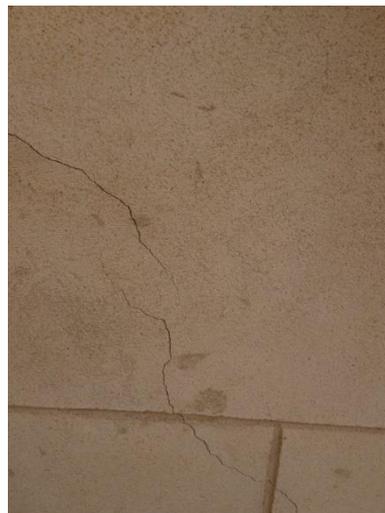
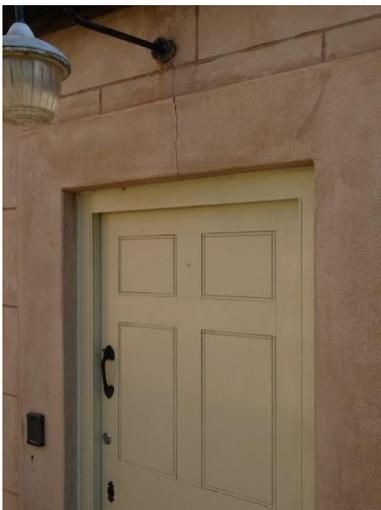
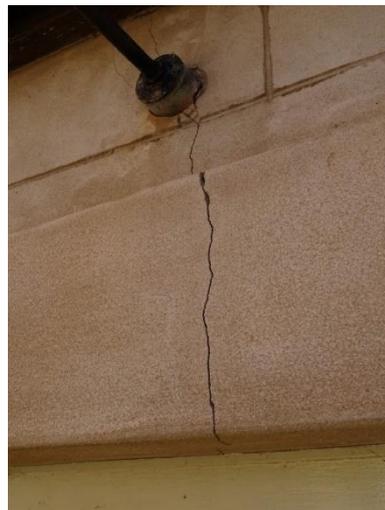
There is further minor cracking above the entry door to the single storey range and to the render finishes around.

As weather tightness repairs these should be made good at next external remedial works as maintenance issues in the absence of any recent or ongoing significant movement or significant structural compromise.

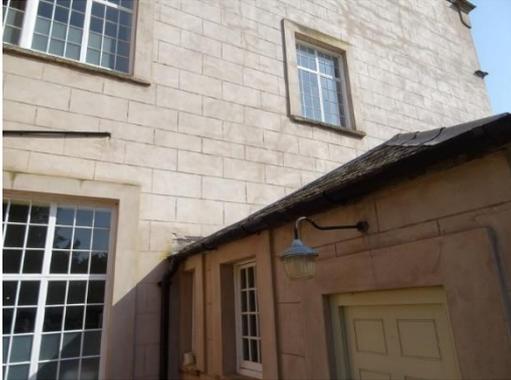
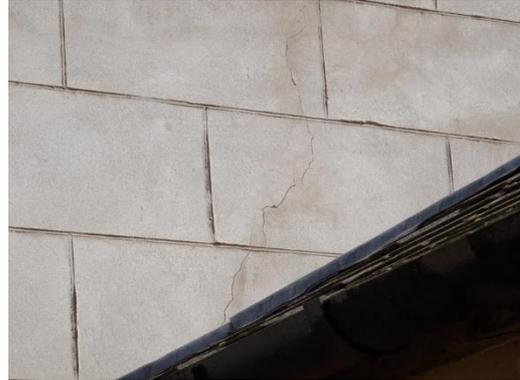
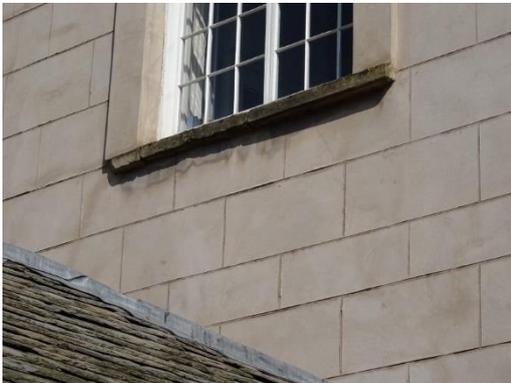
There is minor cracking below the first floor window position.

None were indicative of any significant structural compromise and as external weather tightness repairs should be addressed at the next external works cycle. No apportionment is included in this respect.

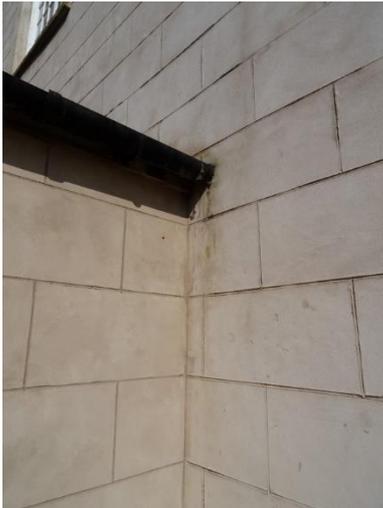
There is localised evidence of overflowing guttering. The guttering should be kept clear to allow proper rainwater discharge. This is a maintenance issue and no apportionment is included in this respect.

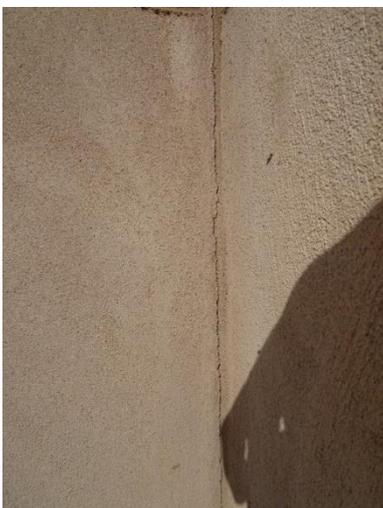
There is minor separation cracking at the junction between the main house and single storey construction.

This raised no significant structural concern and should be anticipated at the juncture between building ranges. In a more modern construction this would be addressed by the use of movement joint detailing. There is no retrospective requirement in this respect and this is considered satisfactory in a property of this age and construction.

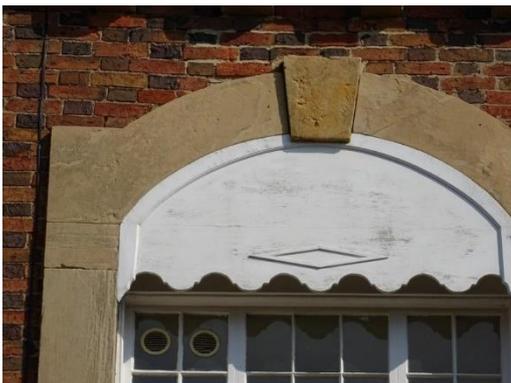
There are again a series of window head timberwork details toward the rear left. These generally appear in a serviceable order though in need of external redecoration to extend their serviceable life.

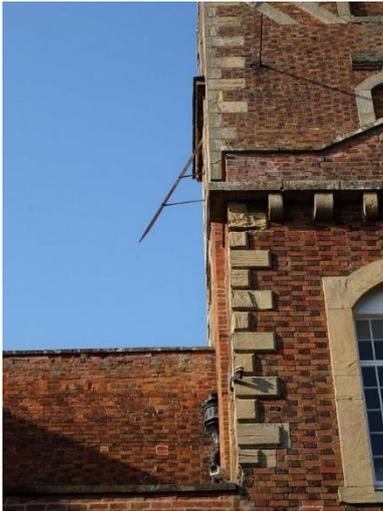
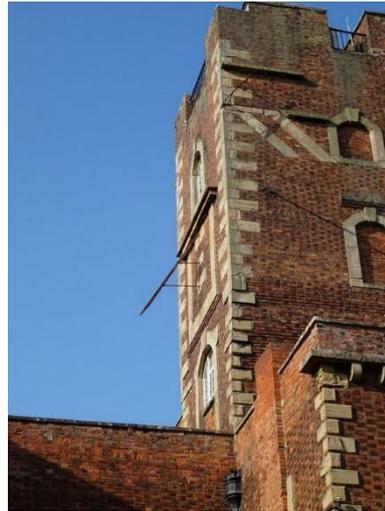
The tower dominates the elevation to the rear. The tower, in line with our advices above is constructed in load bearing construction with brick elevations and with stonework architectural detailing. We highlight that solid wall construction would be anticipated in a construction of this age and type. There are again indications of historic distortion in line with expectations for a construction of this age and type.

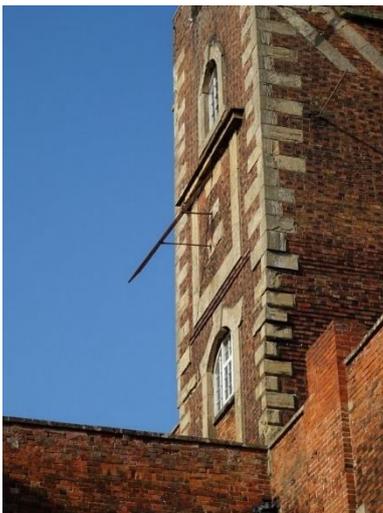
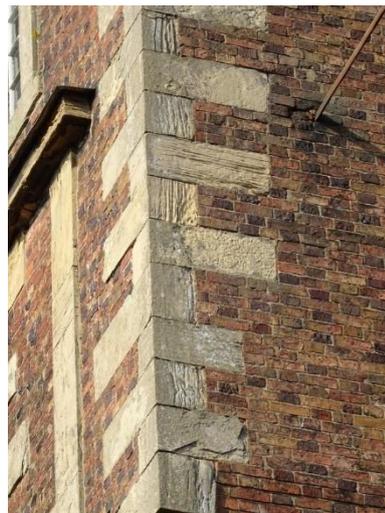
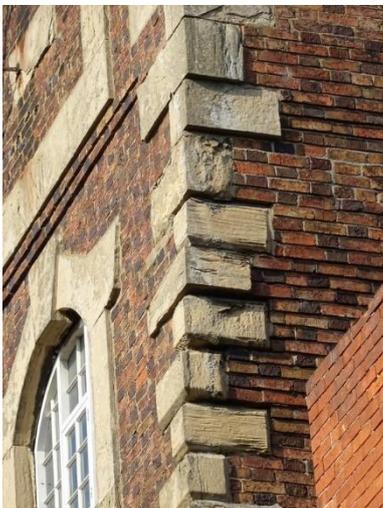
Again we highlight that such distortions are common in a construction of this age and type. The distortions similarly to our advice above are focused at high level to the front facing elevation area and notably the Ashlar quoin detailing is flush to this area as opposed to raised and profiled below and elsewhere. This may reflect historic rebuilding including potentially for the insertion of the wall sundial installation.

Such alterations and distortions are common in historic constructions and this raised no significant structural concern. In the absence of recent or ongoing significant structural movement or significant structural compromise this is considered satisfactory.

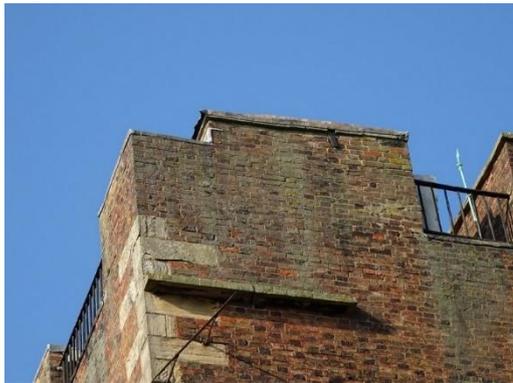
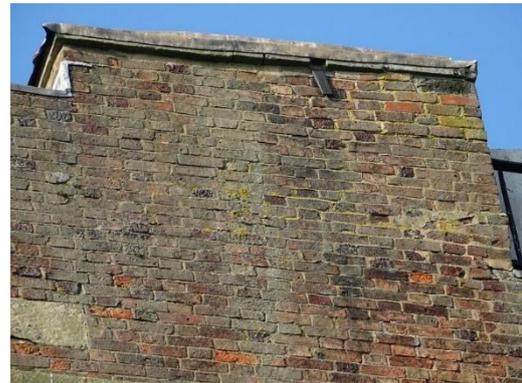
There is some deformation to the brickwork coursing to the crenelation to the front of the belvedere platform.

There were no indications of recent or ongoing significant movement or significant structural compromise and we suggest this likely relates to the minor deformations indicated above. These are considered satisfactory in a property of this age and construction.

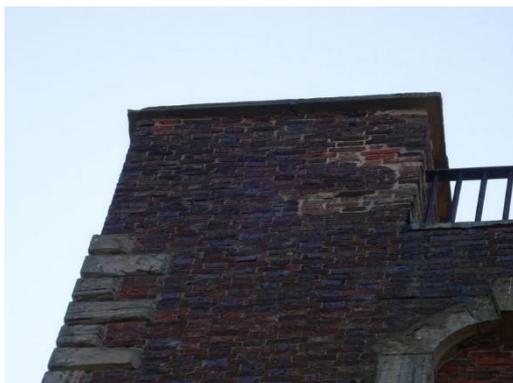
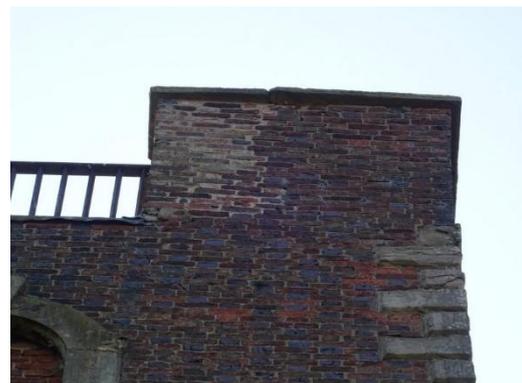
There is further historic deformation indicated to the rear tower face.

This would appear to reflect historic movement with no indications of recent or ongoing significant movement or significant structural compromise and this is considered satisfactory.

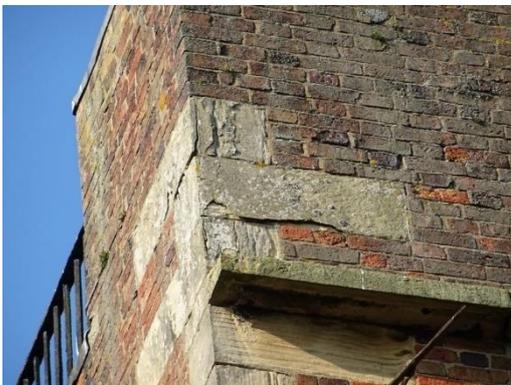
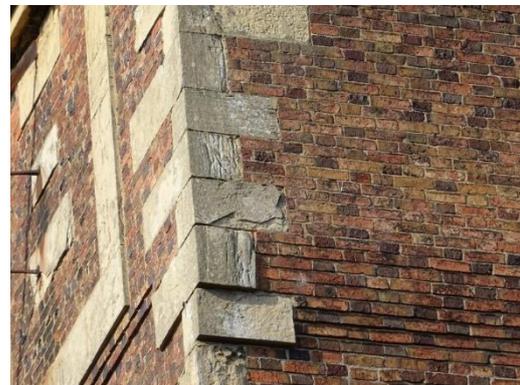
There are again areas of delamination to the stonework detailing and again the detaching stone lenses present a safety risk to those using the building and its environs below.

Typical detail shown.

In line with our advices above we recommend high level inspection and careful removal of detached lenses or their repair and stabilisation. We have included provisional apportionment in this respect.

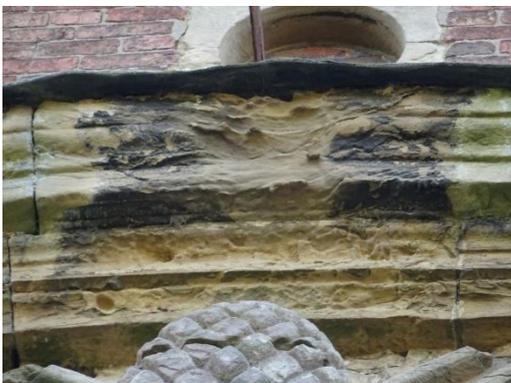
Otherwise there were areas of significant stonework erosion though with no significant structural compromise, these are considered cosmetic and part of the natural patina of the building.

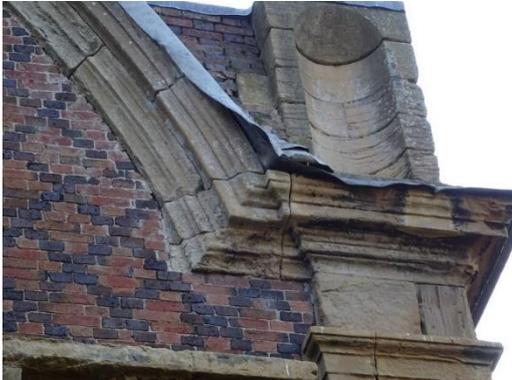
The softer stone materials are capped with a dressed lead flashing. This generally appears in satisfactory order with no significant issue or compromise. Localised rebossing is required to the rear left corner below the niche position and we have included provisional apportionment in this respect.

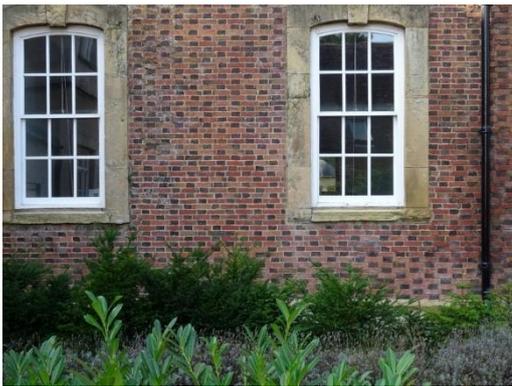
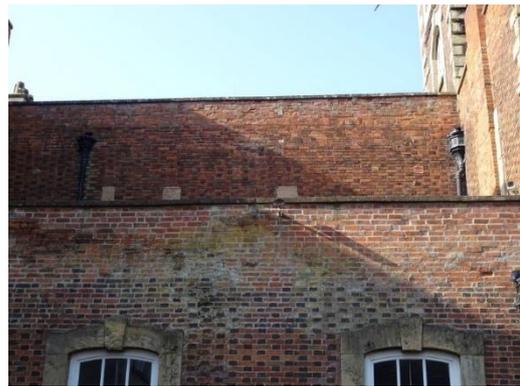
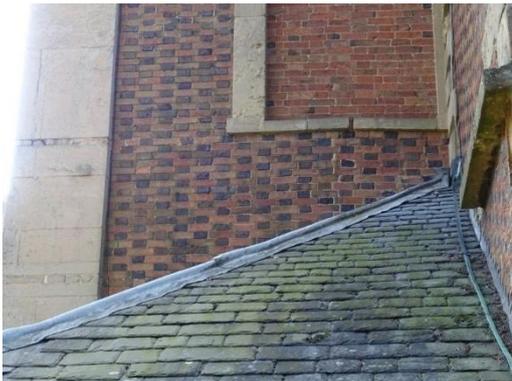
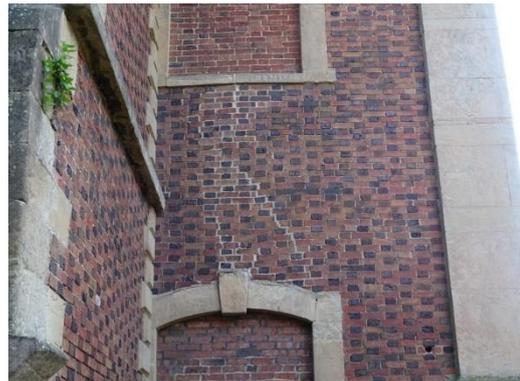
To the lower levels the elevations again continue in load bearing brickwork construction indicated in solid wall construction. There are historic deformations indicated to both general and localised areas.

These include minor cracking and we have included provisional apportionment for localised crack repairs to re-establish brick bond.

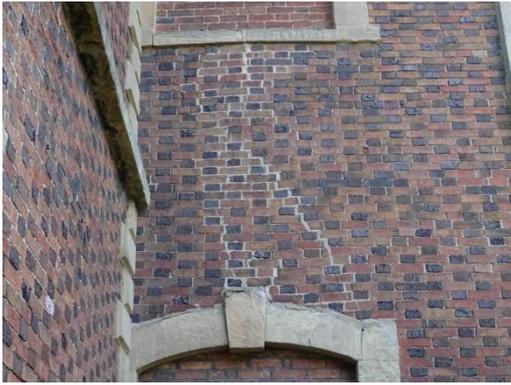
Otherwise we found no significant cracking or structural compromise to the main load bearing walls. The historic deformations are in line with expectations for a property of this age and construction and raised no significant structural concern. Again we recommend these are monitored as part of any quinquennial inspection arrangement.
