BUILDING SURVEY

Level 3

ALLCOTT
RESIDENTIAL

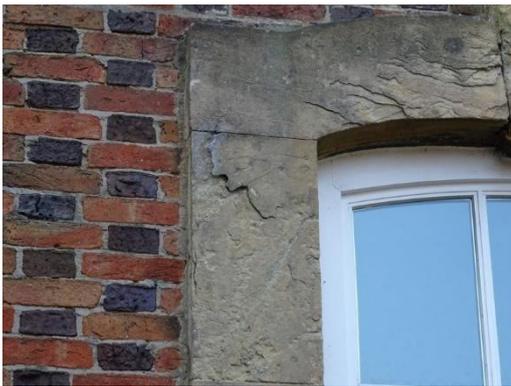
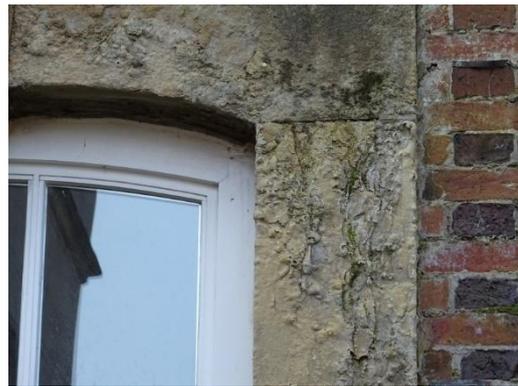
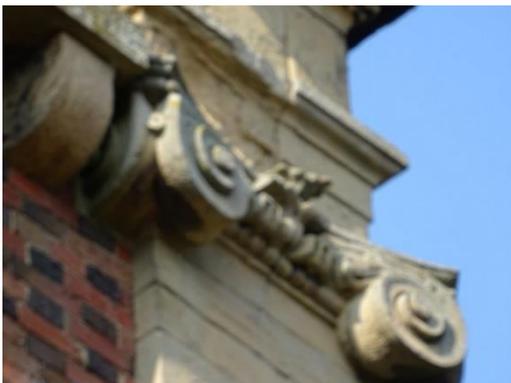
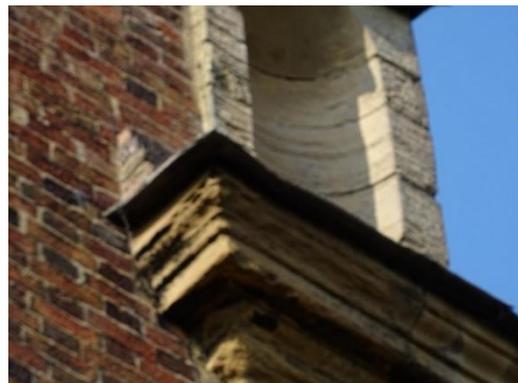
The stonework to the lower levels again shows evidence of erosion, minor spalling and some decay.

There were no indications of significant structural compromise. The building should be managed and maintained to reduce decay. There is some moss and plant growth from within the walling and this should be carefully removed as a maintenance item.

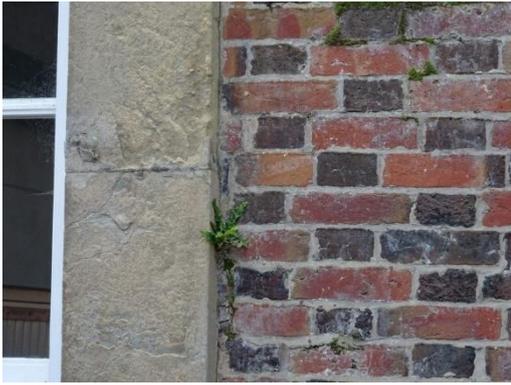
Notably to the inner wall return the issue is focused and the walling is repointed in cementitious based mortars. There are also indications of moisture accumulation to the walling which has a parapet gutter detail behind and around the fall pipe drainage installation.

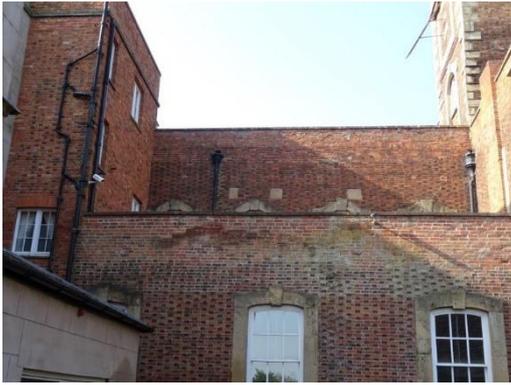
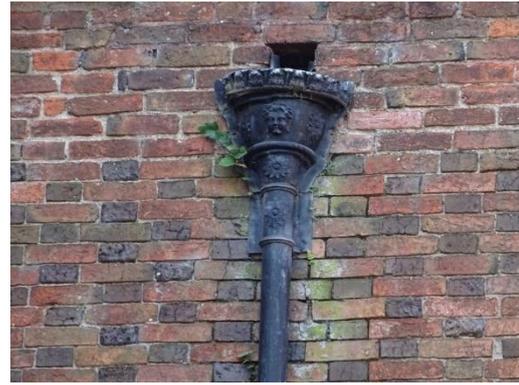
The issues are replicated to the first floor walling above at high level.

In terms of cementitious mortar use we do not recommend this in a property of this age and construction which is designed to naturally absorb/desorb moisture by dint of which there would usually be some slightly elevated moisture levels within the walling. Cementitious mortars limit the natural desorption and can lead to moisture concentrations within the walling. There were no indications of any significant issue or compromise arising at the time of survey and our recommendations are limited to the replacement of cementitious materials with lime based materials when the external repointing works are next completed.

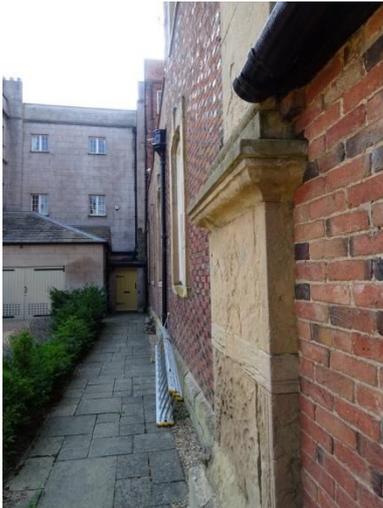
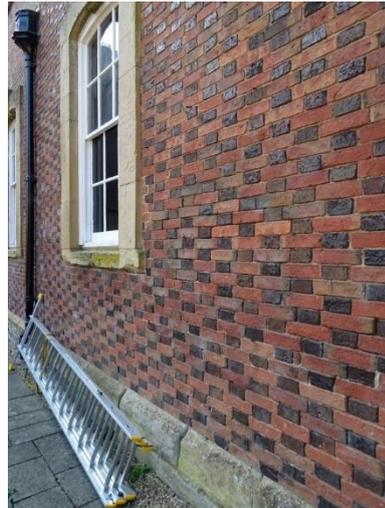
To the right there is some deformation of the walling reflecting the age and construction of the property.

There are no indications of recent or ongoing significant cracking or structural compromise and this is considered satisfactory in a property of this age and construction. There are minor cracks indicated. These are in line with expectations for a property of this age and construction. These have been subsequently repointed and in the absence of any significant issue there is no further works required in this respect.

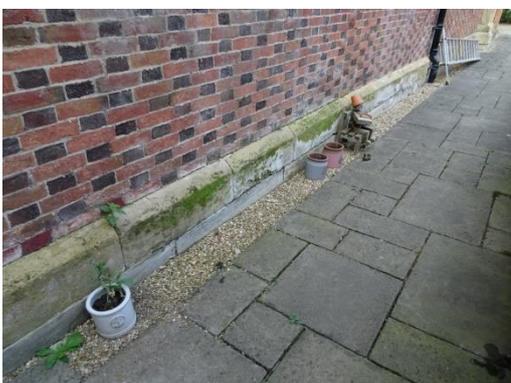
At low level to the rear right there is some moss growth and evidence of moisture retention to the walling. This is below similar indications at high level. There were no indications of significant issue or compromise and this is considered satisfactory.

In line with our advices above we do not recommend the building in or injection of damp proof coursings rather as a maintenance issue we recommend the identification of sources of moisture within the ground/low level building construction and their removal.

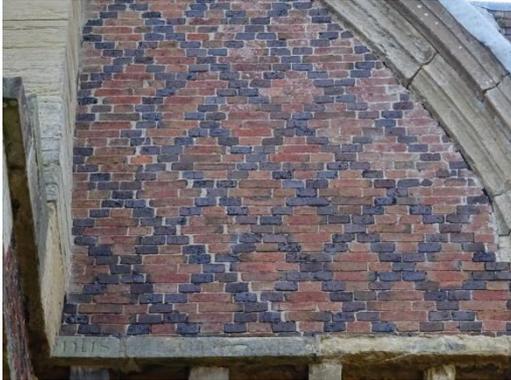
The walls feature a burnt diaper brickwork form.

This is an historic architectural detail and is mentioned for reference purposes only.

We have included provisional apportionment for localised brickwork repointing in lime based materials.

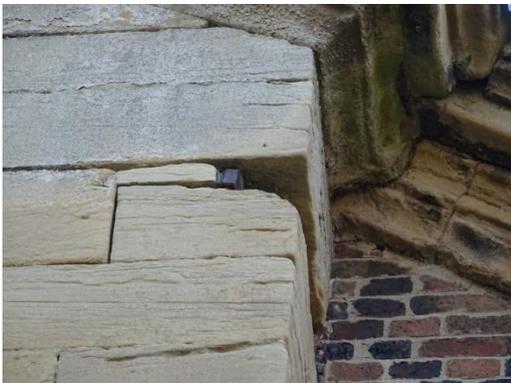
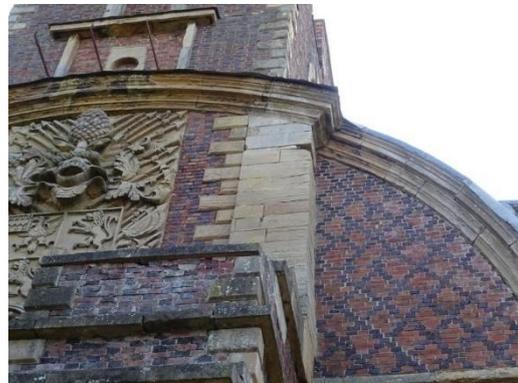
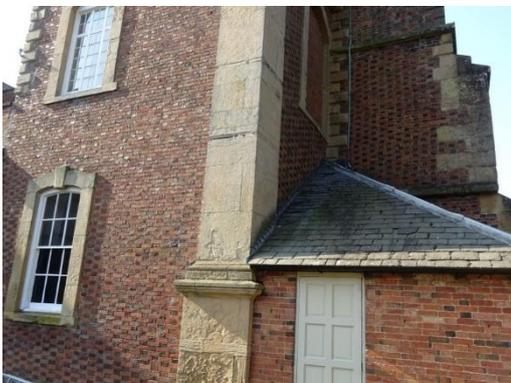
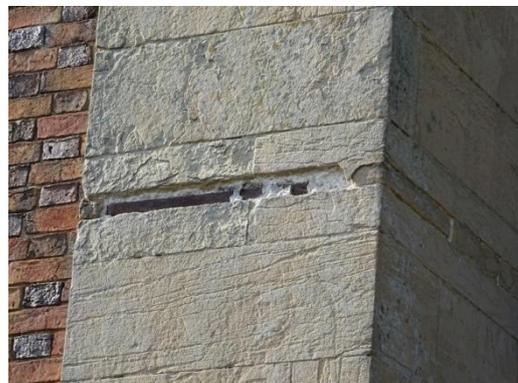
There are iron cramps visible at surface level and with burst stonework adjacent.

When the embedded iron cramps rust this causes expansion known as rust jacking and leads to displaced stonework. We recommend the effected areas are exposed and treated to limit further decay/rusting followed by the running in of plastic lime repairs to address the issue.

There is a further detached stonework section again indicated through rust jacking of wall cramps. We have included a provisional apportionment for remedial treatment of the rusted surfacing together with the running in of new stonework moulding to encase the embedded ironwork and reduce the risk of future decay and damage.

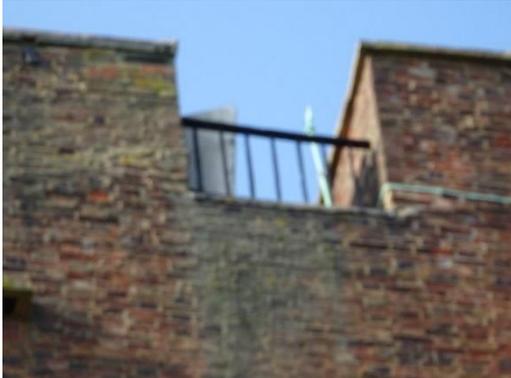
There are no indications of any obvious detachment indicated at the time of survey though the heavy relief of the detail precludes full inspection and we must limit our reporting in this respect. We recommend this is monitored informally in addition to any specific quinquennial inspection. To the viewing vantages between the belvedere crenelations there are metal railings inset. Our close quarters inspection from the belvedere platform show these positioned with a shallow edge distance between the railing and brickwork edge to provide restraint. There is also localised cracking in places around the railing fixing positions. We have included a provisional apportionment for further intrusive inspection and repair around the fixing positions together

with additional discreetly designed strapping installations to provide additional fall restraint capacity to all four sides of the belvedere.

The balustrade details would not meet modern Building Regulation requirements but there is no retrospective requirement in this respect.

The installations subject to stabilisation/strengthening are considered satisfactory in historic terms for the survey purposes. You may wish to provide additional safety glazing or similar installations behind the balustrades to provide additional protection against the risks of small children or pets falling through the railings.

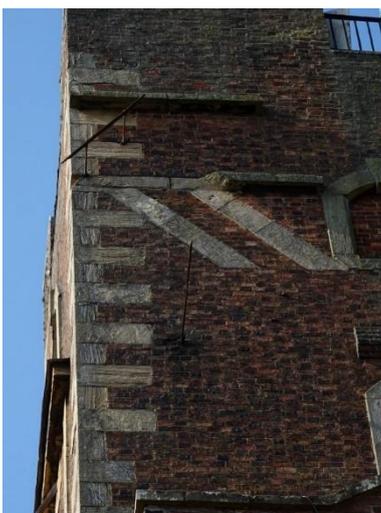
There are metal poles/frames affixed to the right elevation similarly to those to the left.

We refer you to our previous advices in this respect.

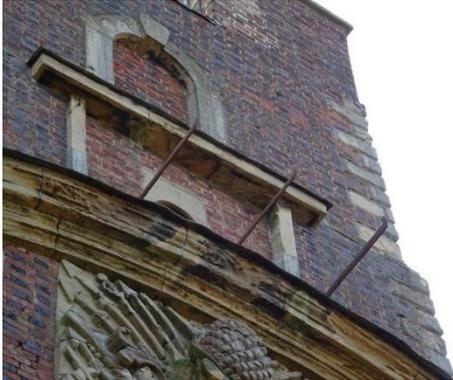
There is similarly iron poles affixed above the stone heraldic detail. These would be anticipated provided to hang a banner/pennant or similar arrangement on special occasions. These generally appear in satisfactory order. In line with our advices above these should be maintained to reduce the risks of rust decay and rust jacking.

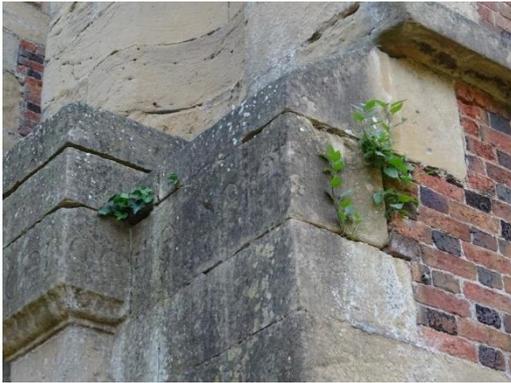
There is some vegetation growth establishing within the stonework joints. This should be carefully removed and the joints repointed. We have included provisional apportionment in this respect.

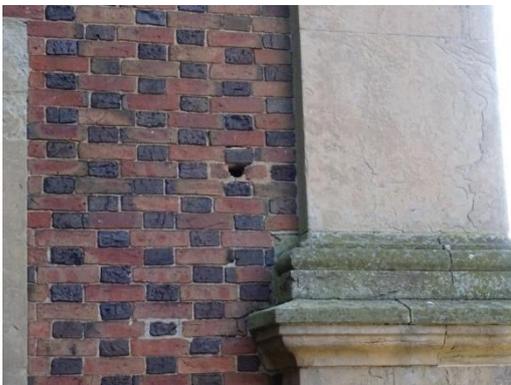
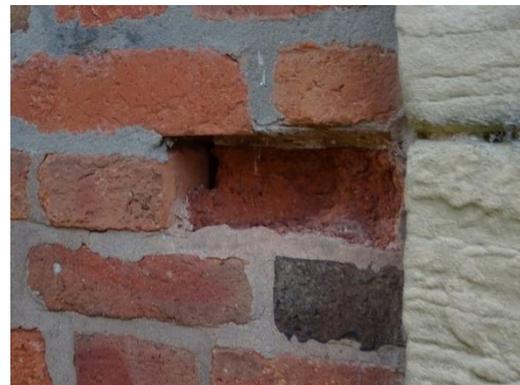
There are localised holes within the brickwork and in places these reflect decay. We have included provisional apportionment for localised repair.

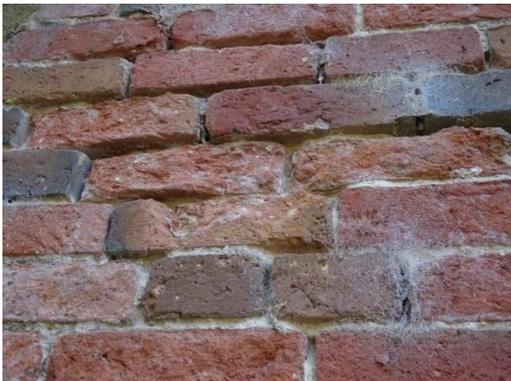
There is also some localised brickwork erosion reflecting the age and construction of the property and notably this is located in areas of lime based rather than cementitious mortar.

In time brick reversal or replacement will be required as a maintenance item. There were no requirements at the time of survey and no apportionment is included in this respect.

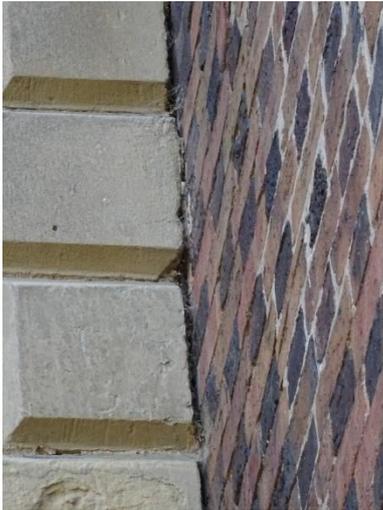
There is localised minor separation cracking/displacement at the junction between the historic tower construction and the later buttressing reflecting the two stages of construction.

There are no indications of recent or ongoing movement or significant structural compromise and this is considered satisfactory.

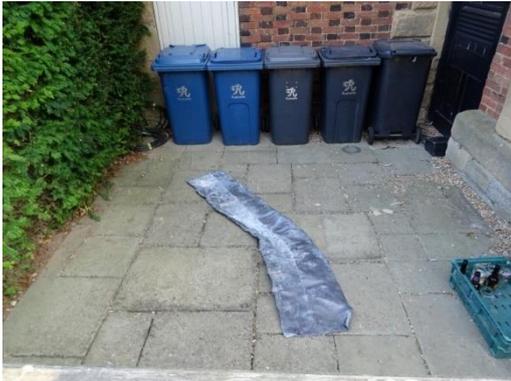
At low level to the rear left corner there is a sheet of detached leadwork laid on the ground. There are no indications above of any obvious or significant loss or displaced material.

We have included a provisional apportionment for further high level inspection to establish the position of any missing material and replacement.

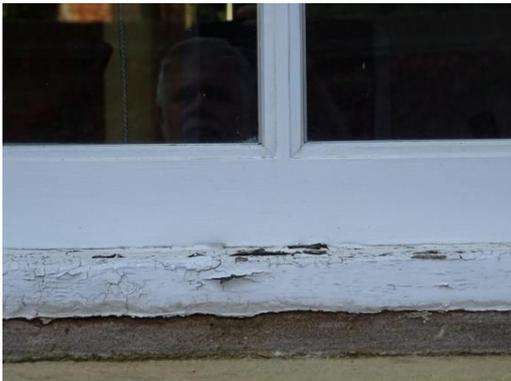
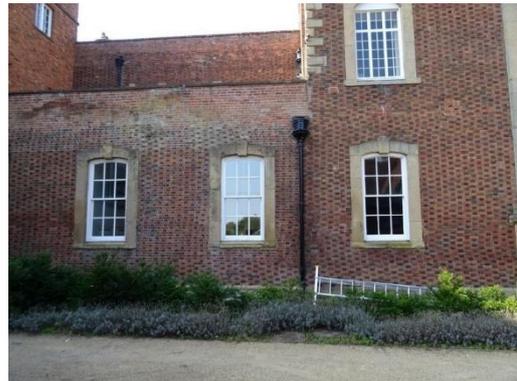
The window installations to the elevation are in timber incorporating single glazing. These generally appear in a satisfactory condition with no significant repair need indicated. There are localised repairs required in particular to the right and we have included provisional apportionment in this respect.

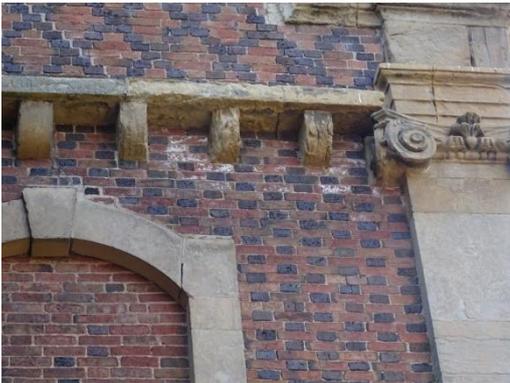
To the rear left corner adjacent to the tower there are areas of sporadic white staining.

In a sporadic presentation this is indicative of the last remnants of historic paint or lime wash finishes rather than any salt efflorescence. Efflorescence would raise concerns as the salts can expand and cause brick bursting or powdering dependant on the type of salt. This is considered satisfactory.

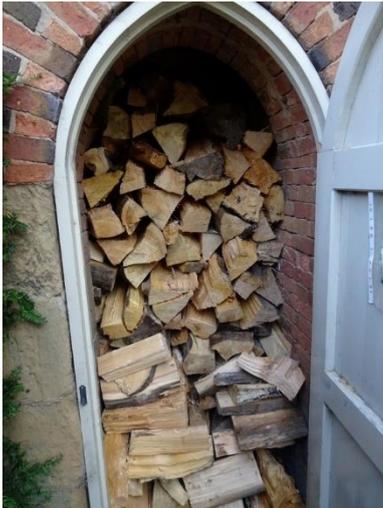
To the rear left corner there is a log store at low level.

The ceiling beyond is formed with a vaulted arch with detaching thin render finishes. We found no evidence of significant structural issue or compromise to those areas accessible to our inspection though must limit our reporting in this respect with the logs precluding inspection. We recommend when the logs are next cleared the area is inspected together with the completion of any necessary additional remedial repairs identified at that time. No apportionment is included in this respect.

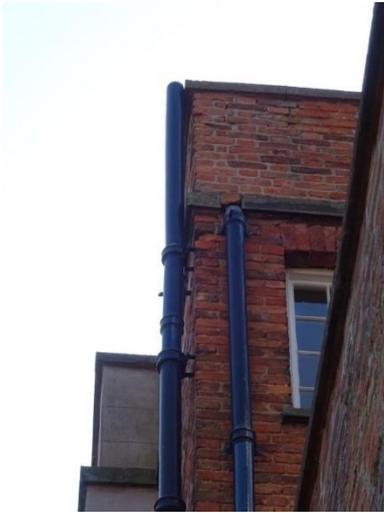
At high level there is an upper cast fall pipe section with no fixing merely seated into the coupling below. We have included provisional apportionment for the introduction of fixings in this respect to reduce the risks of detachment and falling.

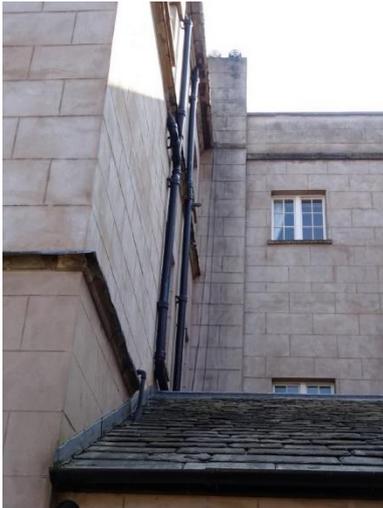
To the centre there is a masonry chimneystack indicated with dressed Ashlar finishes.

Notwithstanding historic deformations the chimney generally appears in a satisfactory structural order with no obvious or significant structural compromise or recent or ongoing movement. In a property of this age and construction the chimneystack distortions are considered satisfactory.

There are flue terminals atop. These generally appear in a satisfactory order though could not be inspected from our ground level vantage and we must limit our reporting in this respect. We recommend the flue terminals together with the chimney head and any seating/bedding/fixing are inspected when high level access is next available together with the completion of any necessary additional remedial repairs identified at that time. No apportionment is included in this respect.

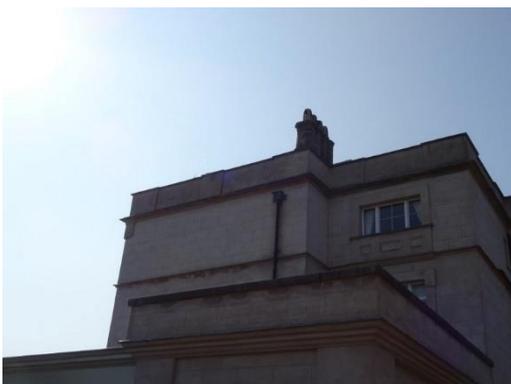
There is a further chimney flue arrangement above the parapet walling toward the rear right corner.

Again the flues and terminals generally appear in a satisfactory order with no significant issue or compromise. We however must again limit our reporting in respect of ground level survey only and recommend when high level access is next obtained that the chimney heads together with any terminals and seating/bedding/fixings are inspected together with the completion of

any necessary additional remedial repairs identified at that time. No apportionment is included in this respect.

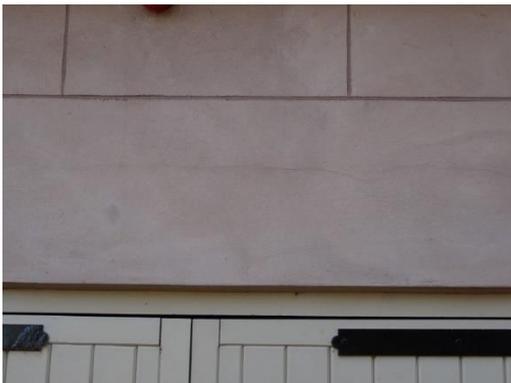
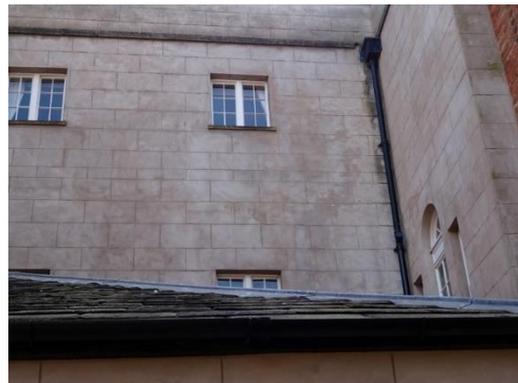
There are minor cracks to the render finishes and again there are areas of discolouration.

In line with our advices above these are considered satisfactory in a property of this age and construction, in the absence of any recent or ongoing movement or significant structural compromise.

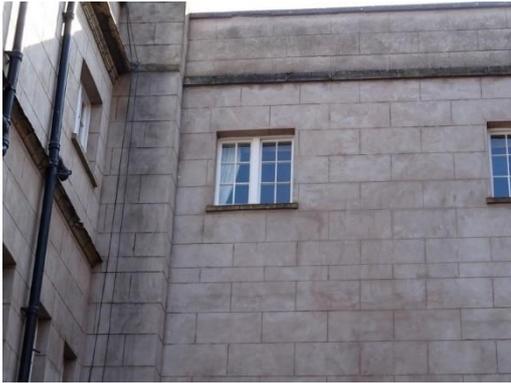
There are some areas where the incised detail to the render finishes distorts. This reflects the construction finishes rather than any subsequent or significant movement and this is considered a cosmetic issue. There are no works arising from our reporting in this respect.

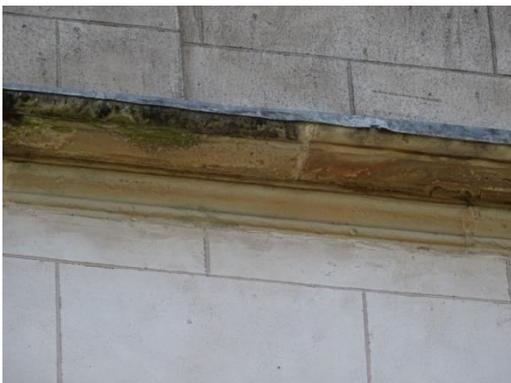
There is historic decay/erosion reflecting the age and construction of the property but with no significant issue or compromise. Typical detail shown.

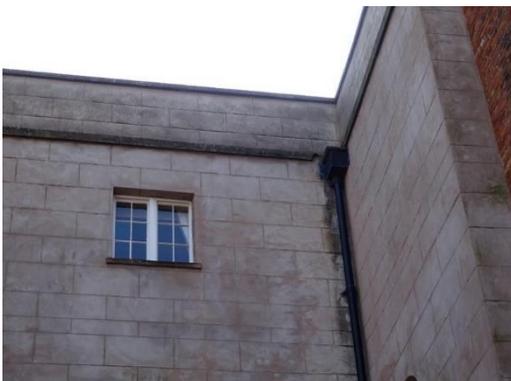
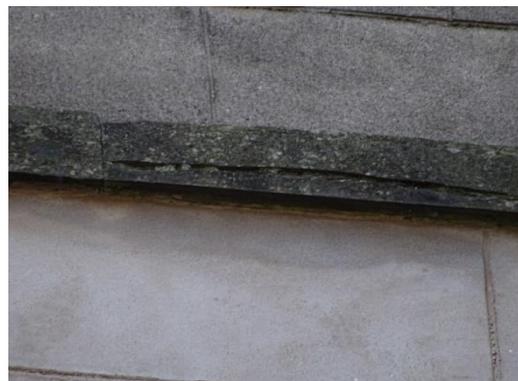
There is a render covered architectural band detail at high level to the rear central area.

This is split and the split section is at risk of falling onto the building and users below. We have included provisional apportionment in this respect.

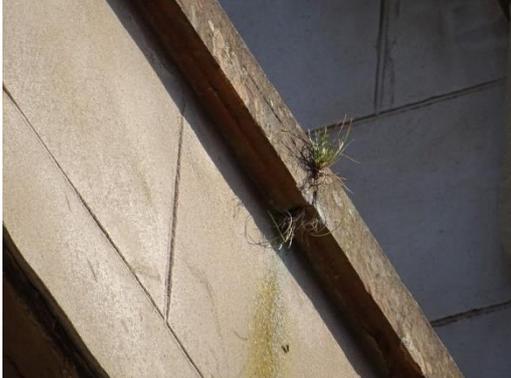
To the rear central area there is some vegetation growth from the wall head copings.

These should be carefully removed as a maintenance item and the gaps repointed with lime based mortars to preclude further growth.

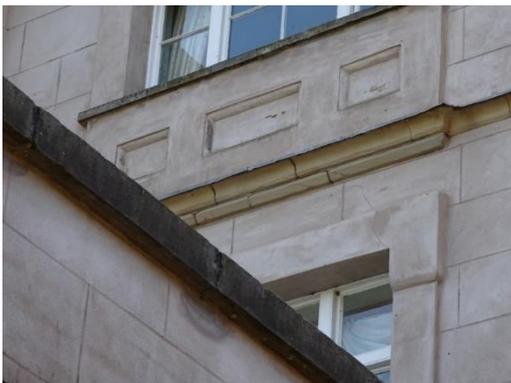
There is minor cracking to the walls through the render finishes.

Typical detail shown.

In line with our advices to the front elevation there are no indications of recent or ongoing significant movement or significant structural compromise and this is considered satisfactory.

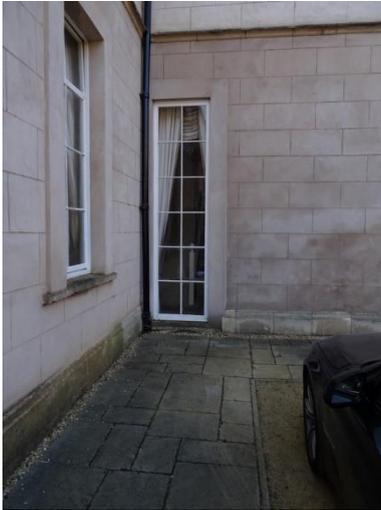
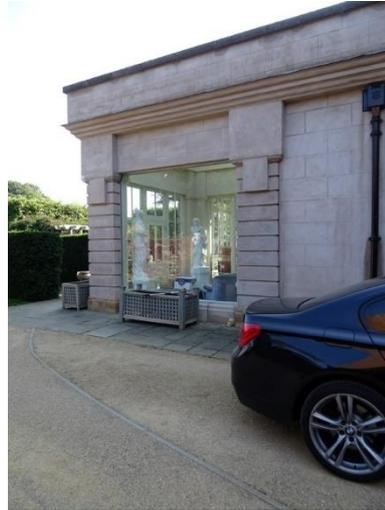
There is low level glazing to the base of the stair and to the porte-cochere.

There is further low level glazing to the porte-cochere and to the orangery. To the porte-cochere and orangery there are indications of thicker/toughened glazing though the use of safety glazing could not be confirmed and we must limit our reporting in this respect. We recommend enquiries via your Solicitor to confirm that toughened/safety glazing was installed as part of any Statutory Approval process.

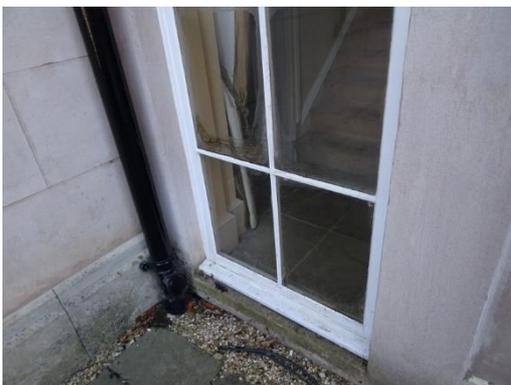
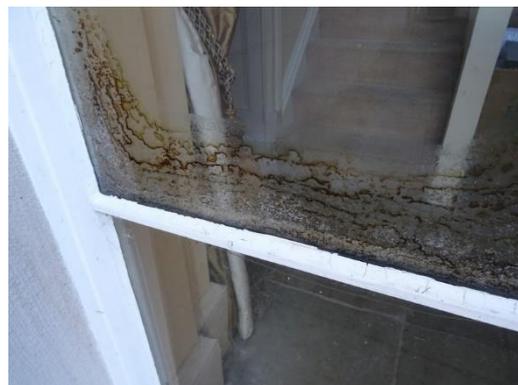
To the base of the stair there is some discolouration to the historic glazing.

This is indicated reflecting prior historic glue residues or similar used in the application of internal glazing films. As a cosmetic matter no apportionment is included in this respect.

The glazing is not indicated as toughened/safety glazing though is noted historic and in this respect there are no works arising from our reporting in this context. We highlight the issue as a safety concern.

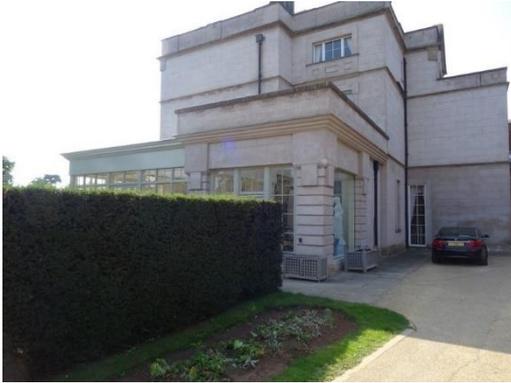
The adaptations to the porte-cochere to bring this into the internal accommodation and the construction of the orangery are both indicated as later alterations to the property.

We recommend enquiries via your Solicitor to confirm that all requisite Statutory Approvals were obtained for the constructions, that all necessary building inspections were completed at the time of construction works and that all Statutory Approval conditions were complied with fully.

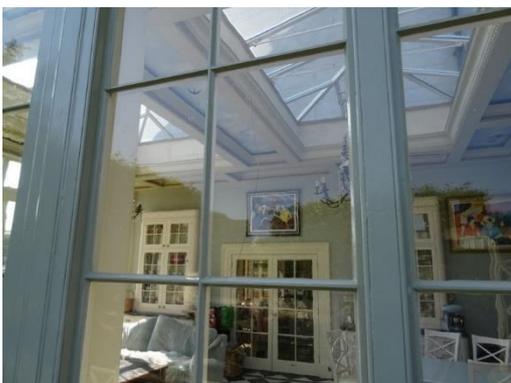
There is localised damage to the orangery glazing.

We have included provisional apportionment in this respect.

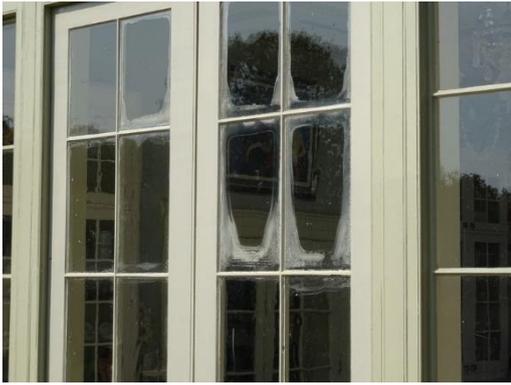
There is further staining indicative of historic glue residue to the orangery glazing.

Again in the absence of any significant issue or compromise this is considered satisfactory.

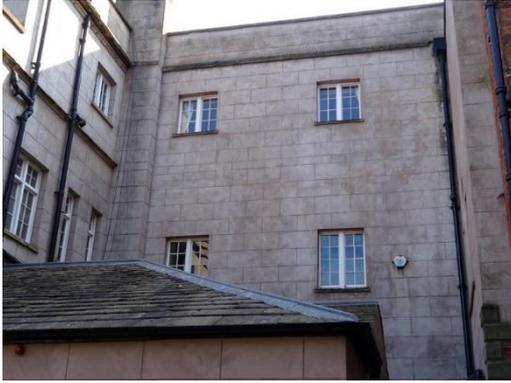
There are historic minor deformations indicated at door and window head positions reflecting the age and construction of the property. There are no indications of recent or ongoing significant movement or significant structural compromise and these are considered satisfactory in a property of this age and construction.

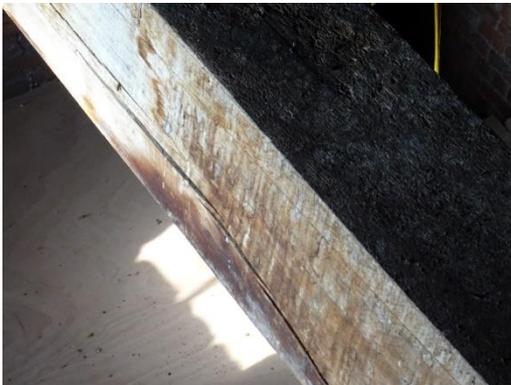
The floors have been formed in substantial exposed timber joists which were noted to be structurally sound with no recent deflection noted. Splitting of the joists was noted, however this is not considered significant for their age and has not affected their structural integrity.

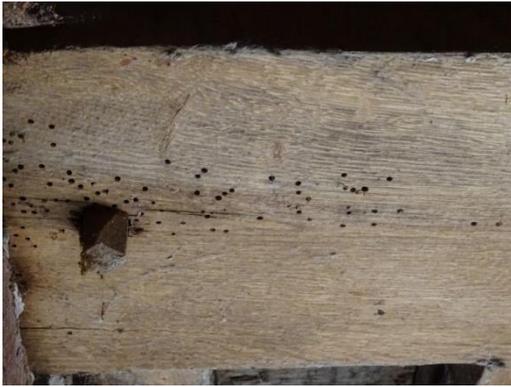
Evidence of a previous infestation was noted to the exposed timbers where we cannot confirm that the infestation is dormant. Unless a recent treatment certificate is available, we would advise that a specialist company is instructed to inspect the timbers and treat as necessary.

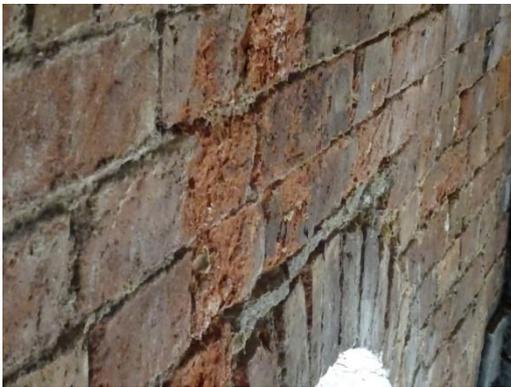
Various isolated bricks have begun to perish, however not considered significant for the age of the property.

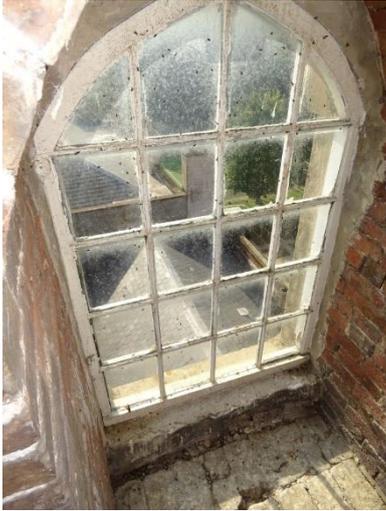
The window is timber framed incorporating single glazing which is generally in poor condition and requires localised repairs and decoration in the immediate term in order to prevent its further deterioration and vermin ingress.

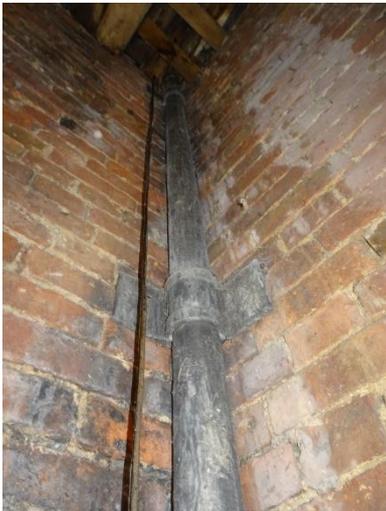
A lead downwater pipe is located adjacent the staircases which is tired, however no evidence of leaks were noted.

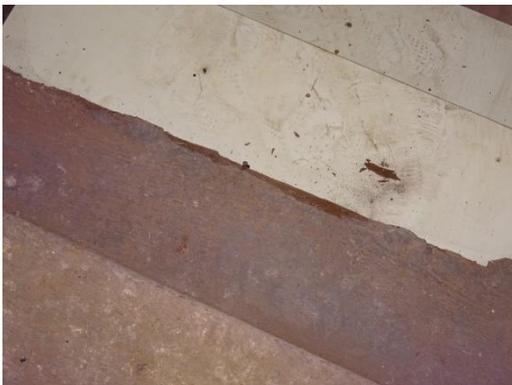
A timber staircase gave access up to the upper floor. The staircase is original and as a result of prolonged infestation, localised damage was noted, resulting in irregular height. We would advise that localised repairs are carried out to the staircase, in order to prevent its ongoing deterioration and improve safety.

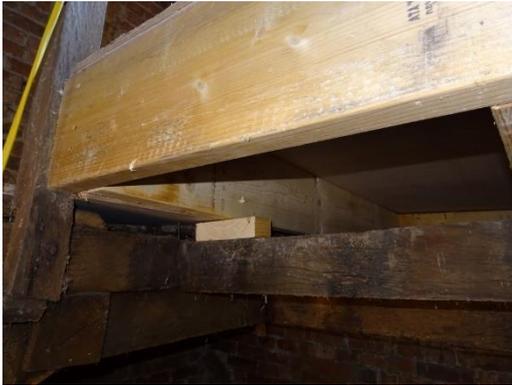
Previous makeshift repairs have been carried out to the staircase which are out of keeping with the character of the property.

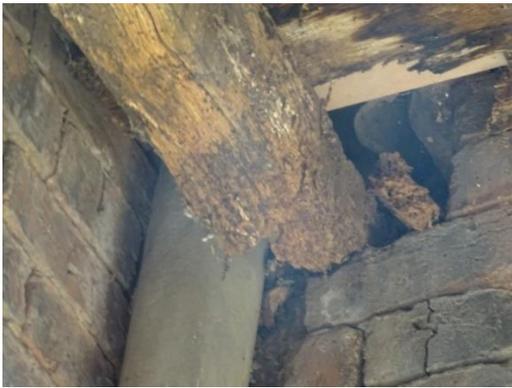
Where the staircase supporting timbers have been subject to prolonged infestation, this has resulted in reducing their structural integrity, therefore as part of the repairs to the staircase, strengthening works will be required.

Note – photo of damaged joists where strengthening is required.

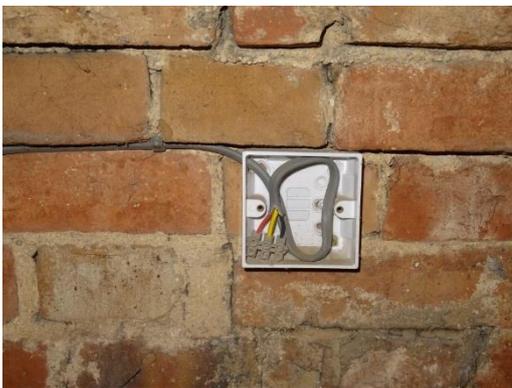
Exposed electrics are noted around the stairwell which we would advise are made safe by a competent and qualified electrician in the short term.

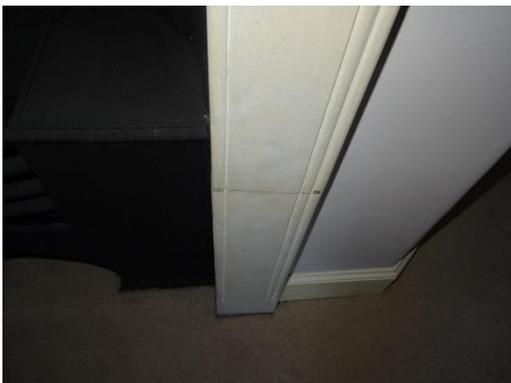
The chimney incorporates a stone surround. Localised damage was noted to the surround most likely as a result of expansion and contraction caused by the heat produced by the fireplace, however this is of no significant concern.

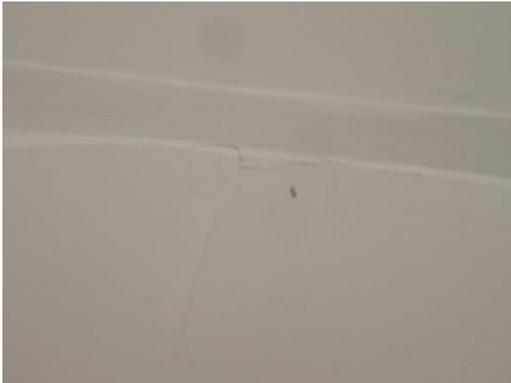
A supporting arch is located within the rear wall. Slight cracking was noted to the head of the arch which has resulted in de-bonding of the plaster. Initially we would advise that the loose plaster is hacked back with localised patch repairs carried out. We would then advise that the arch is periodically monitored and in the unlikely event that further cracking occurs, it will then be necessary to carry out an arch repair in order to reinstate its structural integrity.

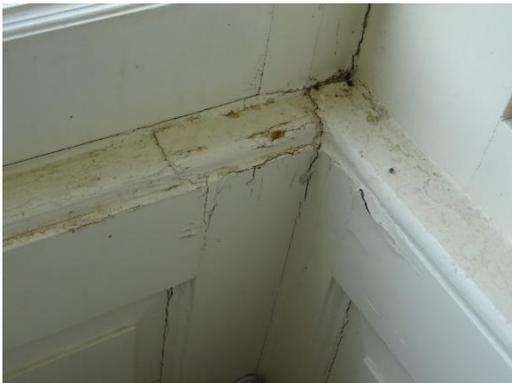
The window is timber framed incorporating single glazing which requires overhaul to include repair of several broken panes and decorations.

Due to the poor condition of the window, localised water ingress has occurred resulting in localised rot which will require repair prior to decoration.

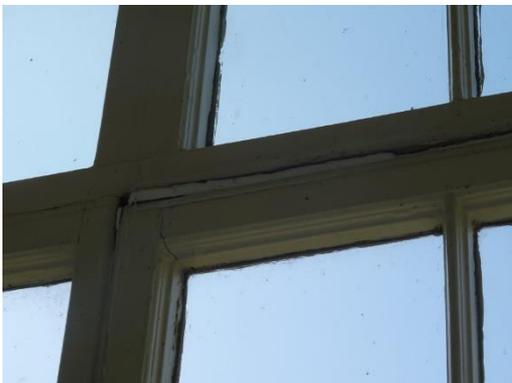
The window has slightly warped and therefore will require adjustment in order to allow its operation and improve its thermal efficiency.

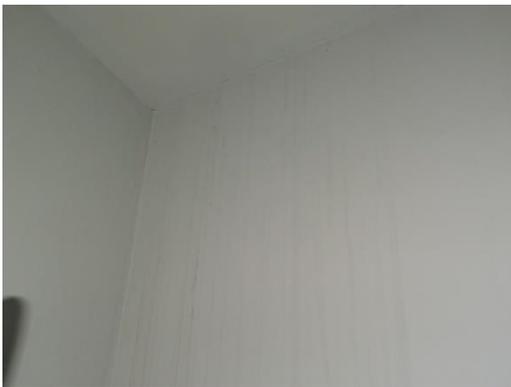
Water staining was noted to the wall adjacent the door which has tracked down the wall. We consider the damp stain to have occurred as a result of water ingress around the edge of the windows within the tower. Once it can be confirmed that the windows are weathertight, we consider that no further water ingress will occur, at which time the damp stain can be stain blocked and then decorated.

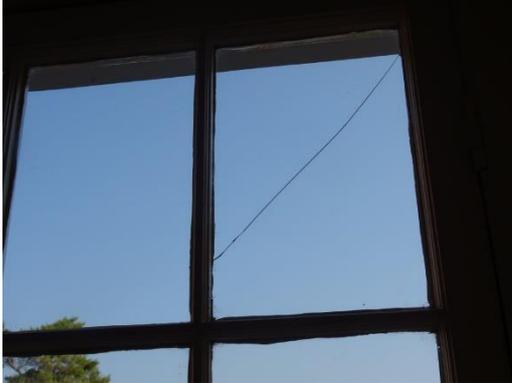
The windows are in a fair condition having been recently overhauled and decorated, however a single glazed panel was noted to be damaged requiring replacement.

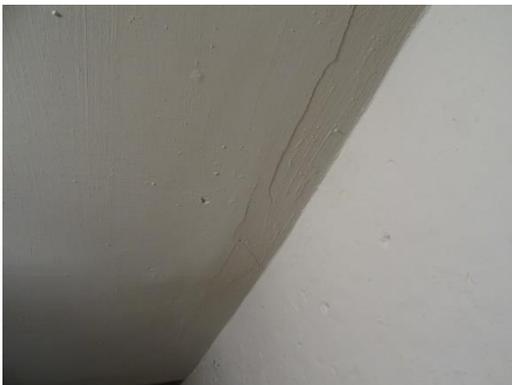
At the end of the hall is an understairs cupboard. The underside of the staircase has been boarded over. Minor de-bonding of the plaster was noted, however of no significant concern and simply due to normal reverberation.

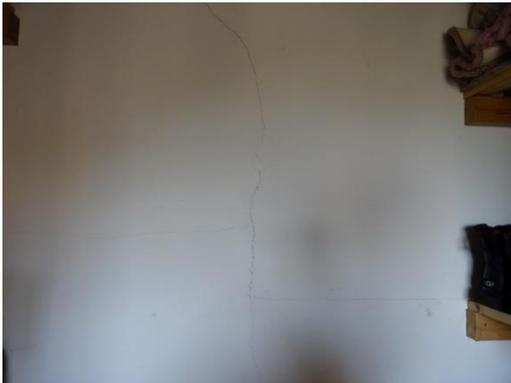
General cracking was noted to the walls however this is of no structural concern and simply due to normal age related wear and tear of the lath and plaster and requires filling prior to decoration.

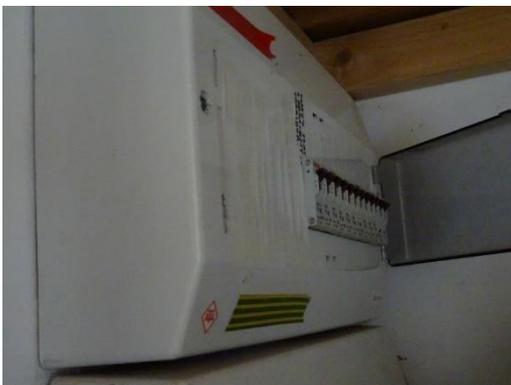
Two consumer units are located within the airing cupboard. The consumer units are relatively dated, however incorporate modern circuit breakers. Where circuit breakers have been removed adhesive tape has been amateurishly applied.

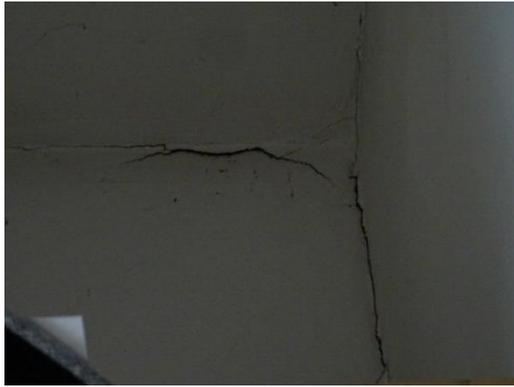
Shrinkage cracking was noted around the corner of the room which is of no structural concern however requires filling prior to decoration.

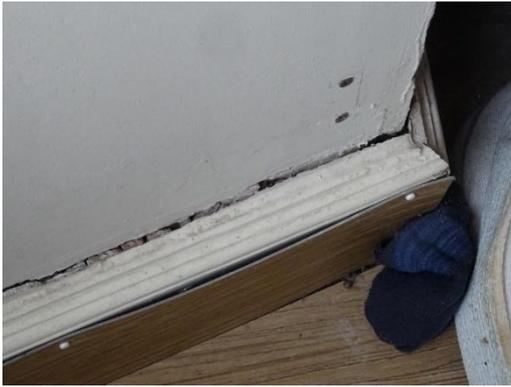
The skirtings were noted to have slightly warped therefore will require localised repairs and securing back to the wall.

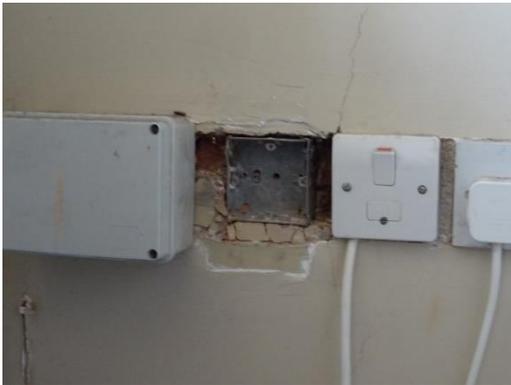
Localised repairs are required to the walls where redundant fixtures and fittings have been removed which we would advise is carried out prior to decoration.

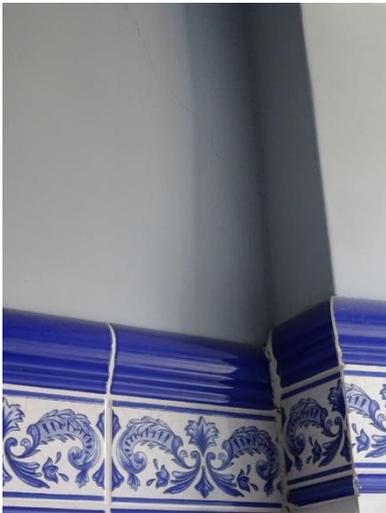
Ceramic tiles have been installed to the walls and floor with no splitting of the tiles noted. Localised opening up of the grouting around the corner of the room is evident where the wall separating the kitchen from the WC has slightly dropped. We consider the wall to most likely have dropped as a result of being supported on a timber joist which would not be considered unusual for the age of the property. The dropping of the wall appears historic and non-progressive which suggests that the deflection of the timber support has reached its limit. We would however advise that the tiles are re-grouted and the slight diagonal cracking adjacent to the window is filled, with the repair then used as a visual monitor. In the unlikely event that further movement occurs to the wall, it will then be necessary to open up the floor to carry out an inspection of the concealed support, with repairs carried out as necessary.

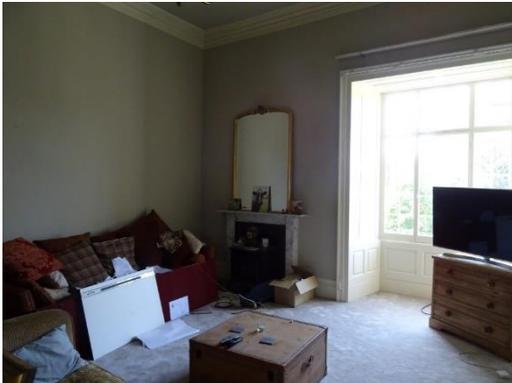
The walls and ceilings are plastered finished with emulsion with no structural cracking noted.

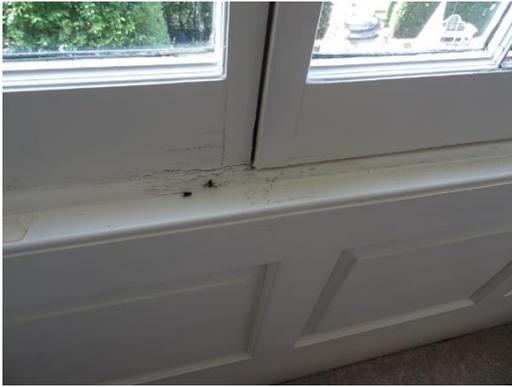
The window is timber framed incorporating single glazing. Minor surface rot was noted to the window as a result of water ingress which will require sanding back and decorating. It should be noted that due to the type and style of the windows, they will be subject to water ingress until such time they are eventually replaced.

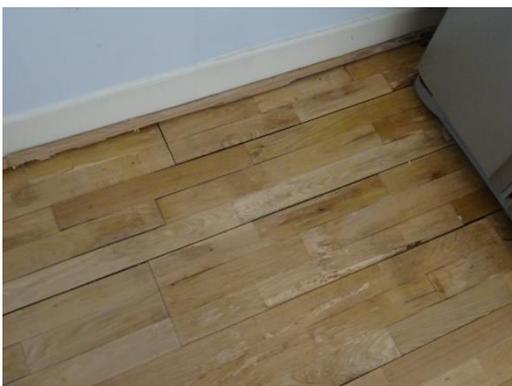
The floor has been surfaced with engineered timber which is in poor condition and has been subject to water ingress where we consider white goods to have failed. Due to the extent of the damage we consider it would be more economical to replace the floor covering rather than to repair.

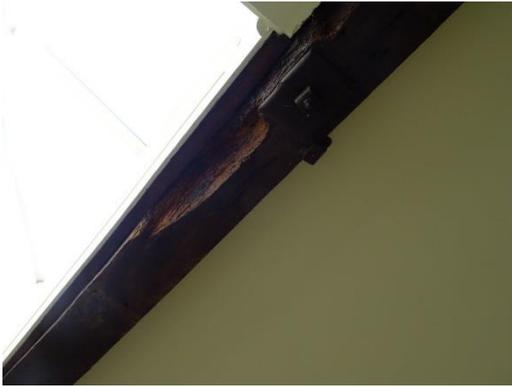
The timber ceiling beam is exposed which has been subject to infestation, however we noted no deflection to the beam to consider it not to be providing adequate support. Where an infestation could be inspected, this appeared dormant with no evidence of an active infestation noted at the time of our inspection.

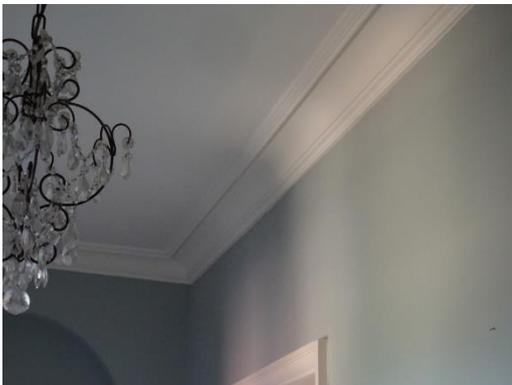
The ceiling within the rear of the hall was noted to slope, however there was no cracking around the coving to consider the sloping to be progressive.

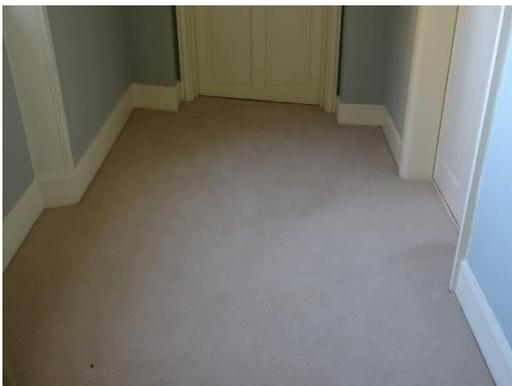
The floor has been covered with a fully fitted carpet. The floor within the rear of the hall was noted to slope down to correspond with the sloping ceiling, however there was no cracking around the joinery to consider the sloping to be progressive.

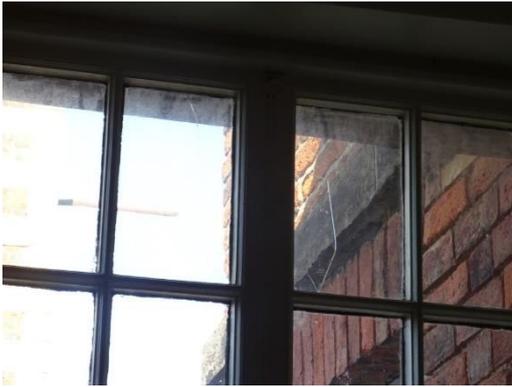
The windows are timber framed incorporating single glazing which have been relatively well maintained. Minor warping of the windows was noted which was not considered unusual for the age of the property. The window within the front of the hall requires localised repairs where several glazed panes were noted to be damaged.

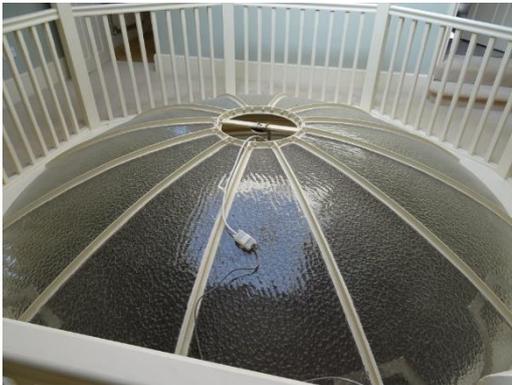
A timber balustrade has been installed around the edge of the domed lightwell to prevent risk of injury to young children.

The balustrade does not provide adequate lateral restraint against falling onto the glazed dome and should be strengthened.

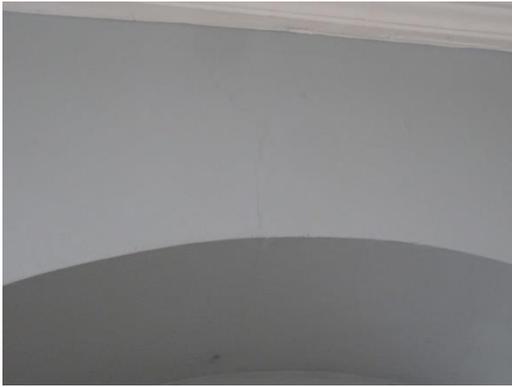
Where arches support the masonry above slight cracking was noted, however this is not considered significant with no failure of the arches noted.

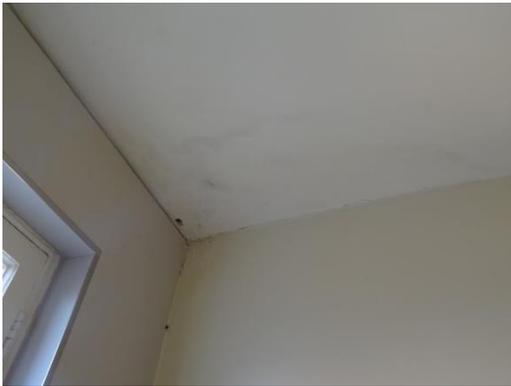
Slight damp staining was noted to the ceiling which suggest that the lead flashing detail above has failed. We would advise that a competent roofing contractor is instructed to inspect the lead detail above and repair as necessary. We would then advise that the damp stain is stain blocked and decorated.

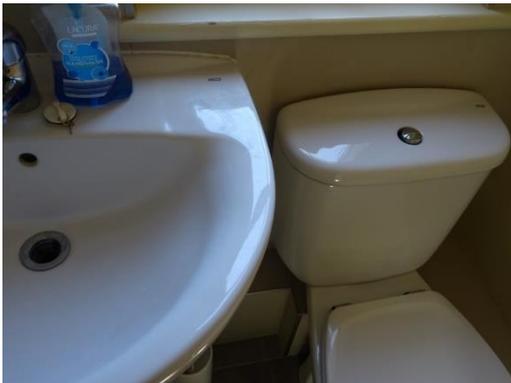
The sanitary fittings are relatively modern however the sanitary furniture does require repair.

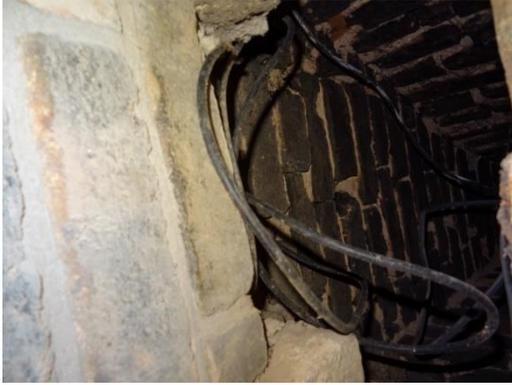
The chimney breast is located within the room which has been left open therefore would benefit from being closed off in order to prevent debris collecting at the base of the fireplace.

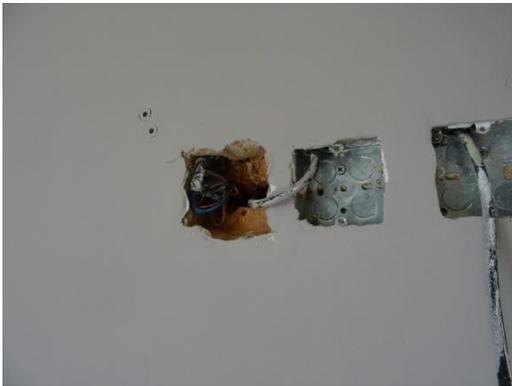
General repairs are required to the walls where redundant fixtures and fittings have been removed.

Exposed electric cables were noted which we would advised are made safe by a competent and qualified electrician.

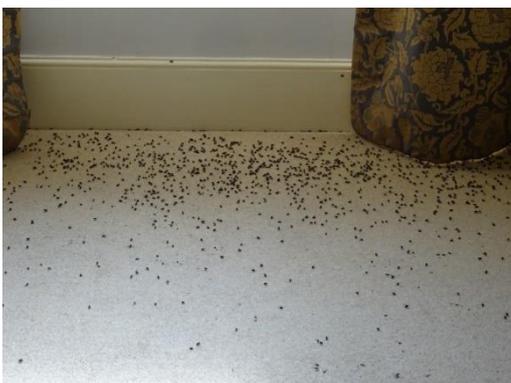
The floor has been covered with a fully fitted carpet which was noted to slightly undulate under foot, however not considered significant. At the time of our inspection we noted an insect infestation which will require removal.

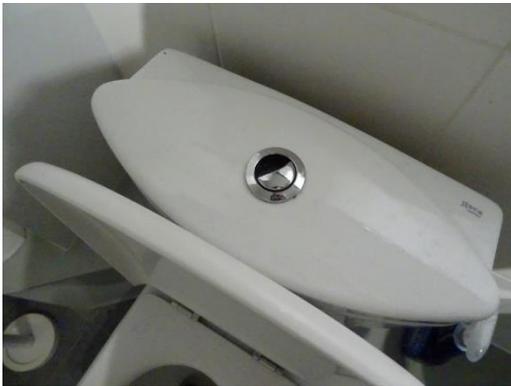
The sanitary furniture requires repair or replacement.
