BUILDING SURVEY

Level 3

ALLCOTT
RESIDENTIAL

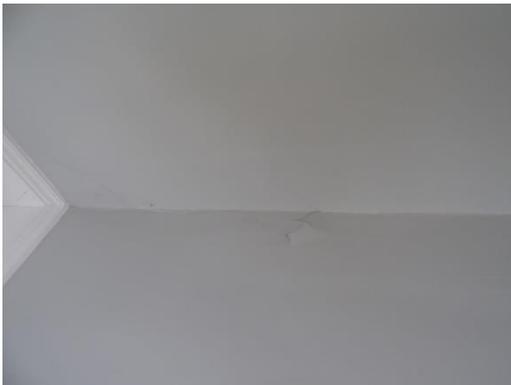
The walls and ceilings are plastered finished with emulsion. Slight plaster debonding is noted within the front left hand corner of the room where the lath and plaster wall abuts the masonry wall which is of no structural concern. We would however advise that the loose plaster is hacked back with patch repairs carried out prior to decoration.

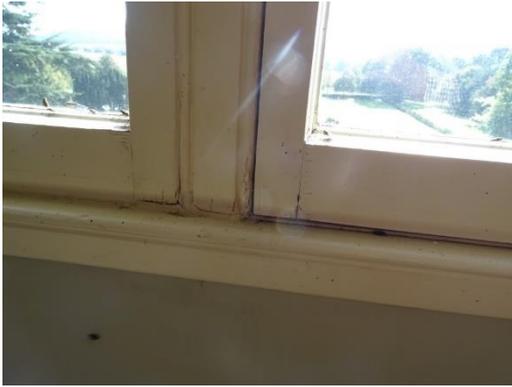
The window is timber framed incorporating single glazing which requires localised repair and decoration.

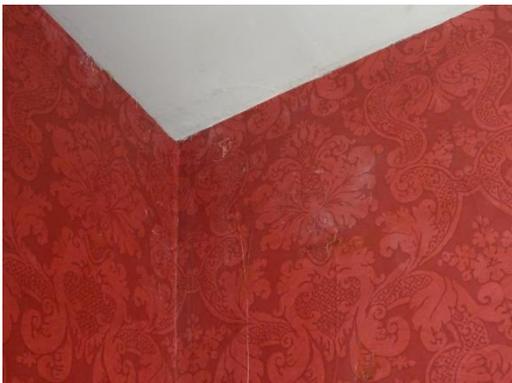
Minor repairs have been carried out to the ceiling within the corner of the room where we consider water ingress to have occurred. There is no recent damp staining which suggests that the water ingress has been previously identified with repairs carried out to the roof above, as necessary. We would simply advise that this is periodically inspected and should further damp occur then it will be necessary to instruct a competent roofing contractor to gain access above and repair as necessary.

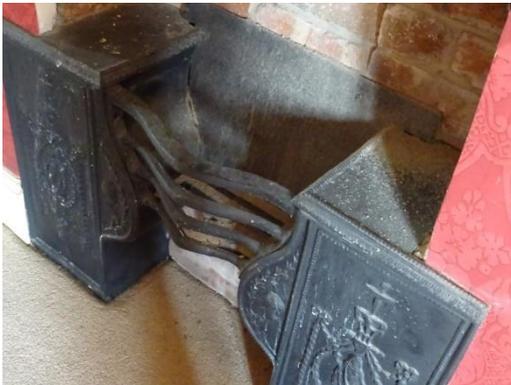
The chimney breast is located within the room to correspond with that noted above and below. The underside of the chimney is open which would benefit from being closed off in order to prevent debris collecting at the base of the fireplace.

A cast iron fireplace has been installed within the chimney which would benefit from being cleaned down.

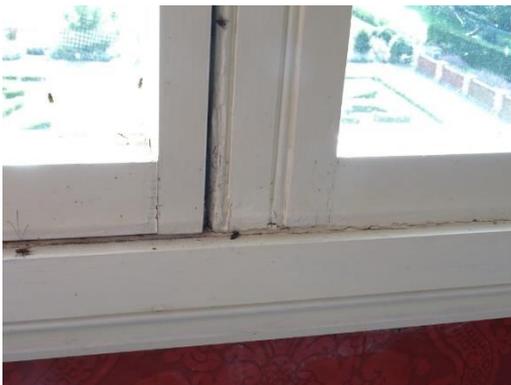
The window is timber framed incorporating single glazing which requires localised repairs and decoration.

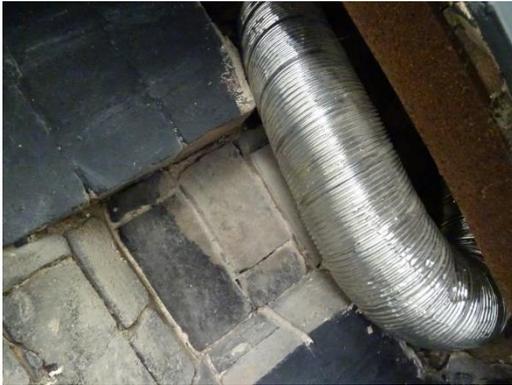
An aluminium flue is located within the underside of the chimney which is redundant and therefore would benefit from being removed with the chimney then closed off.

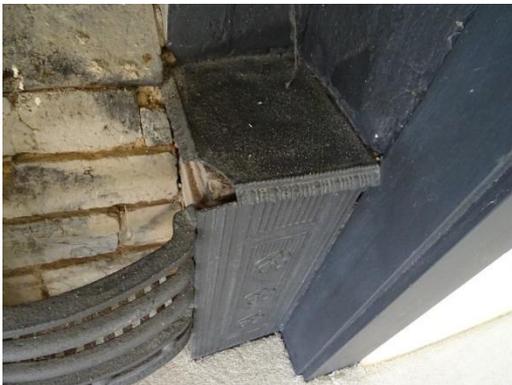
The chimney incorporates an open cast iron fireplace with stone surround. Slight damage was noted to the fireplace which would benefit from specialist repair.

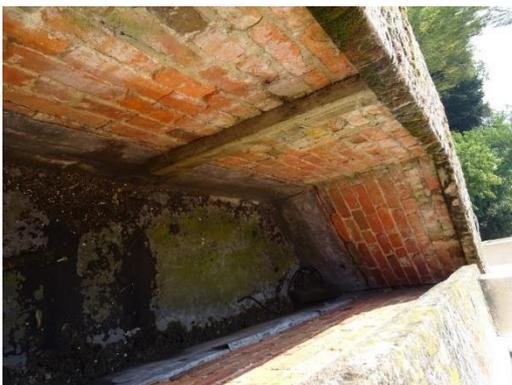
The bay has been formed in fair faced brick which requires general repointing.

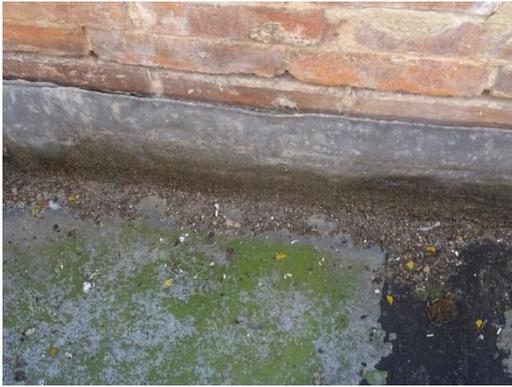
The bay floor has been lined with lead with no splitting of the lead noted. Where the lead abuts the brickwork it has pulled away requiring dressing into the brickwork in order to prevent water ingress.

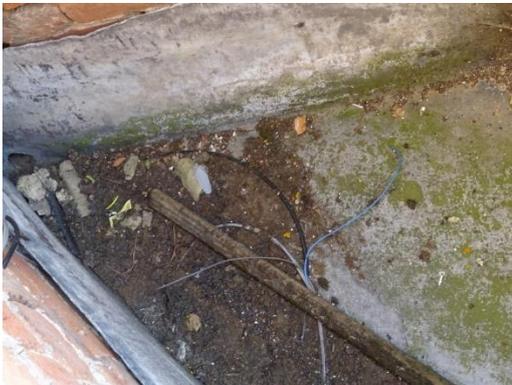
The drainage outlets within the bay were noted to be blocked at the time of our inspection requiring clearing in order to prevent a build-up of standing water. It should be noted that the clearing of the drainage outlets will be an ongoing maintenance issue.

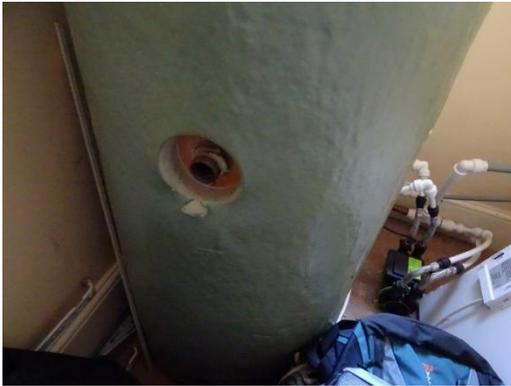
An open pipe was noted within the cylinder which will require closing off.

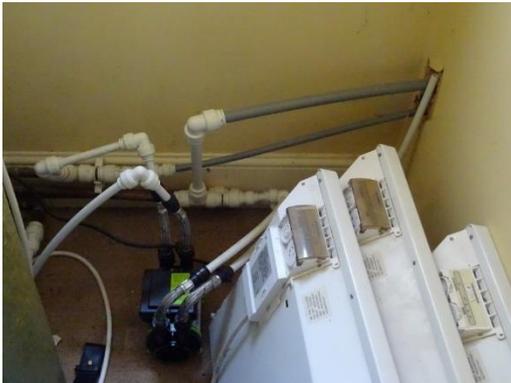
An inline pump has been amateurishly installed to the associated pipework however no evidence of leaks were noted. We would advise that boxing is installed around the pump in order to prevent accidental damage.

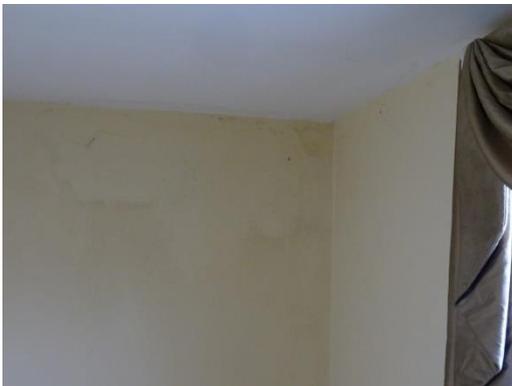
Damp staining was noted to the ceiling where we consider the roof above to have failed. We would advise that a competent roofing contractor is instructed to gain high level access and carry out the necessary repairs with the damp staining then stain blocked and decorated.

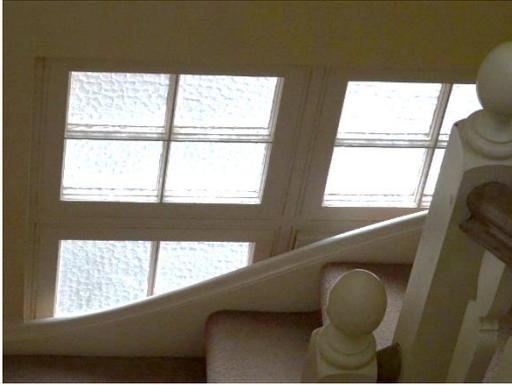
The window adjacent the staircase is low therefore we would advise that a balustrade is installed in order to prevent risk of injury.

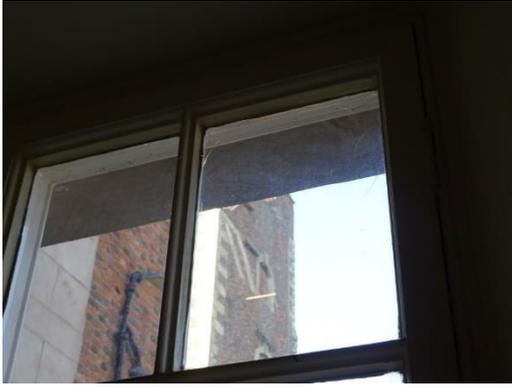
Localised damage was noted to various panes which will require replacing.

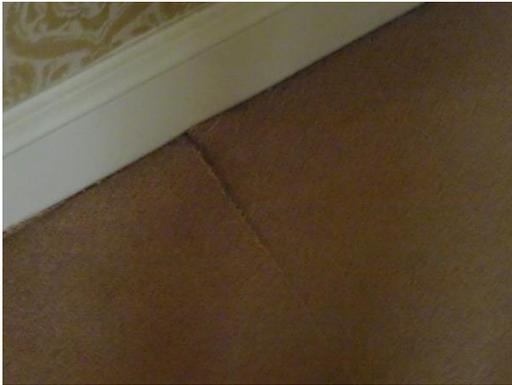
The landing has been covered with a fully fitted carpet which was noted to be lifting at the junction and requires securing into position in order to prevent it being a trip hazard.

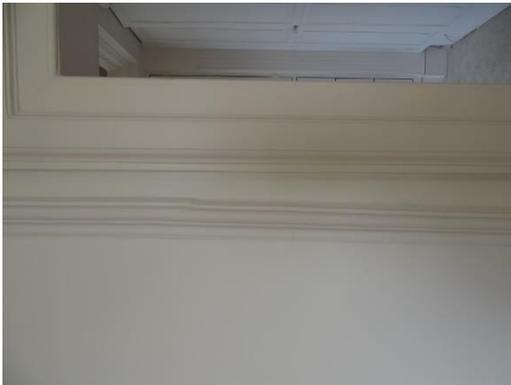
The walls incorporate decorative cornicing. Slight displacement was noted to the cornicing in various locations however this appears historic and non-progressive.

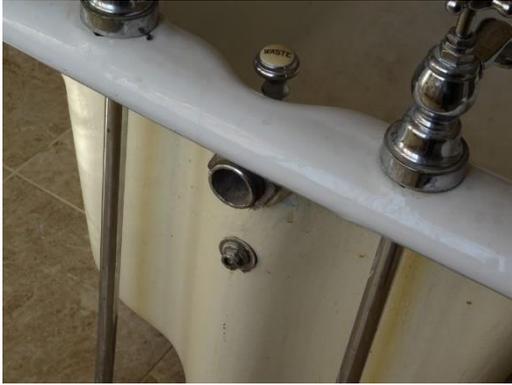
The overflow to the bath requires reinstating in order to prevent risk of water damage to the ceilings below.

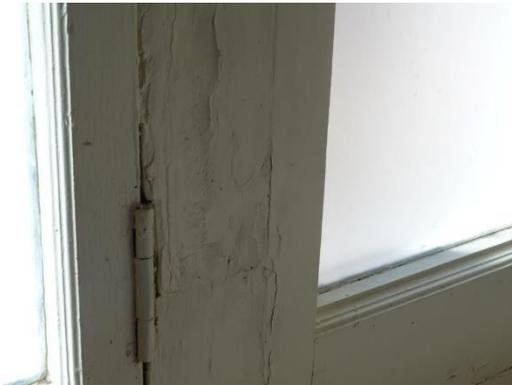
The window is timber framed incorporating single glazing which was in a fair condition however requires localised repair and decoration.

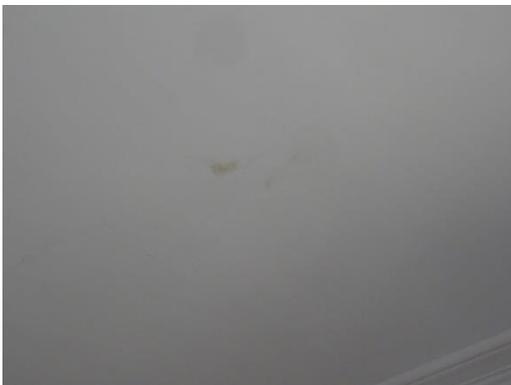
Slight damp staining was noted to the ceiling which is where we noted sanitary fittings above. Once it can be confirmed that the seals around the sanitary fittings above are sound, which consider that no further damp staining will occur at which time the damp stain can be stain blocked and decorated. In the unlikely event that further damp staining does occur, it will then be necessary to instruct a competent plumber to inspect the concealed pipework above and repair as necessary.

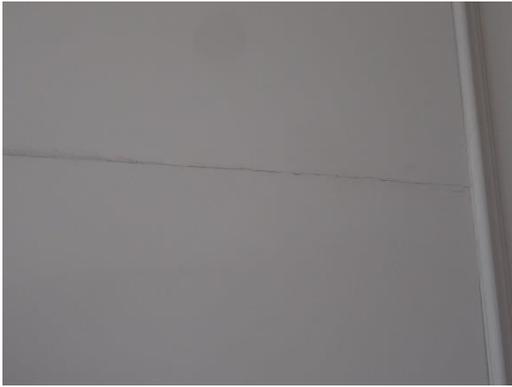
Decorative cornicing has been installed to the walls. Localised board cracking was noted to the cornicing which is of no structural concern and requires filling prior to decoration.

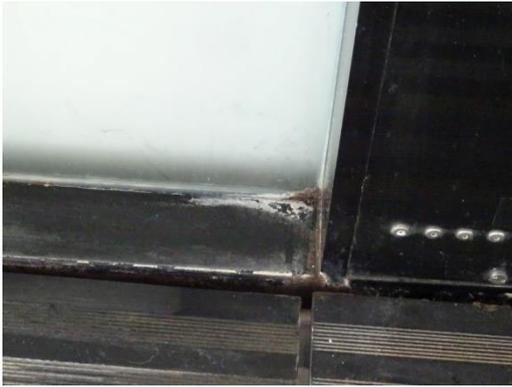
An enclosed prefabricated shower has been installed within the room which is in generally poor condition and we consider it would be more economical to replace rather than to repair.

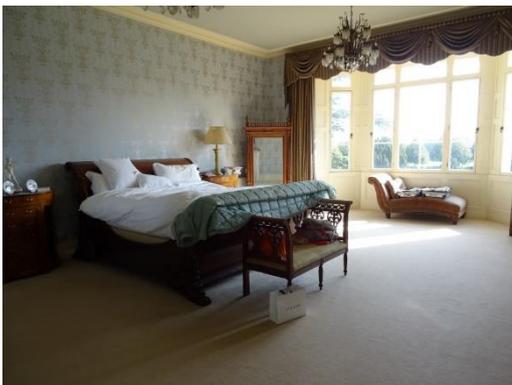
Bedroom Three

The walls and ceilings are plastered finished with emulsion to the ceiling and plain paper to the walls. Slight cracking was noted to the ceiling where the plaster finishes have begun to de-bond due to age related wear and tear, however not considered significant and require filling prior to decoration.

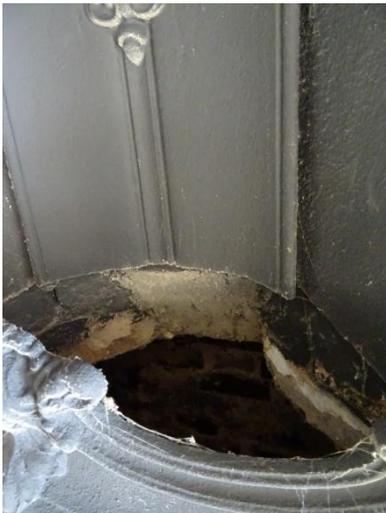
The underside of the chimney would benefit from being closed off in order to prevent debris collecting at the base of the fireplace.

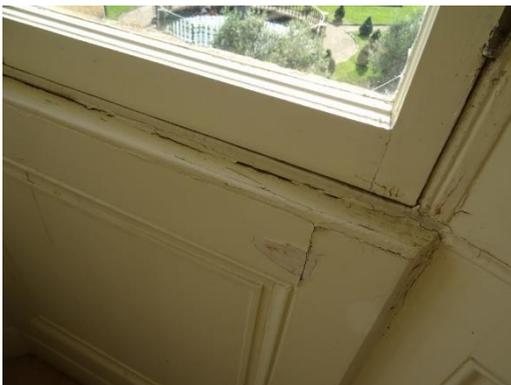
The windows are timber framed incorporating single glazing which require general repair and decoration due to poor fitting frames which has allowed for water ingress.

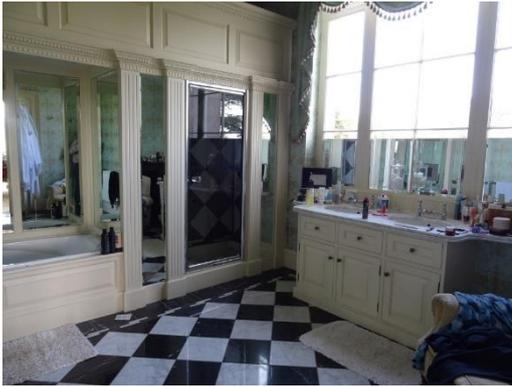
Leading off the bedroom is an **En-suite Bathroom**

Built-in units which incorporate a bath and shower cubicle have been installed within the room are relatively tired requiring localised repairs and decoration.

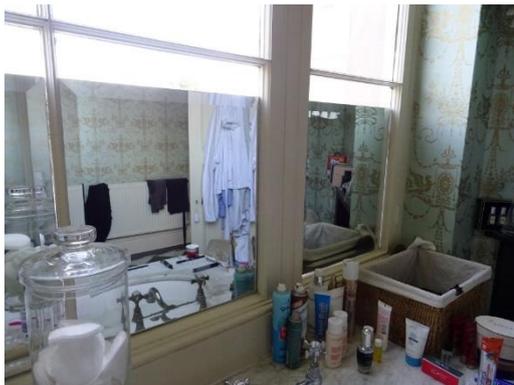
Adhesive mirrors have been applied to the windows in order to improve privacy. The application of the mirrors does however appear to be amateurish.

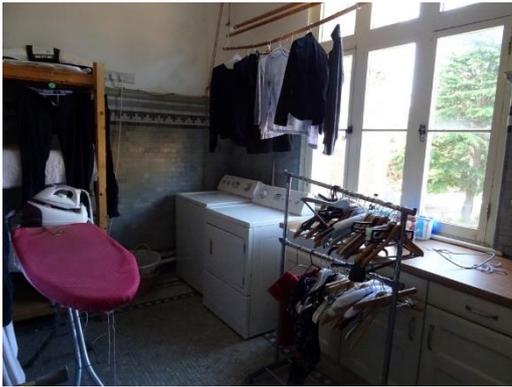
Washing Room

Ceramic tiles have been installed to the walls and floor with no opening up of the grouted joints or splitting of the tiles noted. The tiles are however relatively begrimed requiring cleaning down.

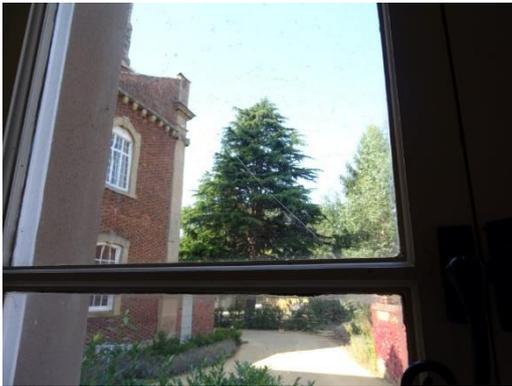
The windows are timber framed incorporating single glazing which are in a fair condition with only general wear and tear noted. Localised damage was however noted to a single glass pane which will require replacement.

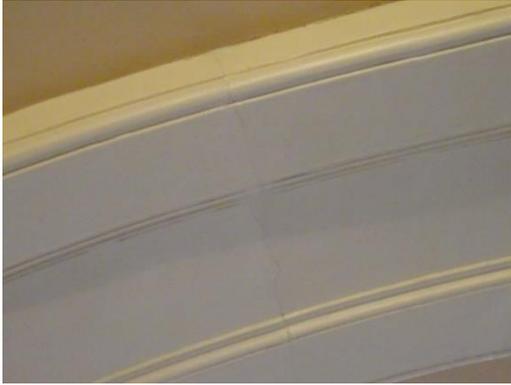
An arched downstand is located within the ceiling for support of the floor above. Slight hairline cracking was noted to the arch which is of no structural concern with the arch considered to be structurally sound.

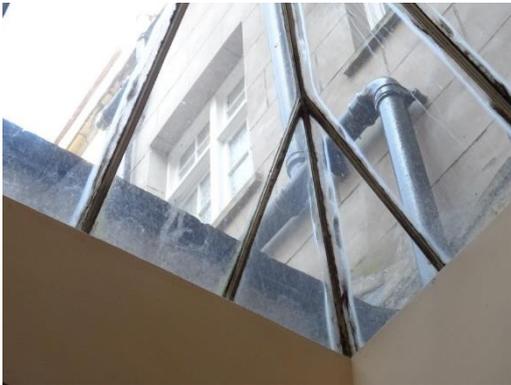
A metal frame skylight incorporating single glazing is located within the ceiling, which is begrimed requiring cleaning down, however no damp staining was evident to the underside of the skylight to consider any failure of the flashings above. It should be noted that due to the extent of the single glazing, the skylight will be relatively inefficient, therefore consideration should be given to its upgrading.

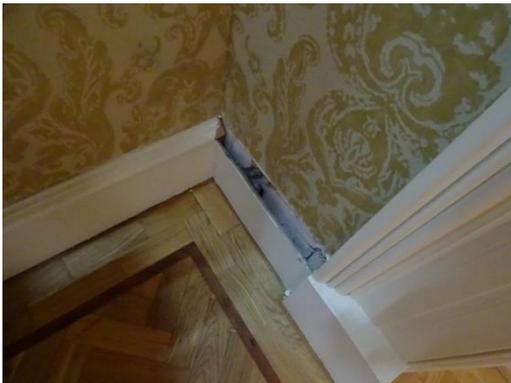
The joinery around the room is in a fair condition with only general wear and tear noted. Repair is however required to the skirtings where services have been installed.

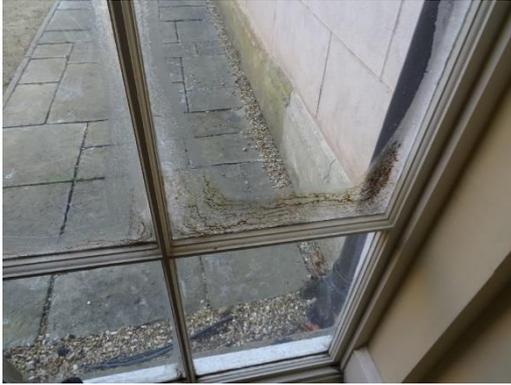
Where the window incorporates low level glazing a safety film has been applied however the film has failed, therefore will require renewal.

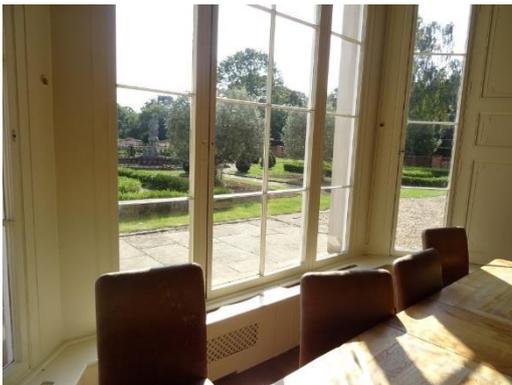
The windows incorporate low level glazing with no safety markings evident, therefore should you decide to keep the existing glazing we would advise that a safety film is applied.

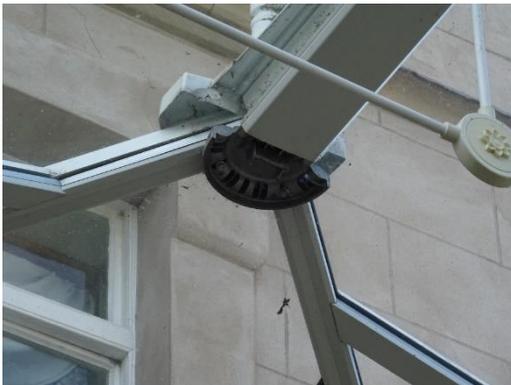
The uPVC capping to the right hand rooflight was noted to be partially missing requiring replacement.

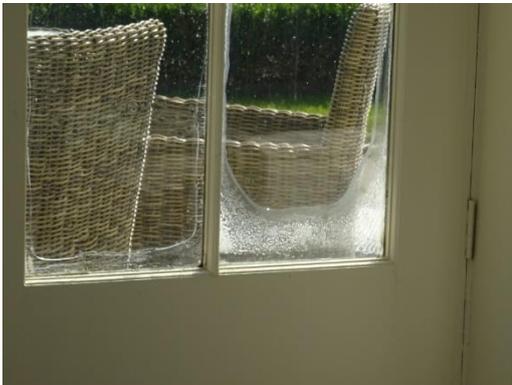
The windows are timber framed incorporating single glazing. No safety marks were noted to the glazing to confirm that the glazing is safety glass, therefore consideration should be given to applying a safety film. Where a safety film appears to have been applied to the doors, this has failed, therefore will require renewal.

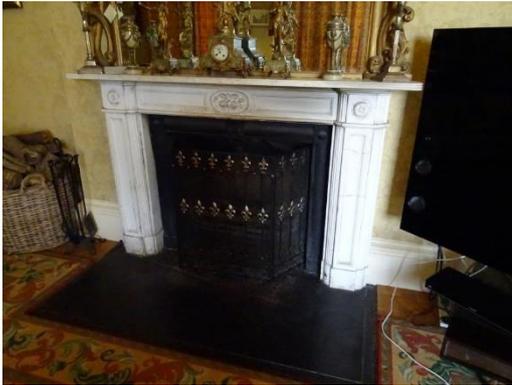
The chimney breast is located within the room to correspond with that noted above. The chimney breast incorporates an open cast iron fireplace with surround and stone hearth. Slight cracking was noted to the surround and hearth due to age related wear and tear however not considered significant.

Should the chimney not have been swept within the last 12 months, we would advise that the chimney is swept prior to further use.

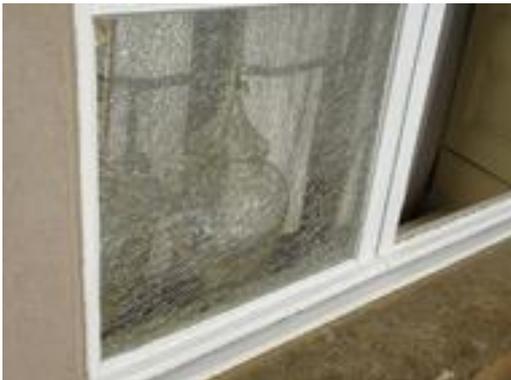
The windows are timber framed incorporating full height single glazing which are in a fair condition however would benefit from decoration. A single pane within the patio door was noted to be damaged therefore will require replacing in the immediate term.

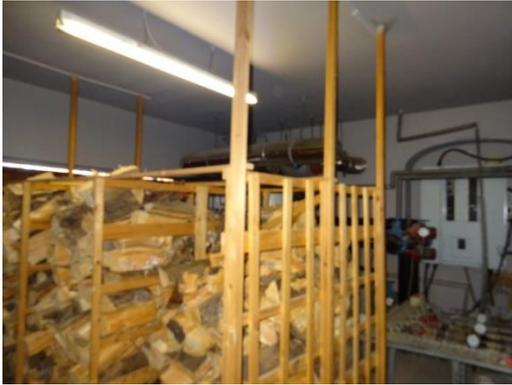
Boiler Room

At the time of our inspection we noted a slight gas odour and therefore we would advise that a test and inspection of the gas appliances are carried out in the immediate term to prevent risk of injury.

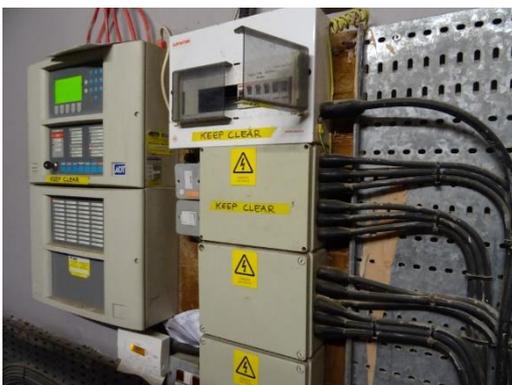
The fire alarm control panel is located within the room. The fire alarm system was not operating at the time of our inspection therefore we are unable to make comment on its effectiveness. We would however recommend it is tested and inspected if it has not been inspected in the last 12 months where it is possible that upgrading works will be required.

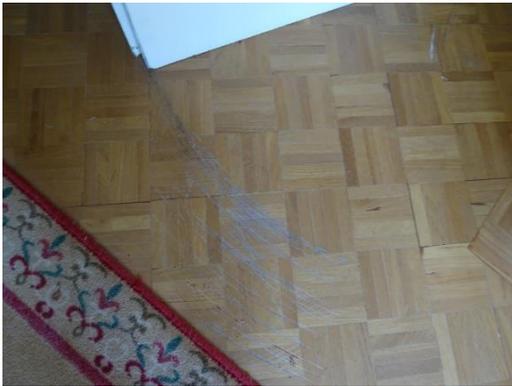
The floor has been surfaced with parquet which is relatively worn with localised damage noted therefore will require refurbishment.

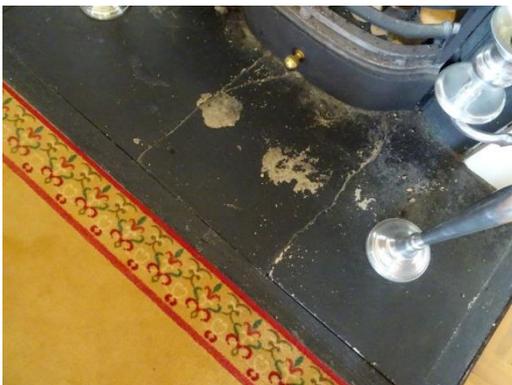
The chimney breast is located within the room to correspond with that noted above. The chimney breast incorporates cast iron fireplace with decorative timber surround and stone hearth. Prior to further use of the fireplace, we would recommend that the chimney is swept should it not have been swept within the last 12 months.

Localised cracking was noted to the hearth as a result of general wear and tear, however no significant concern.

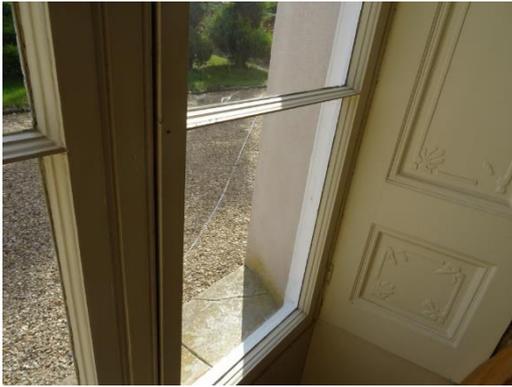
The window is timber framed incorporating full height single glazing which is in a fair condition however requires localised repair and decoration.

Localised damage was noted to a single pane which will require replacement.

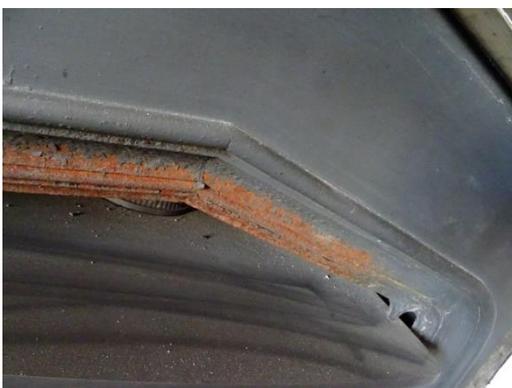
The chimney breast is located within the room to correspond with that noted above. The chimney breast incorporates a cast iron fireplace with a granite surround and stone hearth. Localised corrosion was noted to the fireplace which will require treating in order to prevent the corrosion from progressing.

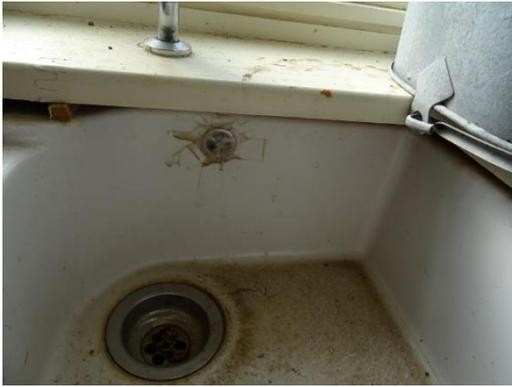
The sink overflow has been taped suggesting that they require plumbing in.

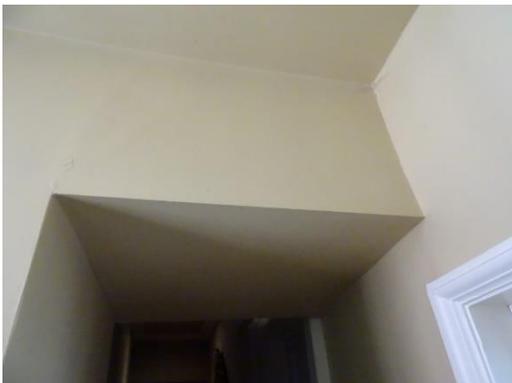
The walls and ceilings are plastered finished with emulsion. Slight cracking is evident within the rear wall which is of no structural concern but has simply occurred as a result of expansion and contraction of the support within the ceiling of the rear cloakroom.

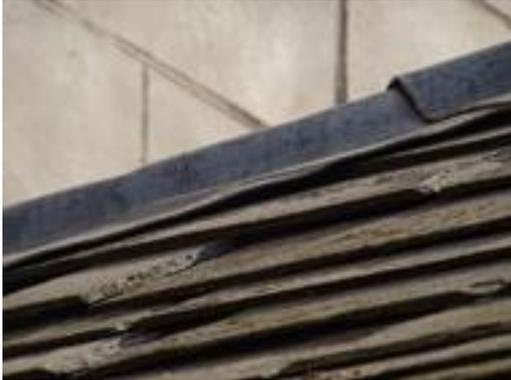
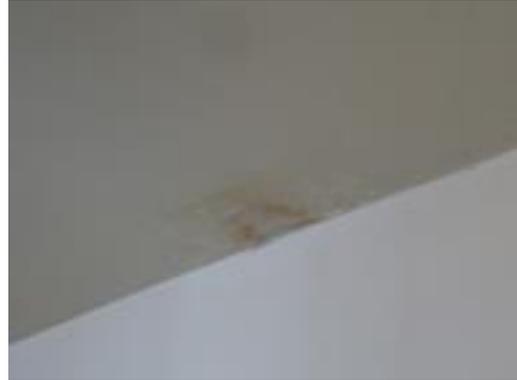
Slight damp staining was noted to the underside of the hip where we consider wind driven rain to have entered beneath the lead. We would advise that the lead to the hip is re-dressed around the slates to prevent further water ingress and prevent further damp staining to the ceiling below.

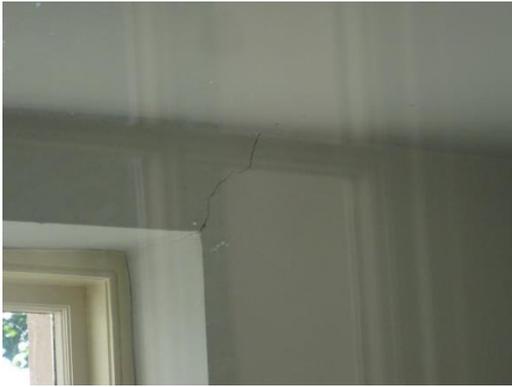
The walls and ceilings are plastered finished with emulsion. Slight cracking is evident above the window, which we consider to have occurred as a result of expansion and contraction of the concealed support and of no significant concern requiring filling prior to decoration.

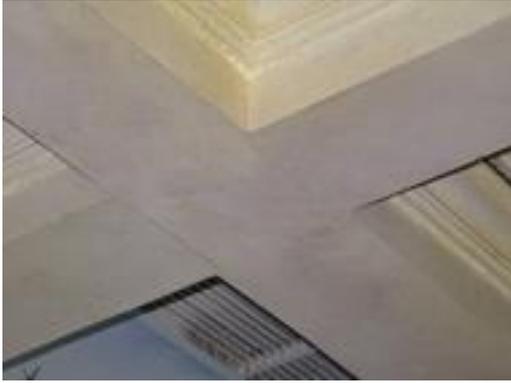
The ceiling has been formed in decorative stone with no significant cracking or deterioration of the stone work noted. Minor opening up of the stone joints was noted however not considered significant.

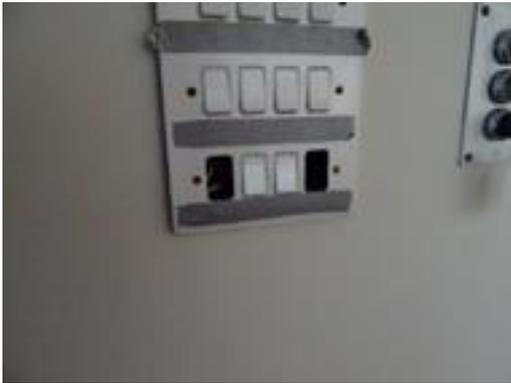
The main light switch has been damaged therefore will require replacing.

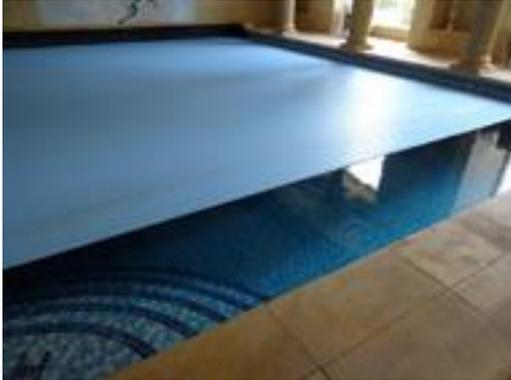
An automatic cover has been installed to the pool, was not operating at the time of our inspection therefore will require repair by a specialist contractor.

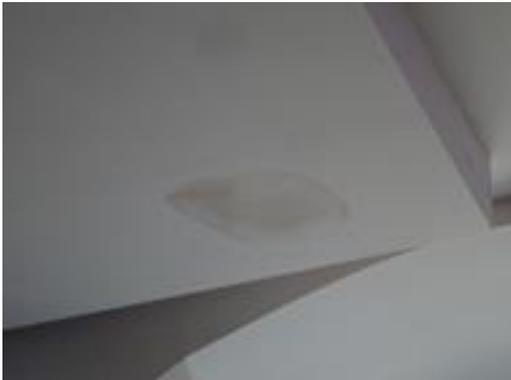
Damp staining was noted to the ceiling. This is where we noted a valley gutter above which we consider to be blocked therefore we would advise that a competent roofing contractor is instructed to clear the valley damp stain and stain block and decorated.

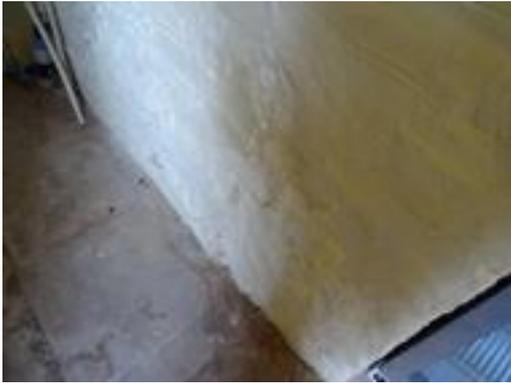
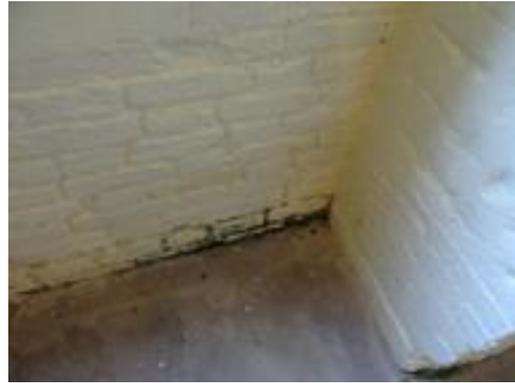
Salts were evident to the walls at low level and to the floor due to raised damp levels however this is not considered significant with the area not forming a habitable part of the

property. Consideration should be given to increasing the passive ventilation within the room in order to prevent a build-up of musty odours.

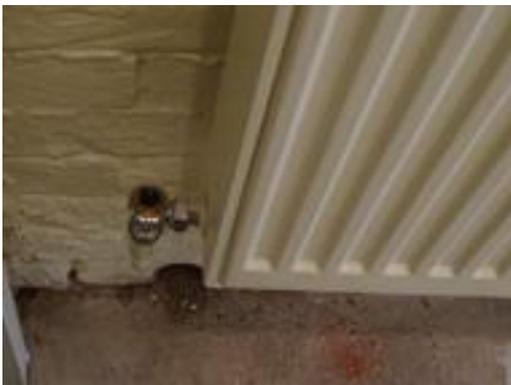
The thermostatic valve to the pressed metal panel radiator was noted to be damaged requiring repair.

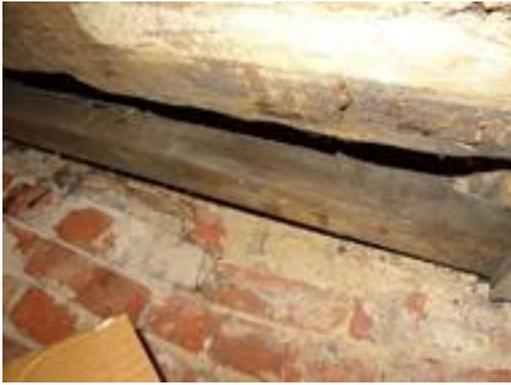
The floor has been formed in brick. Slight perishing of various bricks was noted however this is not considered significant.

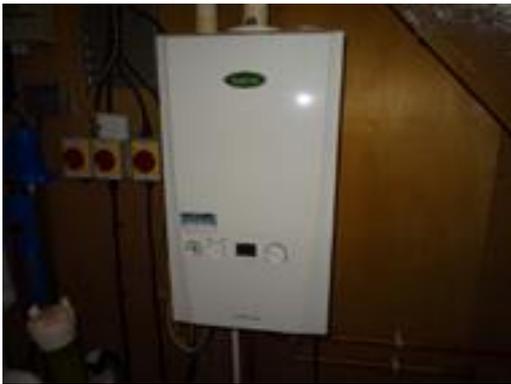
The pool is heated by a modern gas fired boiler which was noted to be fully operable at the time of our inspection with no defect noted to either the boiler or the associated pipework where evident.

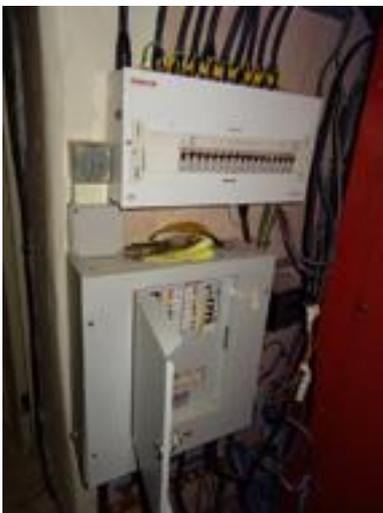
The electrical consumer unit serving the pool and spa area is located within the room and is modern incorporating modern circuit breakers and residual current devices.

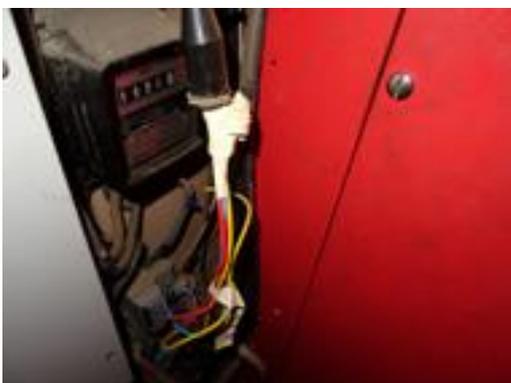
Amateurish alterations were noted to the electrical system within the room which we advise are inspected and made safe by a competent and qualified electrician in the immediate term.

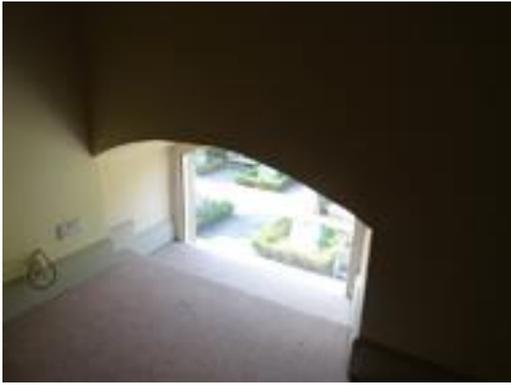
There is an arched support to the masonry above the window with no evidence of failure noted.

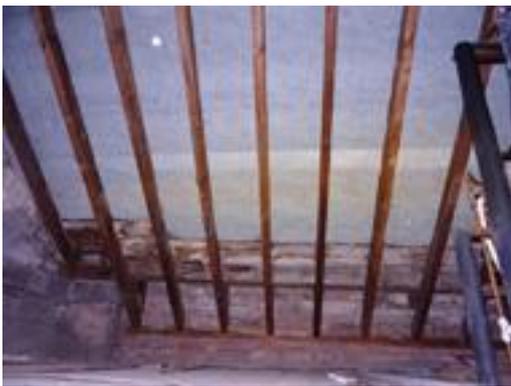
Previous condensation staining was noted to the purlins however we consider this to be historic and most likely it occurred prior to the re-covering of the roof. Should condensation persist then we would advise that ventilation is installed within the roof surfaces.

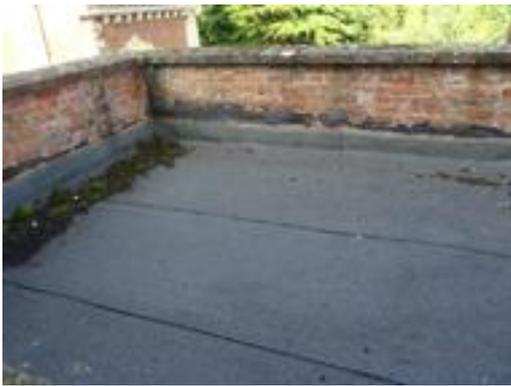
A general build-up of moss was noted to the flat roof which we would advise is removed as part of the pro-active maintenance scheme for the property.

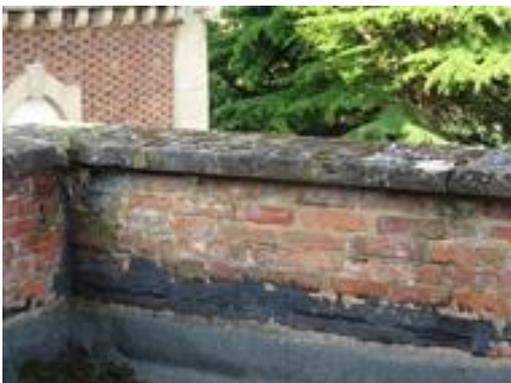
The parapet walls enclosing the flat roof are brick with a coping stone over and were noted to be structurally sound however would benefit from general maintenance in the form of removing the vegetation between the coping stone joints.

Minor perishing of the brickwork was noted however not considered significant.

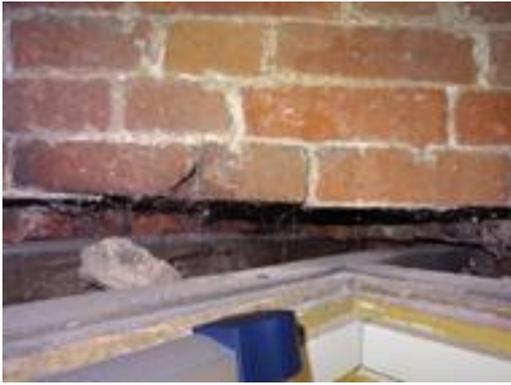
Part of an original chimney breast is unsupported within the roof void. We would advise that as support is installed beneath the brickwork in order to prevent risk of its collapse which may cause injury to persons below.

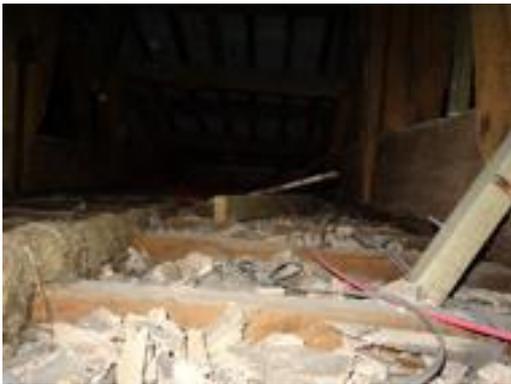
There is no insulation within the roof void therefore we would advise that this is updated in order to reduce heat loss.

A significant build-up of mortar debris is evident within the roof void which we consider will have been the original tile torching which will have been removed at the time the roof was re-covered.

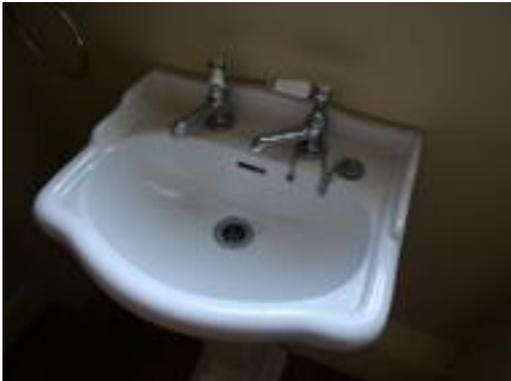
The sanitary fittings are relatively modern however are begrimed and require cleaning down.

The sanitary furniture requires adjusting.

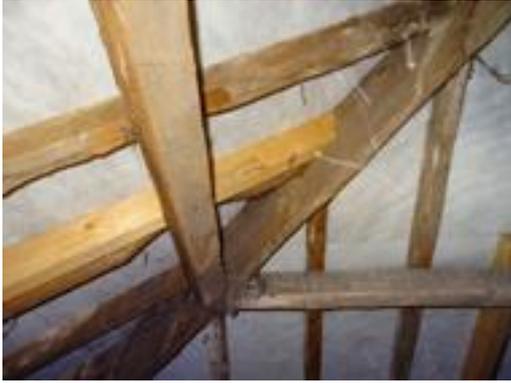
The roof has been formed in traditional cut timber rafters and purlins supporting the coverings. Where the rafters have been damaged by prolonged insect infestation these have been replaced with modern timbers. As a result the roof is structurally sound with no deflection of the rafters or purlins noted.

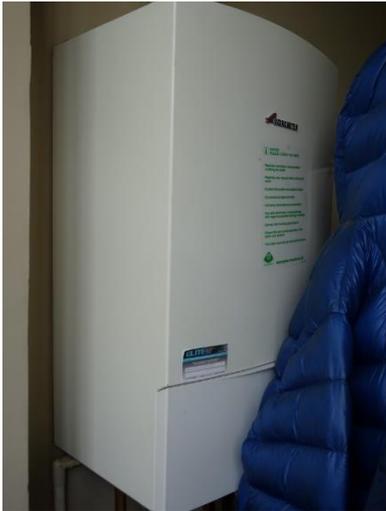
The central heating system serving the three bedroom flat is provided by a gas fired boiler located within the utility room. The boiler is relatively modern and was noted to be fully operable at the time of our inspection with no defect noted with the boiler or associated pipework where evident.

Where the pipework passes through the floor, localised repairs are required.

Consideration should be given to lagging the pipework in order to prevent condensation forming which may result in damp staining to the ceilings below.

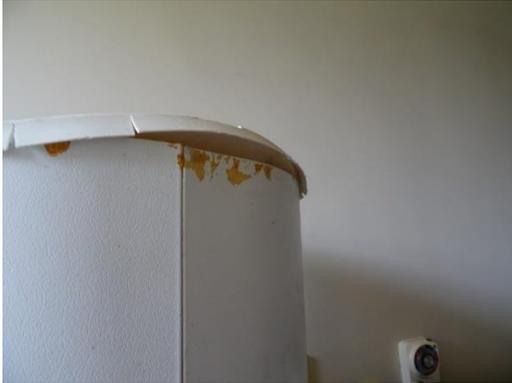
The hot water is stored within a pressurised cylinder. Localised damage was noted to the head of the cylinder however this does not appear to have affected its integrity.

The pressure valves were tested and noted to be fully operational at the time of our inspection.

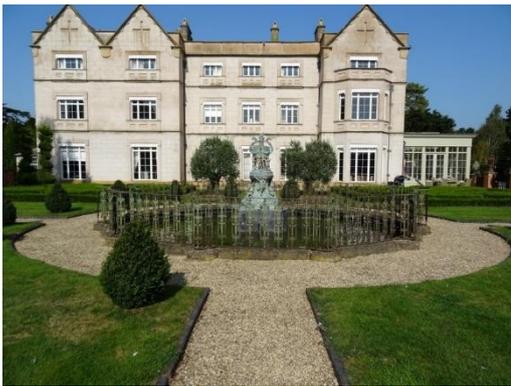
To the central garden area there is an historic water feature indicated with a central fountain. The feature is enclosed by historic iron railed fencing. There is a highly decorative water feature inset to the centre.

These all generally appear in a satisfactory order though notably the fencing in particular is in need of redecoration which should be planned as a maintenance item. No apportionment is included in this respect.

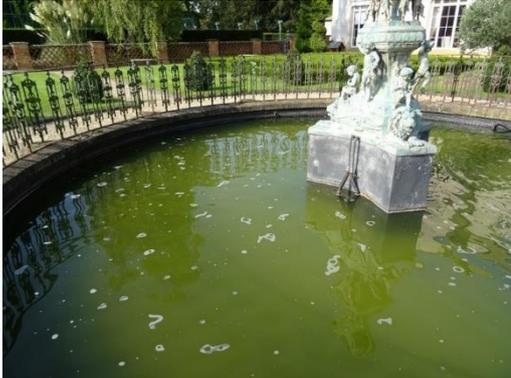
The fountain basin presents a legionella risk and we refer you to our advices below in this respect.

Particular legionella risks are associated with aerated water use such as with the fountain in operation.

There is a pumped arrangement operating within the fountain basin to circulate water. This was confirmed in operation at the time of our inspection. We are not aware of any service arrangement for the pump installation and we recommend this is inspected and serviced by a suitably qualified engineer shortly following purchase if servicing has not been carried out within the last 12 months.

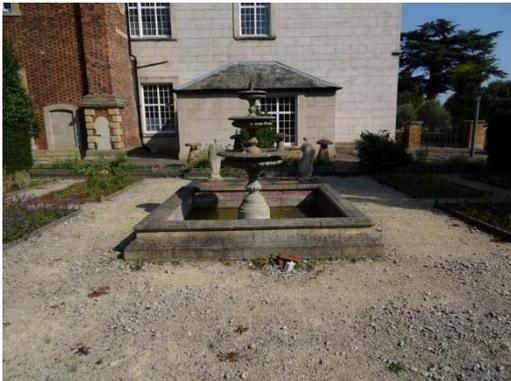
To the centre of this garden area is a brick and stone finished ornamental foundation basin with a multi-tiered fountain to the centre. This generally appears in a satisfactory order. This was not observed in operation at the time of our inspection and we must limit our reporting in this respect.

In line with our advices above we recommend the fountain pump system is inspected and serviced by a suitably qualified pump engineer shortly following purchase if servicing has not been carried out in the last 12 months.

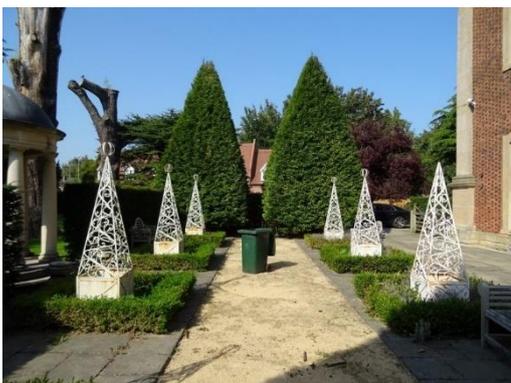
To the centre and rear there are further formal garden arrangements together with a cupola topped folly installation with statue to the centre. The surrounding landscape is formed with gravel and flagged finishes with low clipped Box hedging flanked by pyramidal topiaried trees to front and rear.

These all generally appear in a satisfactory condition.

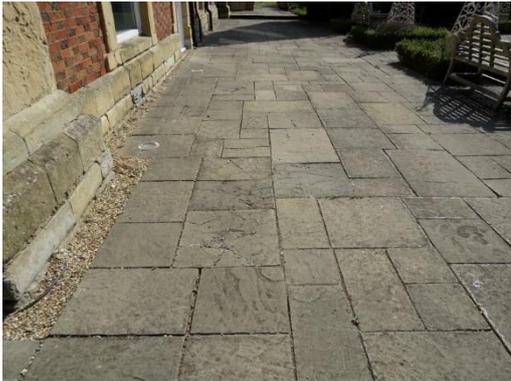
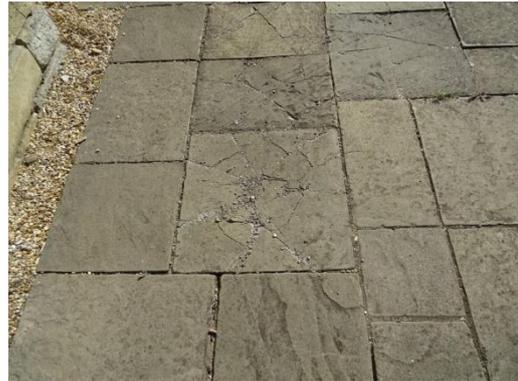
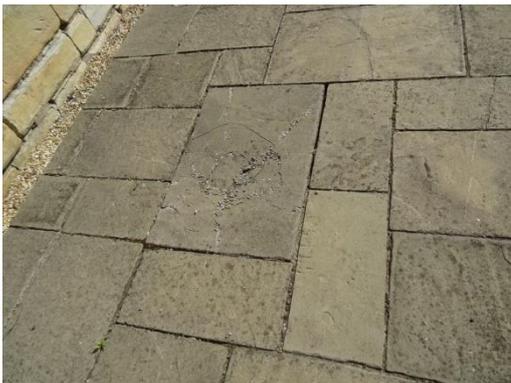
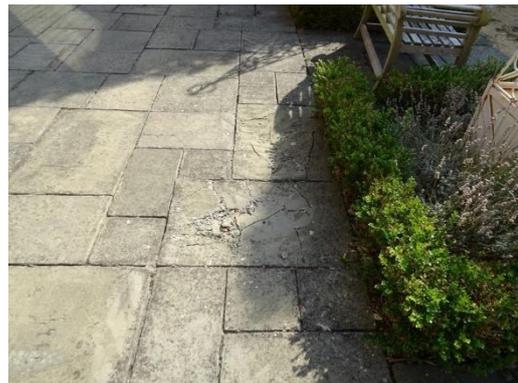
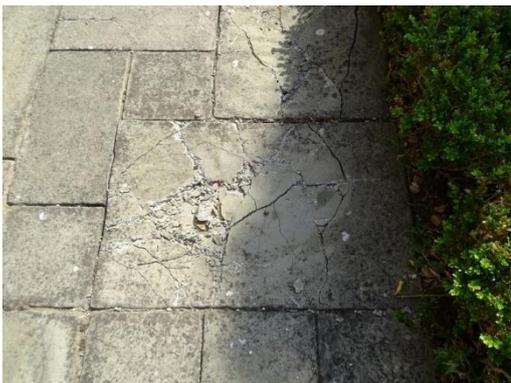
The cupola folly is in a reconstituted stone material with a metal dome indicated. The folly has concrete flags to the base. These all generally appear in a satisfactory order though

with some loose flags to the base and we have included provisional apportionment for release and rebedding locally.

The flagged area adjacent to the building has various areas of flag work damage. It is unclear whether this relates to the vehicular use or impact damage. We have included provisional apportionment for flag work replacement locally in this respect.

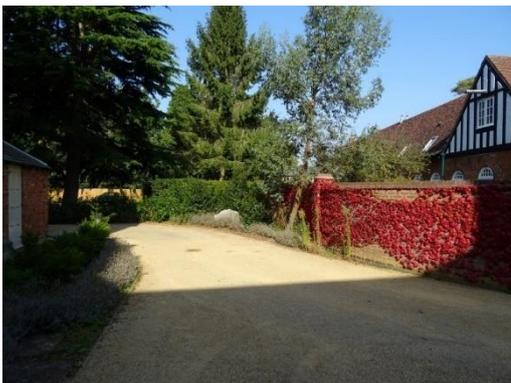
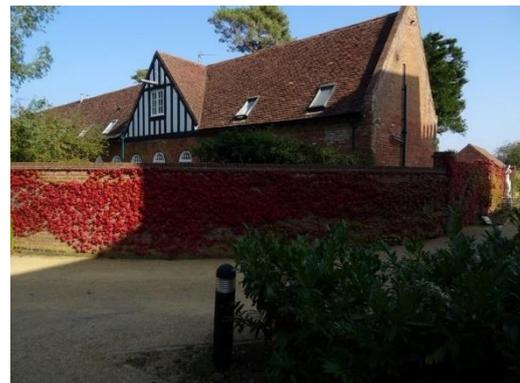
Toward the right the boundary is indicated by a sinuous curved wall, largely obscured by planting growths.

Where visible to our inspection we found no obvious evidence of significant cracking or structural deformation though must limit our reporting where the walling is concealed by vegetation. We recommend the wall is inspected when the vegetation is next cut back or removed together with the completion of any necessary additional remedial repairs identified at that time. No apportionment is included in this respect.

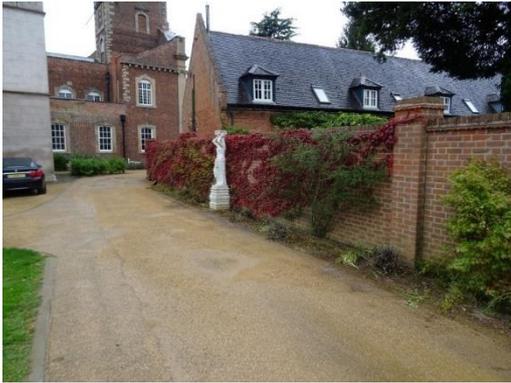
The indicative boundary wall is in brick. This generally appears in satisfactory order though similar to the rear to significant areas toward its left are concealed by trailing vegetation.

Our reporting must be limited in this respect and we recommend the walling is inspected when the vegetation is next cut back or removed together with the completion of any necessary additional remedial repairs identified at that time. No apportionment is included in this respect.

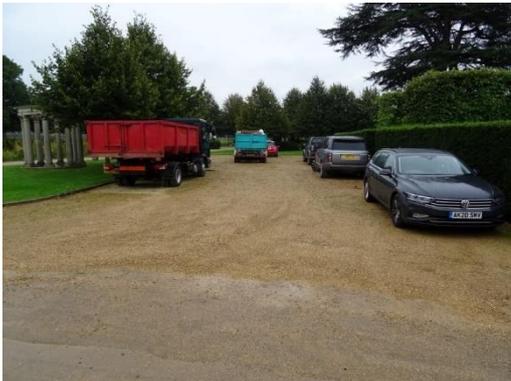
Off the driveway adjacent to the formal gardens to the right there is an area of stone chipping type material referred to as clunch. This provides an area of off road car parking.

The area generally appears in serviceable order though with some weed growth establishing which should be managed at the earliest opportunity.

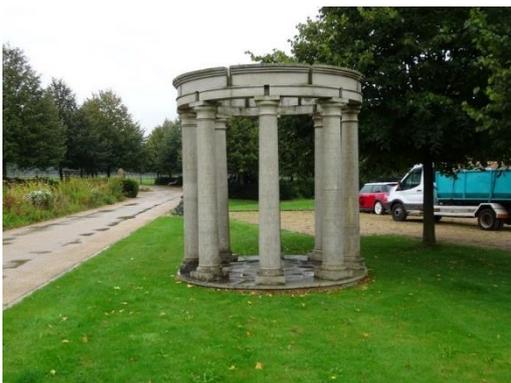
Between this and the drive is an area of grass finishes with low tree plantings. These generally appear in a satisfactory order. Inset to this grassed area is a columned frame support but with no cupola above. This is supported on a flagged base. The installation as a whole shows some lean toward the right. There were no indications of any significant compromise and this is indicated in satisfactory order.

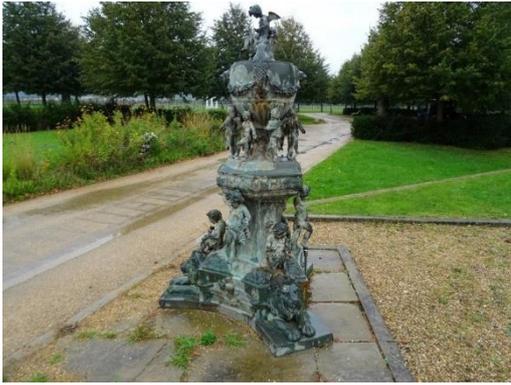
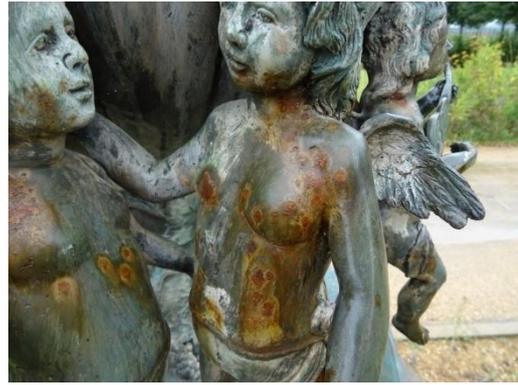
Frontward of this position is a metal fountain installation. This generally appears in satisfactory order though in places with some rust emerging through the patination. We recommend as a maintenance item this is addressed to reduce future decay risks. No apportionment is included in this respect as a maintenance item.

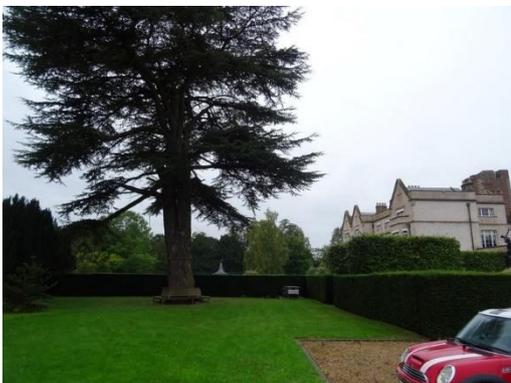
There are maturing and mature tree growths within the area. Of these there is a coniferous parkland specimen tree growth. This does not appear to be adversely affecting the property or its foundations at the time of survey though has the potential to do so if left unchecked and we recommend this is managed and maintained to reduce future foundation movement risks.
