BUILDING SURVEY

Level 3

ALLCOTT
RESIDENTIAL

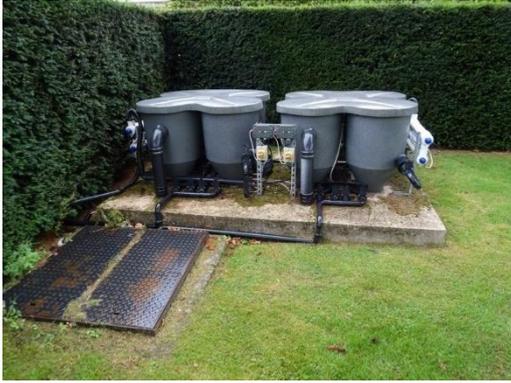
To the rear left corner of this area there is a tanked installation indicated providing pumping to the garden water features. This appears a modern installation and generally in a satisfactory condition and was confirmed operational at the time of our inspection.

We are not aware of any service arrangement for the installation and recommend this is inspected and serviced by a suitably qualified pump engineer shortly following purchase if servicing has not been carried out within the last 12 months.

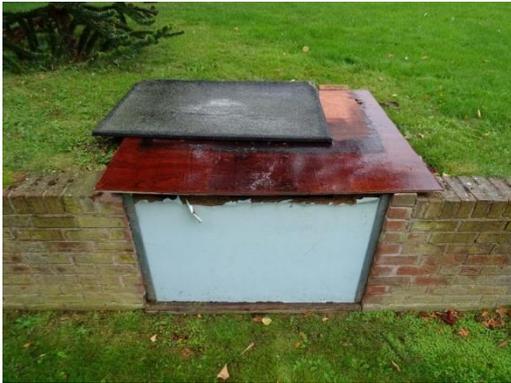
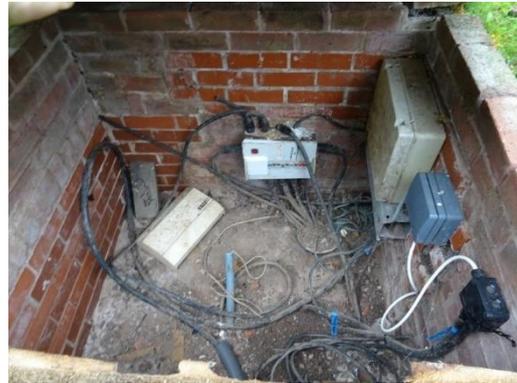
Behind the ha-ha wall there is a shallow pit housing electrical switch gear.

The pit area generally appears in serviceable order though is not weathertight and we have included a provisional apportionment for improvements in this respect.

Alongside the ha-ha wall are external uplighter installations. There is some damage and we have included provisional apportionment in this respect.

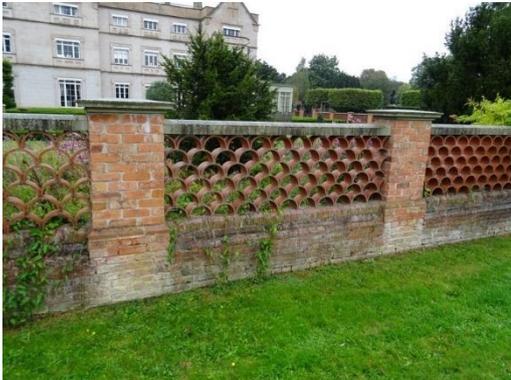
The lower walling though presenting a low retaining wall is a historic construction anticipated pre-dating Statutory Approval requirements.

The upper walling construction date could not be confirmed though is a later addition. Your Solicitor should confirm the obtaining of all requisite statutory approvals, any requisite site inspections and compliance with all Statutory Approval conditions.

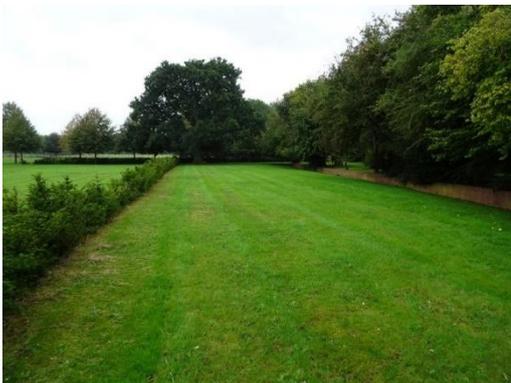
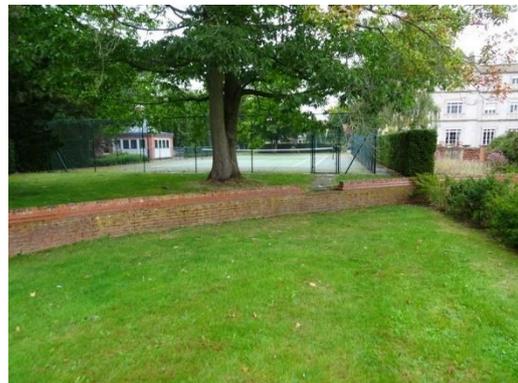
To the left of this position there is a further area of lawned garden landscape again with maturing tree growths and Yew or similar hedging to the front of the tennis court area.

The area again generally appears in a satisfactory order. The low ha-ha type wall is again a more modern construction and we reiterate our advices above for obtaining confirmation via your Solicitor that all requisite Statutory Approvals were obtained for its construction, that all building inspections were completed at the time of construction works and that all Statutory Approval conditions were complied with fully.

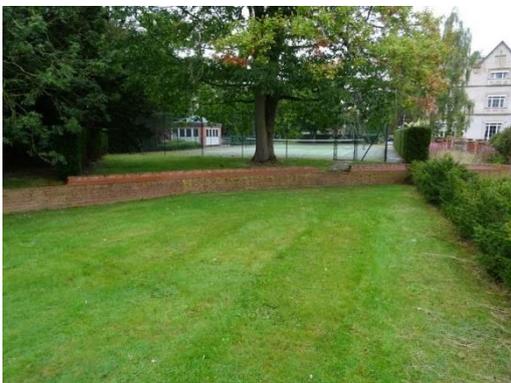
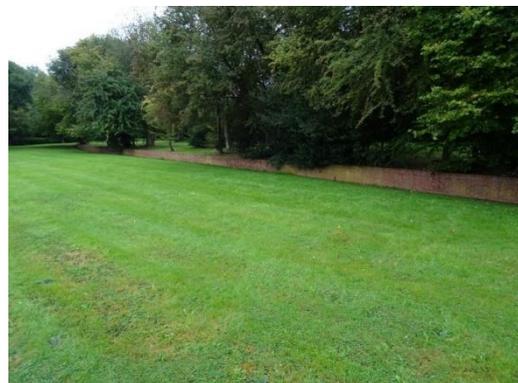
There is a mature specimen tree growth toward the front of this area. This generally appears in satisfactory order though no arboricultural assessment is included within the scope of this survey.

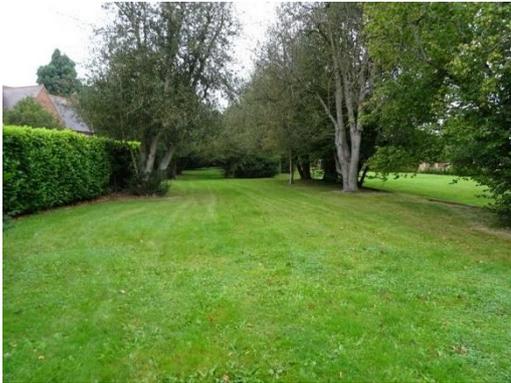
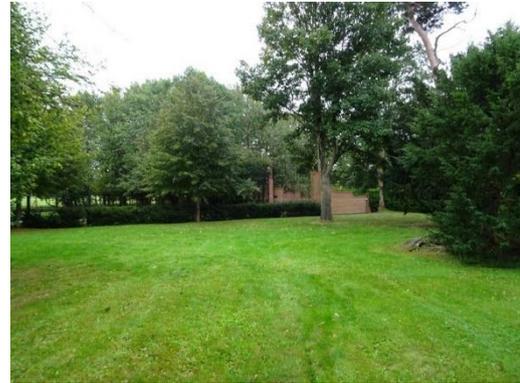
Behind the retaining walling there is an area similarly garden with planted finishes and low hedging together with maturing tree growths.

These generally appear in a satisfactory order.

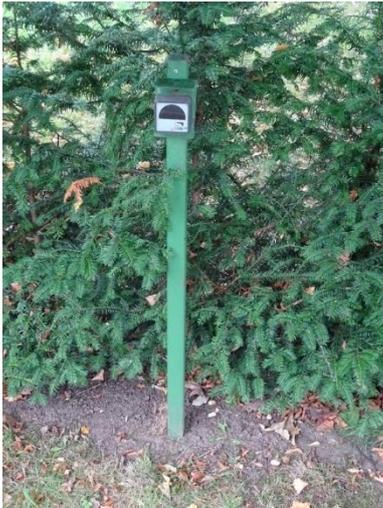
Toward the roadway there are large metal gates inset between brick pillars. The brick pillars have reconstituted stone stylised pineapples atop. The gate set has a historic mechanical operating system indicated though this has been disconnected and was not operable.

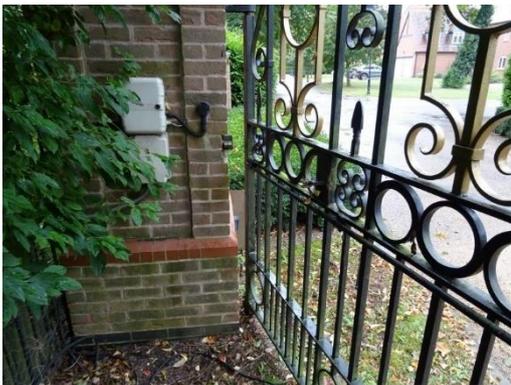
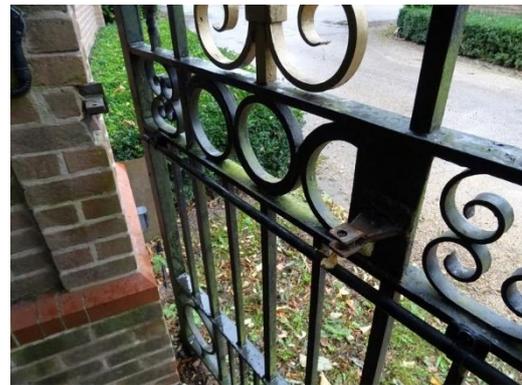
There is similarly a keypad entry affixed to the right gate pillar on approach from the exterior. The disconnection of the mechanical gate operating system indicates this to be defunct and there is no requirement in this respect. The gates however were not able to be closed catching significantly on the driveway finishes. We have included provisional apportionment for the adjustment of the gate installation. The gate appears to indicate some movement within the brickwork finishes and we would anticipate a significant cost for reinstating manual gate operation. Our apportionment reflects this.

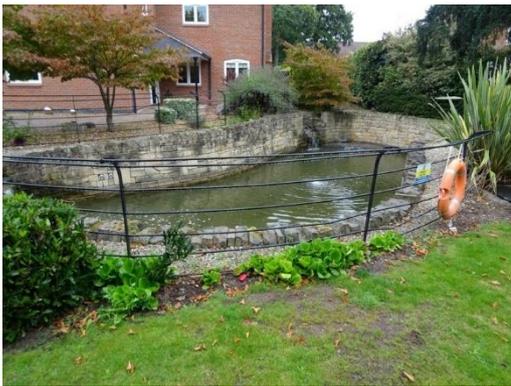
Alongside the driveway to the right on exiting is a water feature indicated as a balancing pond similar arrangement. This is suggested as serving the new development within the historic grounds.

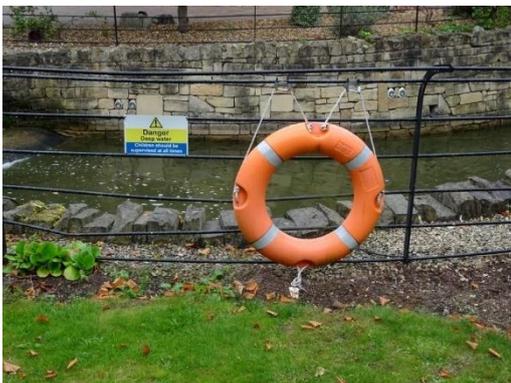
There is a sign advising “Danger, deep water, Children should be supervised at all times”, metal balustrade railings and a lifebuoy.

We highlight this as a safety risk.

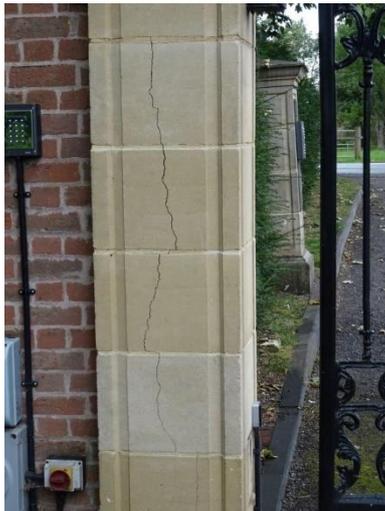
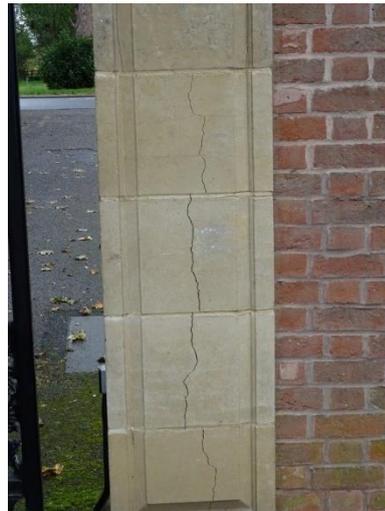
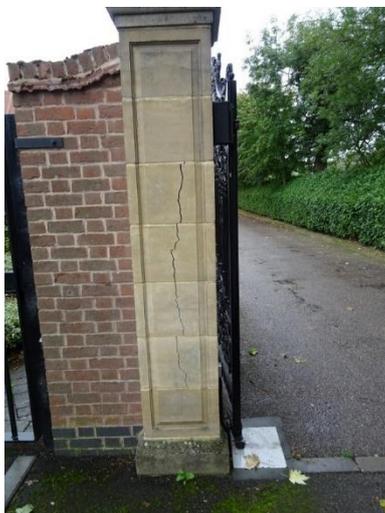
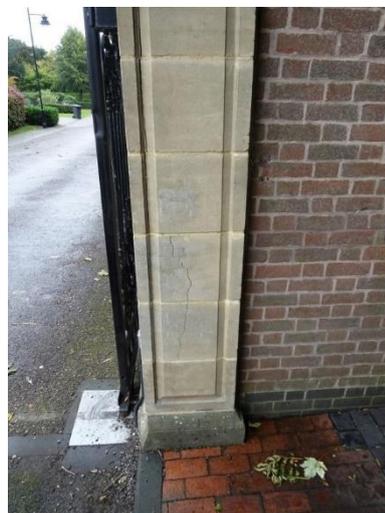
To the end of the internal driveway section there are brickwork flanking walls, reconstituted stone finished pillars and decorative reconstituted stone finials. These generally appear in a serviceable condition though with significant cracking noted to the reconstituted stone gate pillars.

Though the gate installation was operational some significant repair is indicated and we have included a provisional apportionment in this respect.

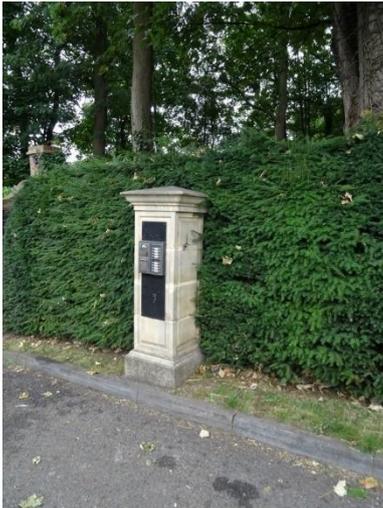
To the right on external approach there is a reconstituted stone pillar with the entry gate operating controls attached.

There is some movement of the pillar from its anticipated vertical constructional alignment.

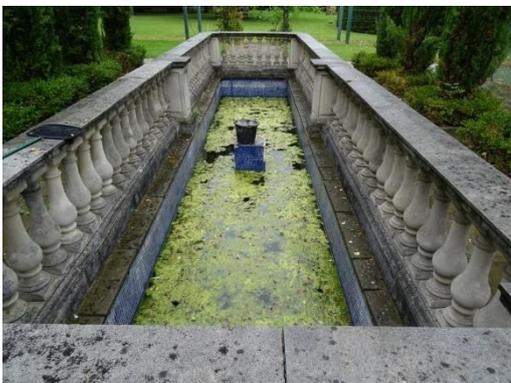
There is an inset water feature to the rear of the tennis pavilion. This has reconstituted stone balustrading around and above the water feature basin. This generally appears in satisfactory order.

No inspection of the basin itself was viable with a significant blanket weed coverage. Our reporting must be limited in this respect. We recommend the basin is inspected when the water feature is next emptied and cleared together with the completion of any necessary additional remedial repairs identified at that time.

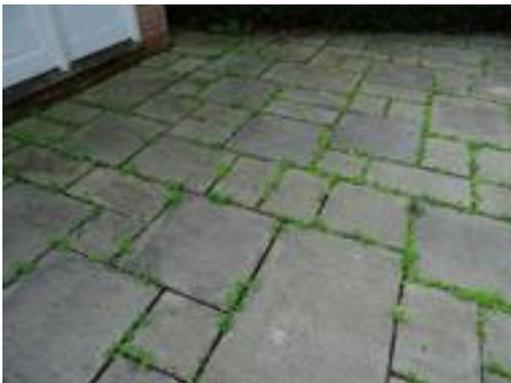
Concrete paving slabs have been laid adjacent to the tennis court which are relatively level however would benefit from general maintenance in the form of removing the vegetation between the joints.

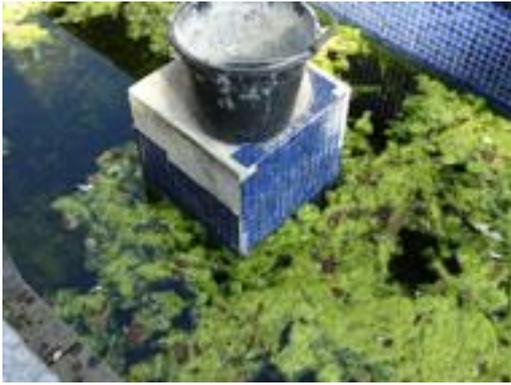
The water feature walls have been surfaced with ceramic tiles which were undergoing repair at the time of our inspection. The water feature then requires a pro-active maintenance scheme in order to bring it up to full working order.

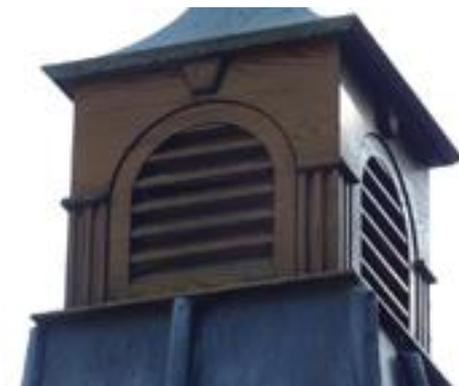
A timber bell tower with a copper cap has been installed to the head of the pyramid roof with no rot or infestation noted however it would benefit from decoration in the short term.

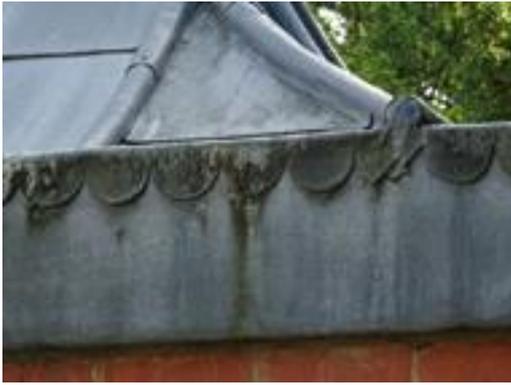
The main roof has been lined with lead with no splitting of the lead noted. The lead would however benefit from being cleaned down.

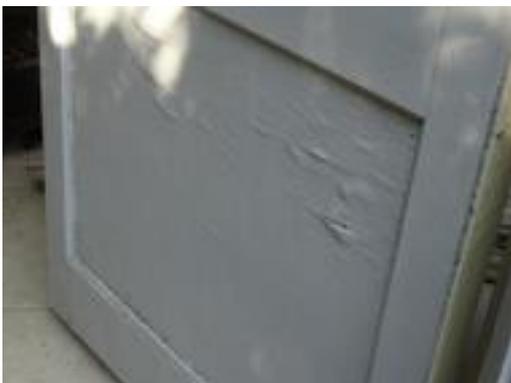
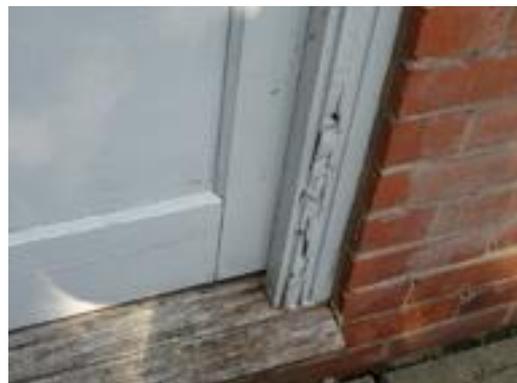
The doors and windows are timber framed incorporating single glazing and are in poor condition with localised rot noted. Due to the poor condition of the doors and windows we consider it would be more economical to replace rather than to repair.

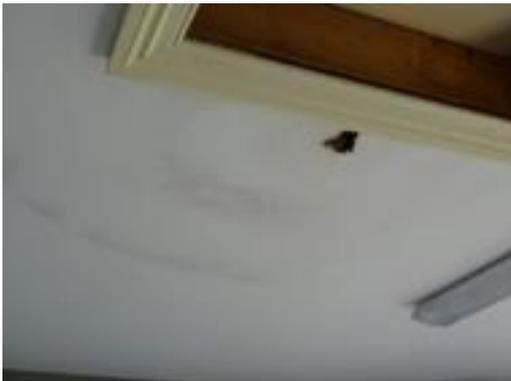
Localised damp staining was noted to the ceiling where we consider rainwater to have entered through the bell tower in times of wind driven rain. We would advise that the weather proofing to the bell tower is improved with localised repairs then carried out to the ceiling as necessary.

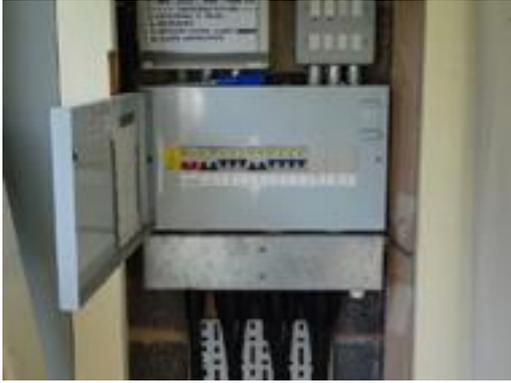
The consumer unit serving the tennis courts is located within boxing. The consumer unit is modern incorporating modern circuit breakers and a residual current device.

The door giving access into the consumer unit boxing has pulled away from its hinges requiring re-securing into position.

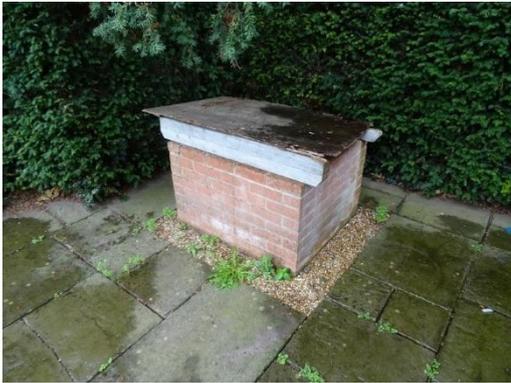
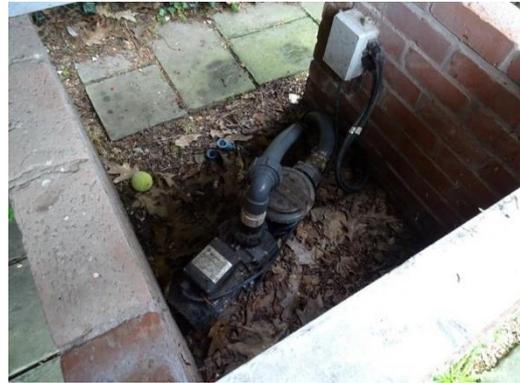
To the front of the tennis pavilion there is a low brick housing with a loose boarded timber top with a water pump installation inside.

The pump was not indicated as operational at the time of our inspection and we must limit our reporting in this respect.

The pump may serve the water feature previously described though this could not be confirmed.

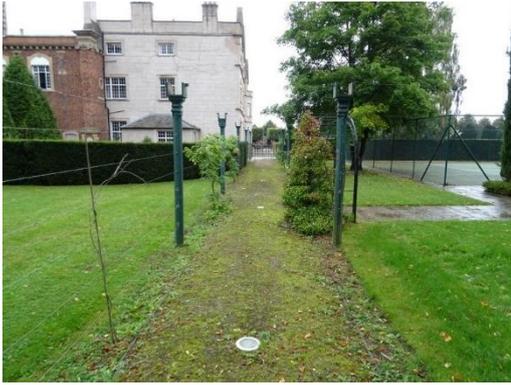
To the rear of this area there is a series of cast columns straddling a historic walkway and a pergola arrangement or similar is indicated historically.

The columns generally appear in a serviceable order though in need of external redecoration which should be planned as a maintenance item.

Between the columns there are espalier cables. In places these require tightening or replacement and we have included provisional apportionment in this respect.

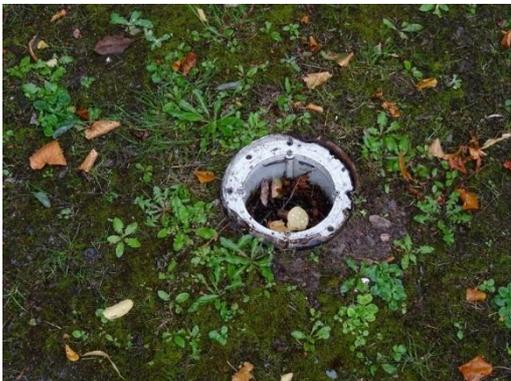
Inset to the path is a series of ground level uplighters. These generally appear in satisfactory order though were not observed in operation at the time of our inspection and we must limit our reporting in this respect.

There is a damaged fitting however to the left and we have included provisional apportionment in this respect.

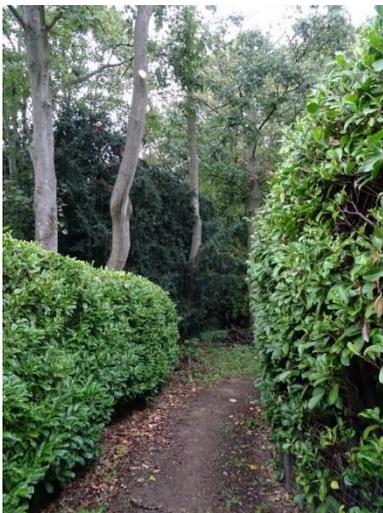
To the left the hedge boundary returns broadly parallel with the road with internal fencing. This generally appears in serviceable order though with some fencing repairs required and we have included a provisional apportionment in this respect.

The area again contains mature tree growths.

These should be managed and maintained to reduce future foundation movement risks though this time to adjoining newly built properties.

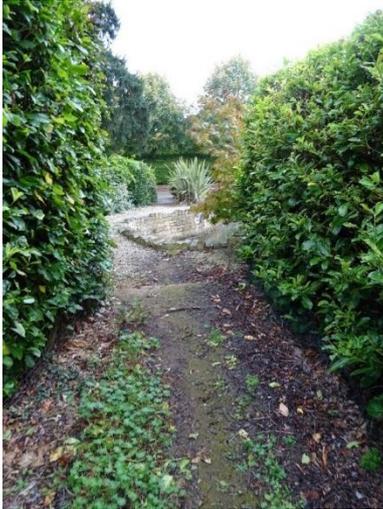
From this area there is a pathway leading through to the balancing pond/water feature described above. The pathway is in earth/loose gravel finishes and generally appears in serviceable order. Your Solicitor should confirm ownership, access arrangements, entitlements, obligations and any maintenance and repair liabilities.

Notably the water feature at this position does not benefit from any balustrading or support railing alongside to limit falls into the installation and we highlight the safety risks associated.

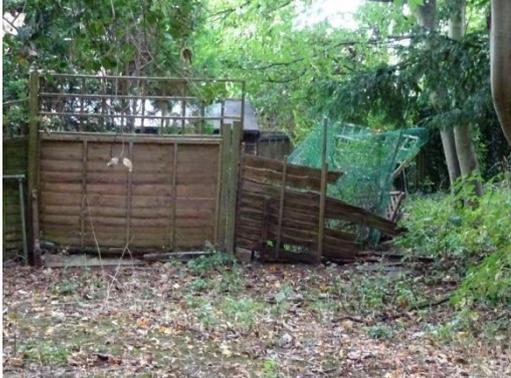
The boundary at this point has tall brick walling which generally appears in satisfactory order with no obvious issue or works indicated. Beyond when heading rearward the boundary has timber panel fencing inset to concrete posts. These generally appear in a satisfactory order generally though with some repairs indicated necessary.

The fencing is indicated with the adjoining ownership and no apportionment has been included in our reporting in this respect.

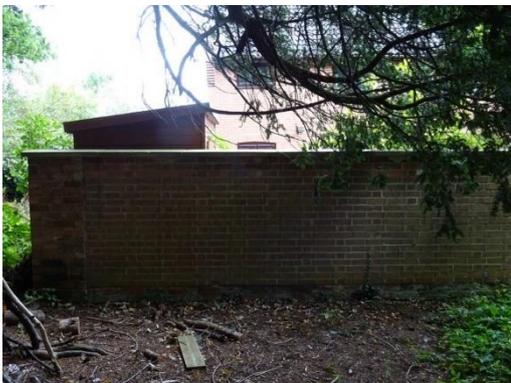
Further rearward the boundary provision is formed by brick walling and this generally appears in a satisfactory condition though notably the properties beyond are indicated positioned at a lower level.

A retaining wall construction is indicated. Whilst there were no indications of significant structural compromise we would anticipate a requirement for Statutory Approvals for any retaining wall construction. The walling would appear to lie with the adjoining ownerships.

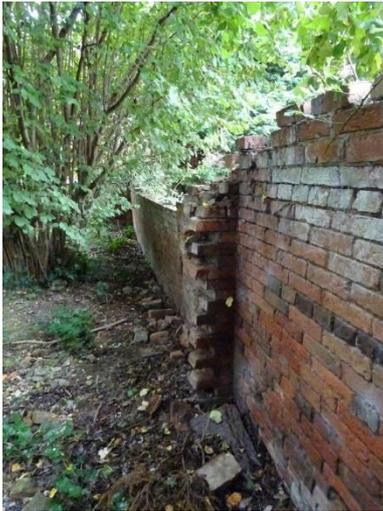
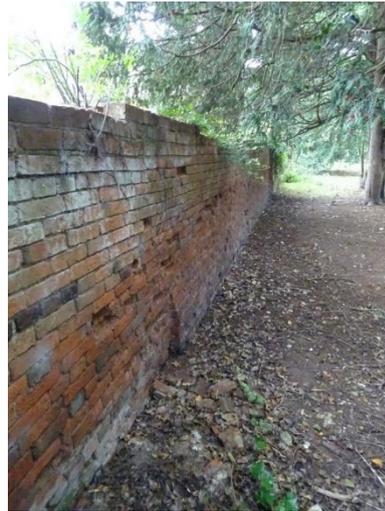
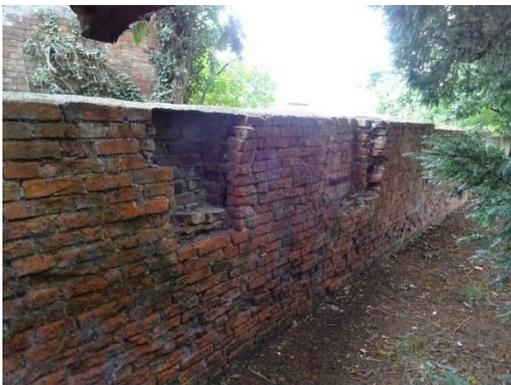
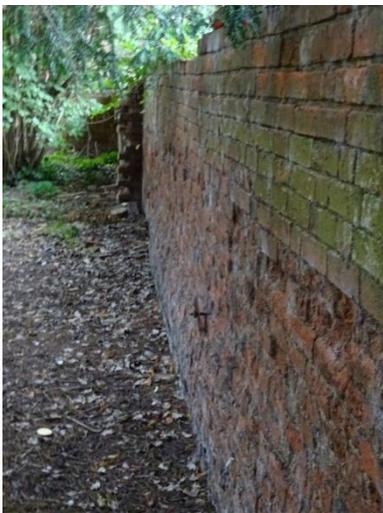
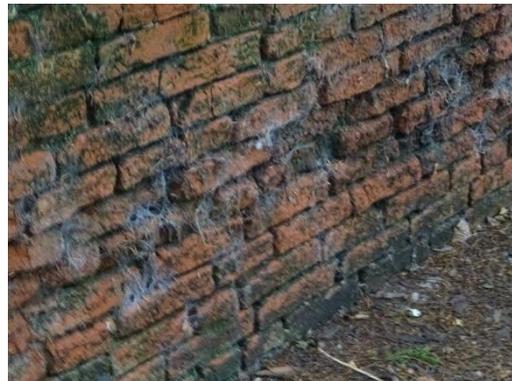
Further rearward the walling is indicated a more historic construction and generally appears in a serviceable order though with some historic deformations and decay.

Whilst there were no indications of significant structural compromise repair is required and we have included a provisional apportionment in this respect.

Notably the walling lies alongside an adjoining Public House premises and associated car parking. We recommend these works are planned to limit future injury risks and any associated claims which may arise.

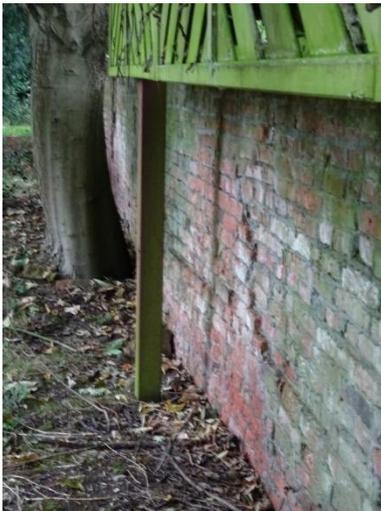
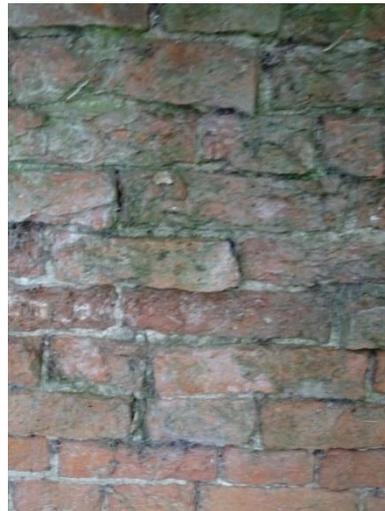
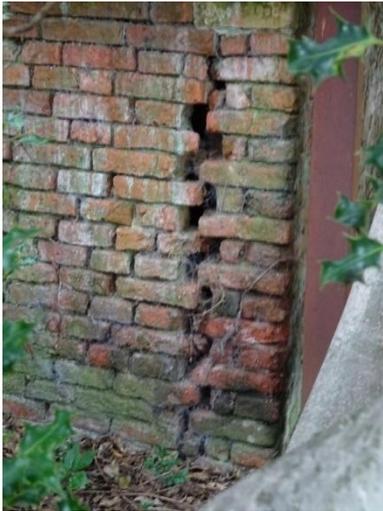
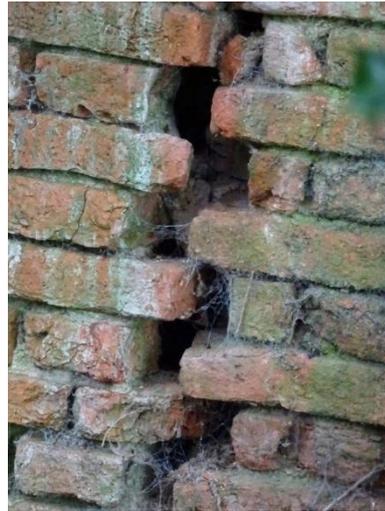
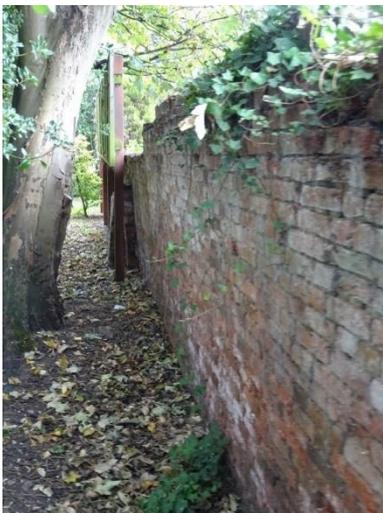
The garden historic walling continues alongside this area. Again there are areas of wall lean and some localised rebuilding and repair required.

We have included a provisional apportionment in this respect.

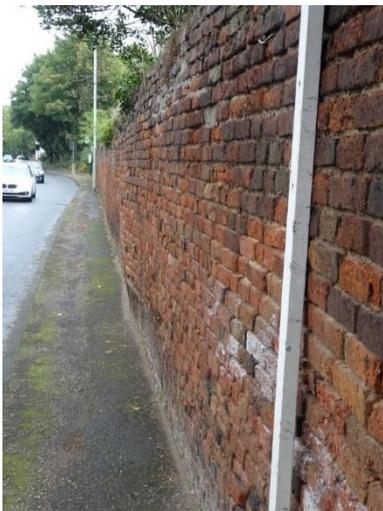
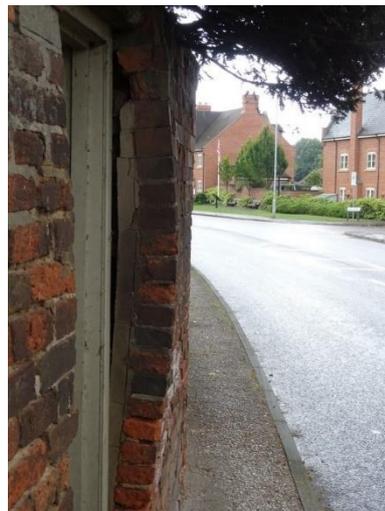
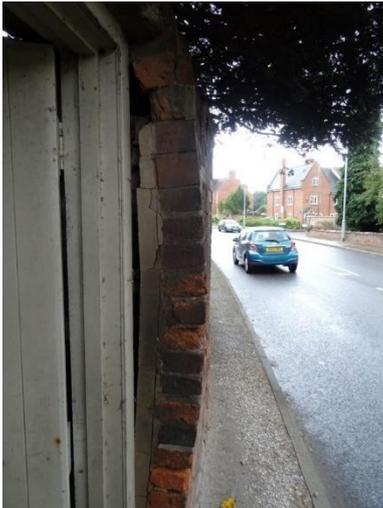
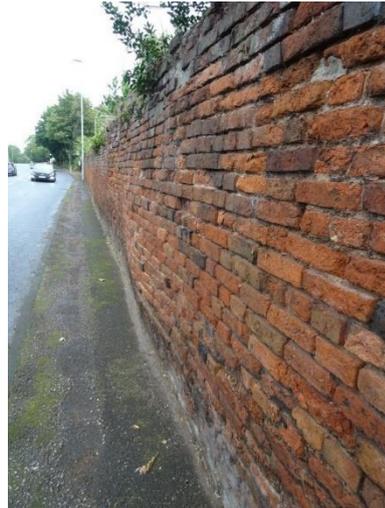
Externally the wall was inspected alongside the highway at this point.

The wall is compromised structurally to a significant extent and there is a significant risk of localised collapse and injury and/or damage caused to adjacent footpath and road users. We have included provisional apportionment for wall repairs. These include localised rebuilding reusing the existing materials where practicable.

We recommend this work is prioritised to reduce public safety risks. We would anticipate a localised lane closure being necessary during careful down taking of the materials at a minimum.

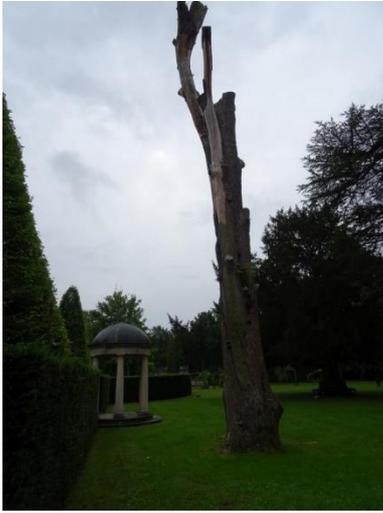
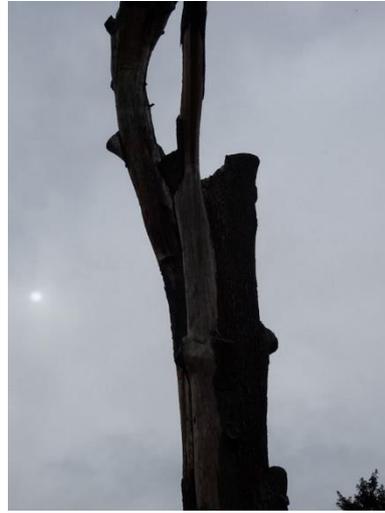
The mature specimen tree growths both lopped and non-lopped generally appear in a satisfactory order though again arboricultural inspection is excluded from the scope of our survey. We are however mindful of that nearest to the property with significant bark stripping and similar evidence of decay.

We recommend arboricultural inspection of this particular tree specimen.

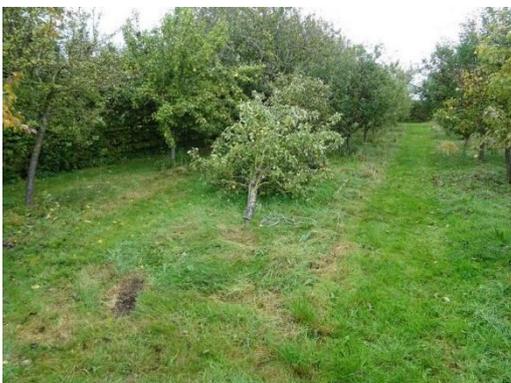
The orchard contains a number of apple, pear and damson tree growths. These generally appear in a satisfactory order though with one over toppled pear tree.

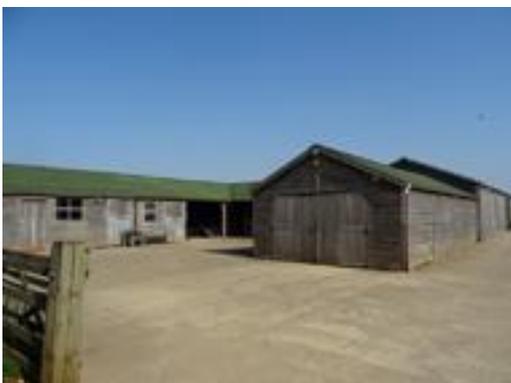
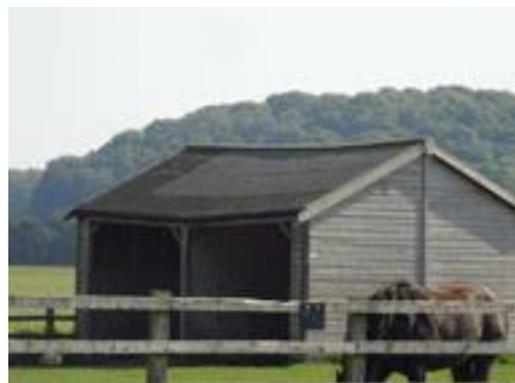
The roofs are pitched and gabled and covered with felt shingles. The roofs require general overhaul in the form of replacing the shingles where they were noted to be missing.

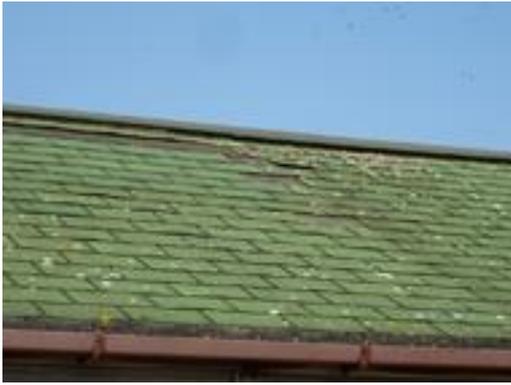
The roof above the separate stable within the field has deflected therefore will require strengthening in order to prevent risk of its future collapse.

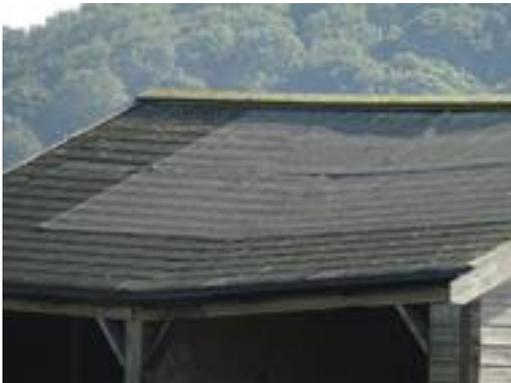
The gutters and downwater pipes are uPVC which require general overhaul in the form of re-connecting the downwater pipes to the gutters and renewal of the failed seals.

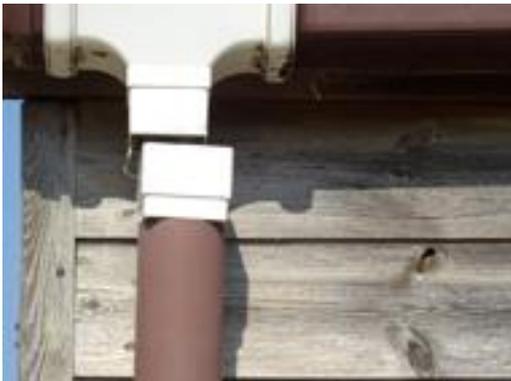
The elevations have been formed in feather edged board. Minor localised damage was noted to the boarding in various locations due to normal age related wear and tear. We would advise that the damaged boards are replaced as part of the ongoing pro-active maintenance scheme for the stables.

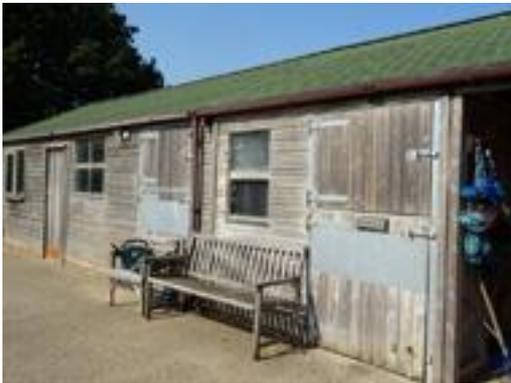
The electrical sockets around the stable areas have begun to corrode therefore will require replacement.

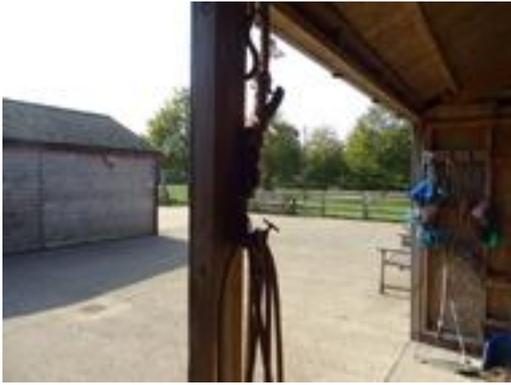
Surface mounted electric cables are evident around the stables which at low level have been ducted to comply with current regulations of health and safety.

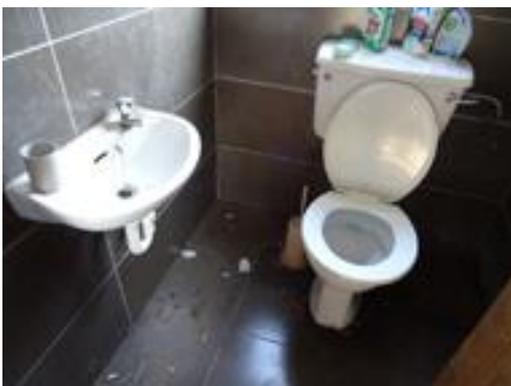
The walls and floor within the WC area have been surfaced with ceramic tiles with no opening up of grout to joints or splitting of tiles noted. The tiles to the ceiling are however begrimed requiring cleaning down.

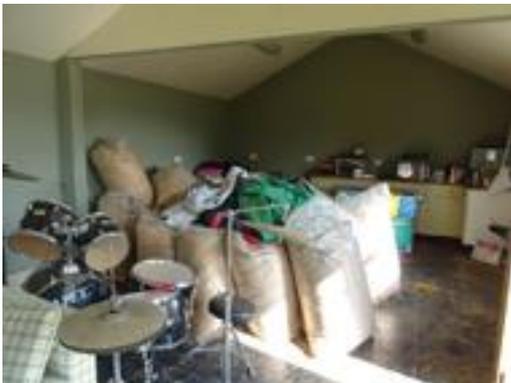
The walls and ceilings are plastered finished with emulsion. Localised damage was noted to the plaster finishes in various locations which will require patch repairing.

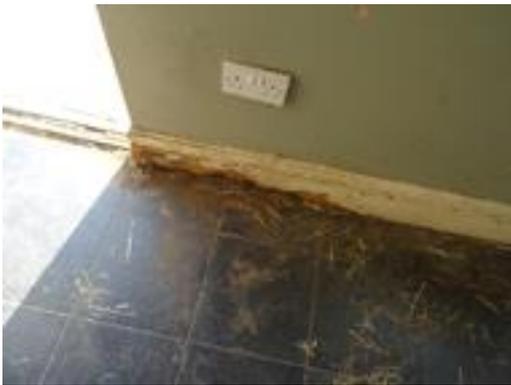
The floor has been surfaced with ceramic tiles with no opening up of grout to joints or splitting of tiles with the floor feeling level and firm under foot.

The kitchen area features base units which are heavily tired therefore would benefit from being replaced.

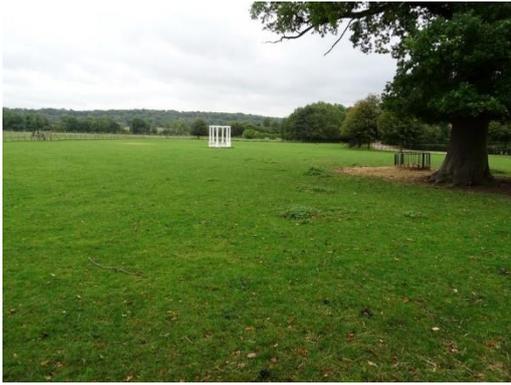
There is a central columned cupola frame but with no domed roof. This generally appears in satisfactory order though no close quarters inspection could be completed with several deer within the enclosure and with the onset of the rutting season. Our reporting must be limited in this respect. We recommend the installation is inspected when safe access can next be obtained together with the completion of any necessary additional remedial repairs identified at that time.
