BUILDING SURVEY

Level 3

This service is delivered in accordance with the Home Survey Standard (1st edition) RICS Professional Statement and is equivalent to Level 3.

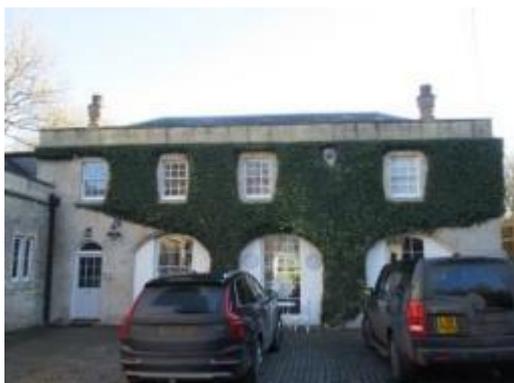
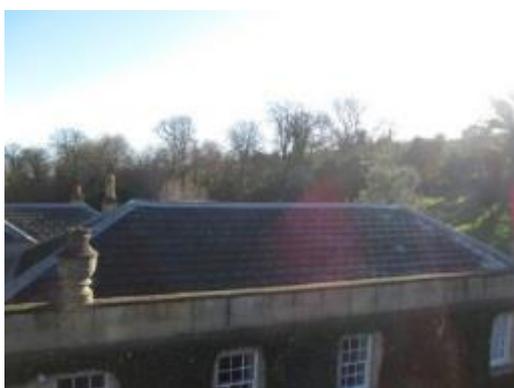
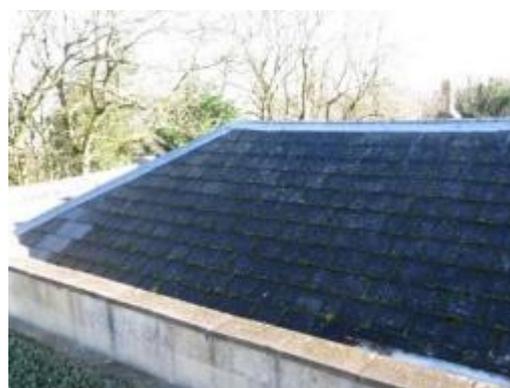
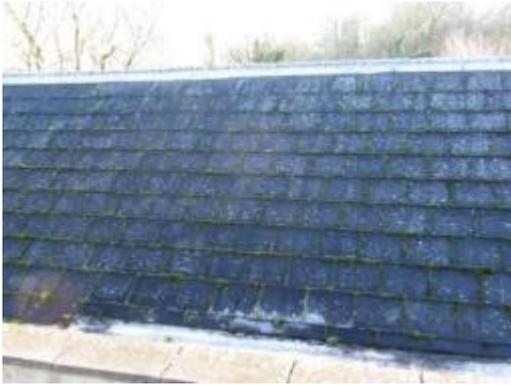
The roof is pitched and hipped with a covering of cement-fibre slates with metal cappings to the ridge and hips. Some slight deflection was noted to the ridge line, but this was not excessive and is not unusual in properties of this age and type of construction. The hip lines are level. The ridge and hip cappings are weather stained, but are otherwise sound. The roof slope is flat. The roof covering is weather stained and is supporting a small quantity of moss growth and there is evidence of a number of previous repairs to the roof in isolated locations. A number of tingles were noted to the slates. The roof covering is weathertight presently and no evidence of water ingress internally was noted, but ongoing repair and maintenance works will be required in the short to medium term. We would recommend that consideration be given to renewing the roof covering in the medium to long term.

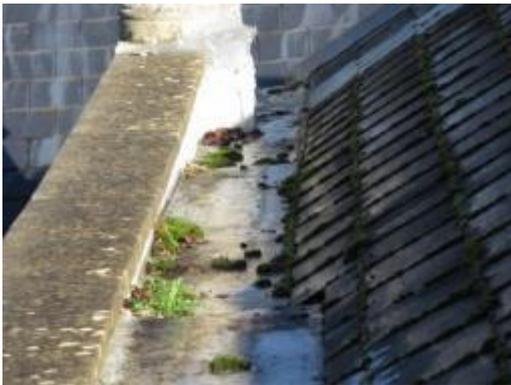
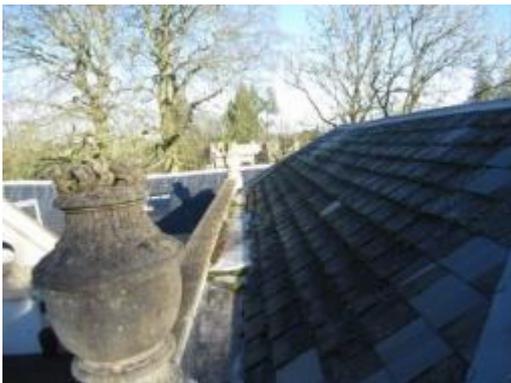
A parapet gutter is formed at the base of the front roof slope. This is provided with a sheet lead lining. The gutter lining is weather stained and there is some vegetation growth and debris to the parapet gutter. We would recommend that the vegetation growth and debris are cleared away to allow effective discharge of the rainwater. The parapet gutter lining appears to be sound and no evidence of water ingress internally was noted, but it is considered likely that some repair works may be required in the medium term.

The parapet wall is constructed in solid masonry with a concrete coping over. Some minor areas of defective pointing were noted to the coping, but these are not considered to be significant and can be remedied during the normal course of cyclical maintenance works. The masonry is weather stained, but the parapet wall is otherwise sound.

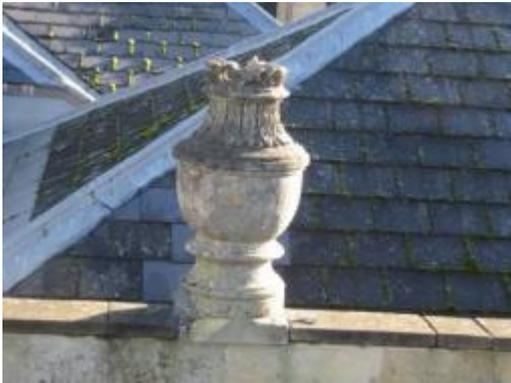
Two decorative stone urns are provided to the parapet wall. Some mechanical damage was noted to the urn to the left-hand side. We would recommend that this is repaired to minimise the possibility of further erosion and damage to the stonework.

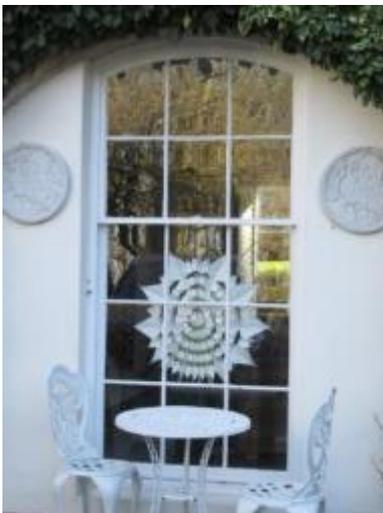
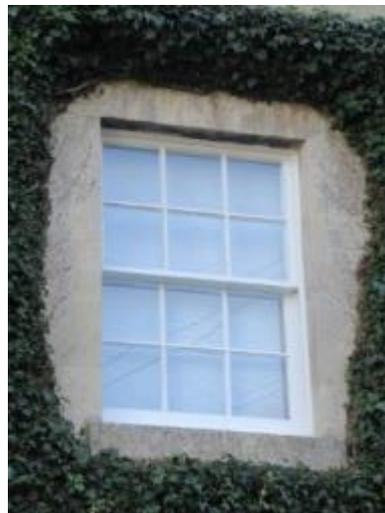
The windows are timber framed, single-glazed, double-hung, sliding sash windows. We are advised that the windows to the front elevation have been renewed within the last three years. The decorations to the windows are slightly soiled, but they are otherwise sound and in satisfactory condition.

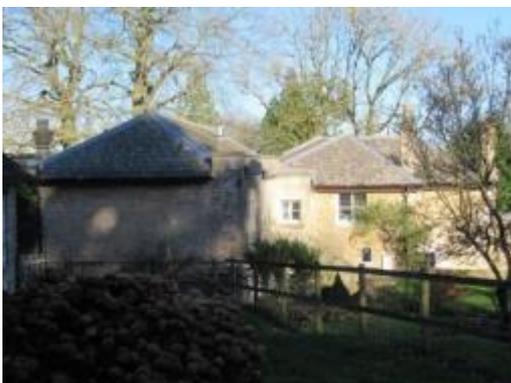
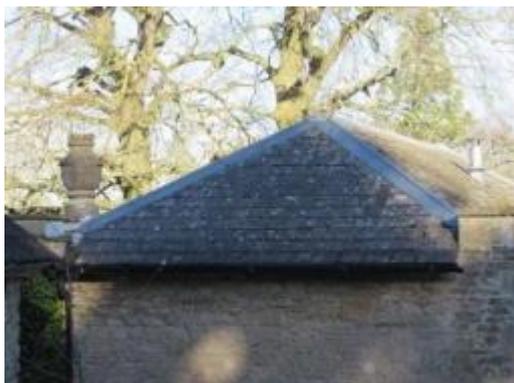
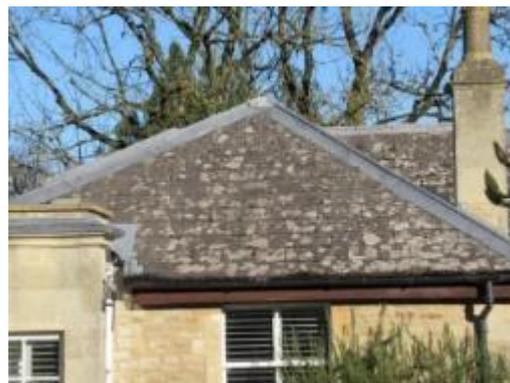
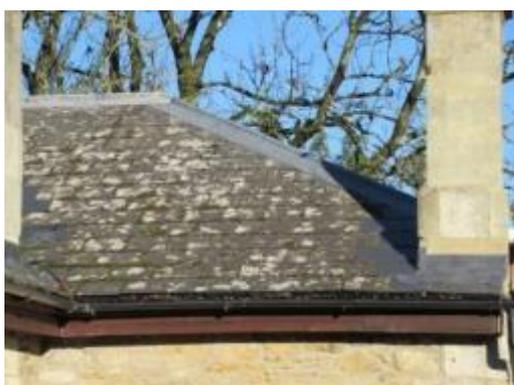
The main roof areas are constructed as previously described. The hip lines are level and the roof slopes are flat. The metal cappings to the hips are slightly weather stained, but are otherwise sound. The roof coverings are weather stained and are supporting a quantity of moss growth. The finish to the cement-fibre slates is denatured generally. The roof covering is sound and no evidence of any water ingress internally was noted, but there is evidence of a number of previous local repairs in isolated areas. It is anticipated that some further maintenance and repair works will be required in the short to medium term. We would recommend that consideration be given to renewing the roof covering completely in the medium to long term.

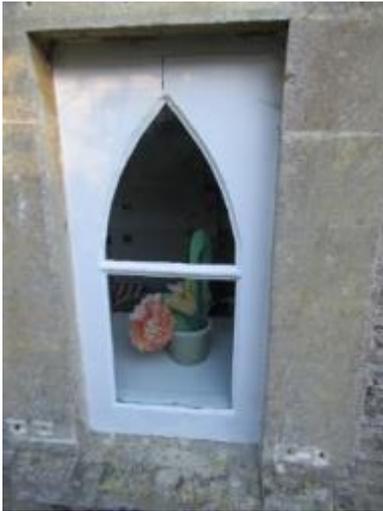
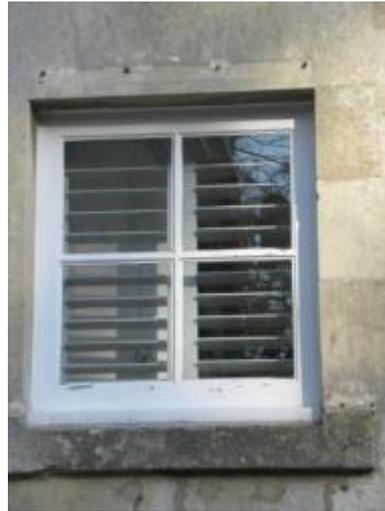
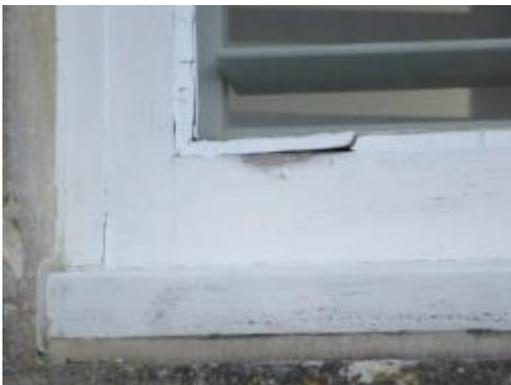
The windows are a combination of timber framed, single-glazed, fixed and opening lights and timber framed, single-glazed, double-hung sliding sash windows. The decorations to the windows are in fair condition only with some areas of flaking and otherwise defective paintwork and some minor areas of defective timber. We would recommend that the windows are eased, adjusted, overhauled, repaired, prepared and redecorated.

While the windows are serviceable presently you may wish to give consideration to replacing the windows in the medium term.

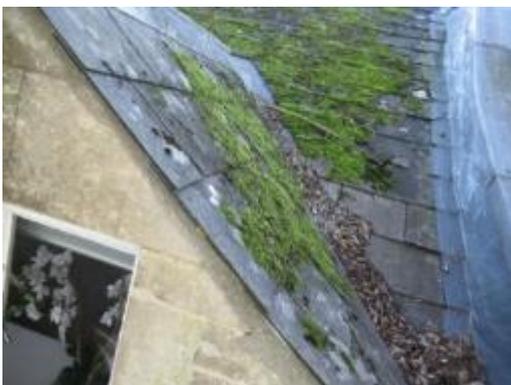
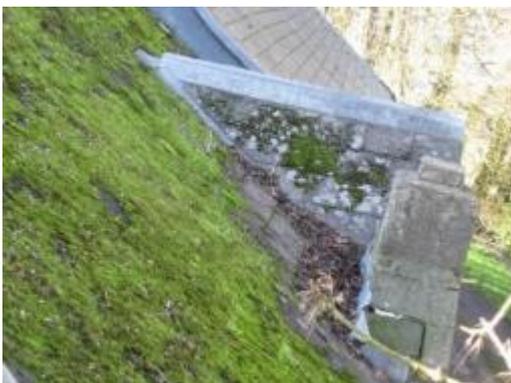
Valley gutters are formed at the intersection of the roof to the bay with the main roof slope. These are provided with a sheet lead lining. The valley gutters were largely obscured by debris at the time of our inspection. The visible areas are weather stained, but appear otherwise to be sound. We would recommend that the debris is cleared away from the gutters to allow effective discharge of the rainwater.

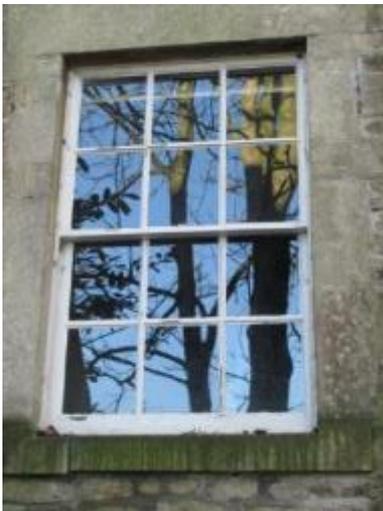
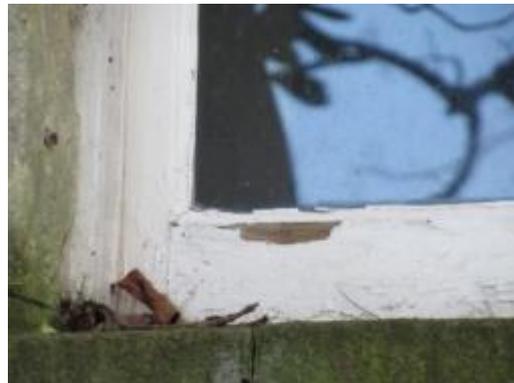
The windows are a combination of timber framed, single-glazed, double-hung, sliding sash and casement windows and timber framed casement type windows with sealed double-glazed units. The decorations to the windows to the right-hand side of the elevation are in fair condition only with areas of flaking and otherwise defective paintwork and some minor areas of defective timber. We would recommend that these windows are repaired, eased, adjusted, overhauled, prepared and redecorated.

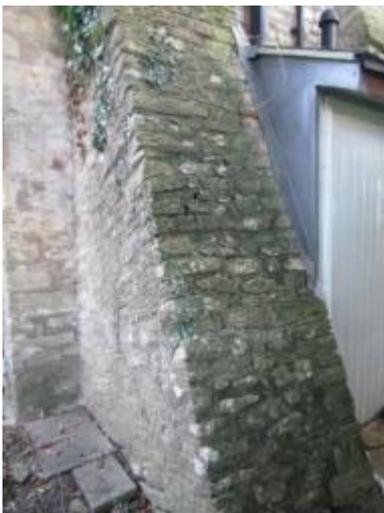
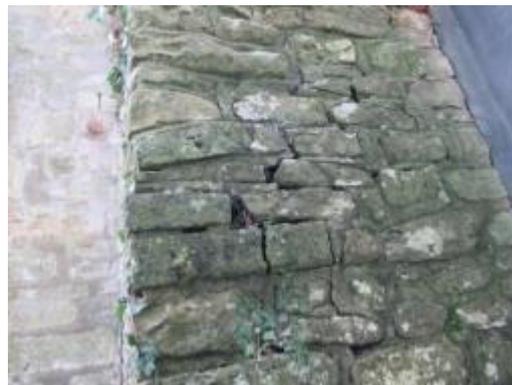
Two substantial stone buttresses are provided to the centre of the elevation. A number of areas of defective pointing were noted to the buttresses and we would recommend that these are raked out and repointed. This will minimise the possibility of further water ingress to the buttresses and any disruption to the stonework. The elevation is otherwise sound with no significant cracks noted.

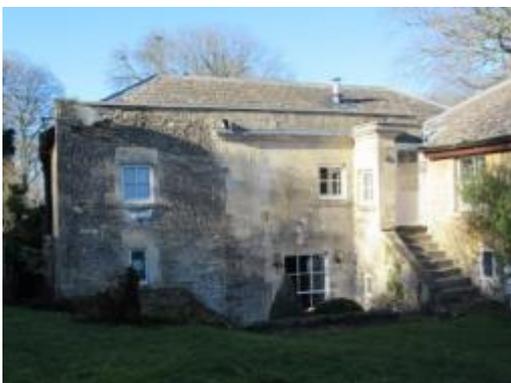
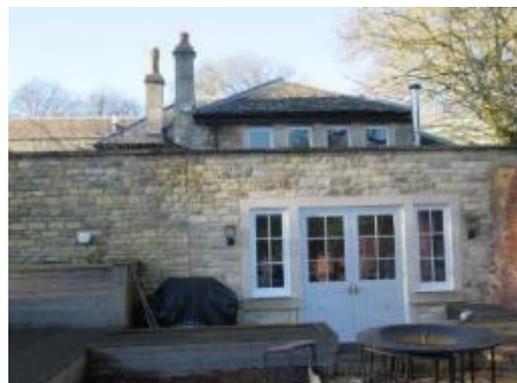
The main roof areas are constructed as previously described. Some slight deflection was noted to the ridge line of the main roof, but this was not excessive and is not unusual in properties of this age and type of construction. The ridge and hip cappings are weather stained, but are otherwise sound. Some slight deflection was noted to the main rear roof slope. This was not excessive and is not unusual in properties of this age and type of construction. The finish to the roof covering is denatured and weather stained and the roof coverings are supporting a quantity of moss growth. We would recommend that this is cleared off periodically to avoid a build-up of debris within the gutters. There is evidence of numerous previous repairs to the roof slopes in isolated locations, particularly to the centre rear roof slope. The roof coverings are sound and weathertight presently, but it is anticipated that ongoing repair and maintenance works will be required in the short to medium term. We would recommend that consideration be given to renewing the roof coverings completely in the medium to long term.

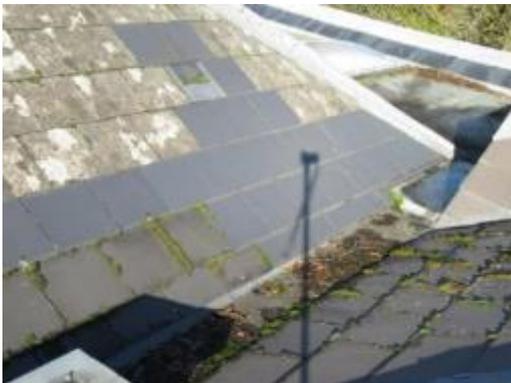
A valley gutter is formed at the intersection of the main rear roof slope with the front roof slope of the rear part of the house. The valley gutter is provided with a sheet lead lining. The valley gutter lining was partially obscured by debris at the time of our inspection. We would recommend that the debris is cleared out to allow effective discharge of the rainwater. The valley gutter lining appears otherwise to be sound and no evidence of water ingress internally was noted.

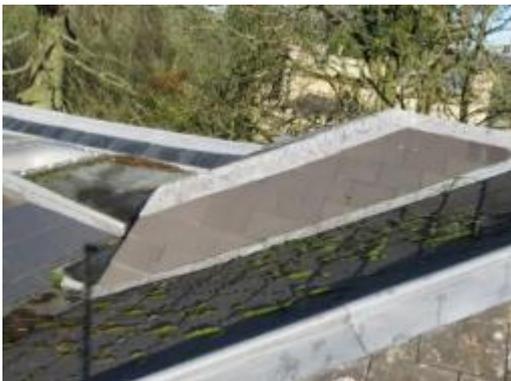
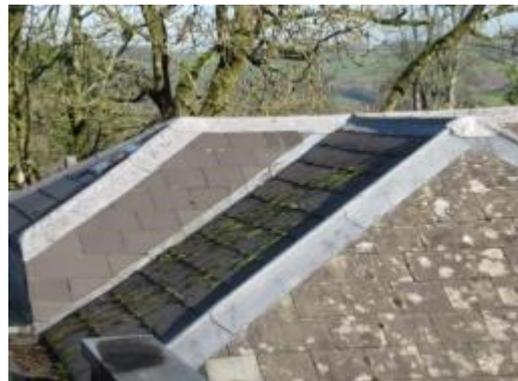
Valley gutters are formed at the intersection of the front bays to the rear roof with the main roof slopes. These are provided with a sheet lead lining. The valley gutter linings are weather stained, but appear otherwise to be sound.

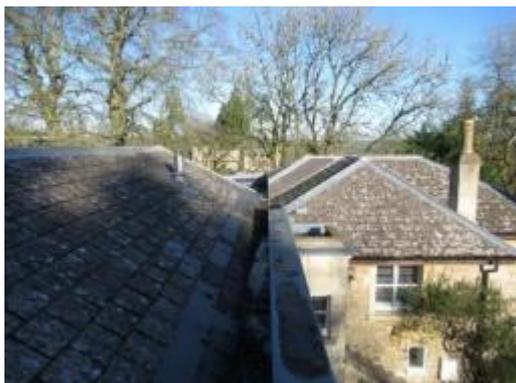
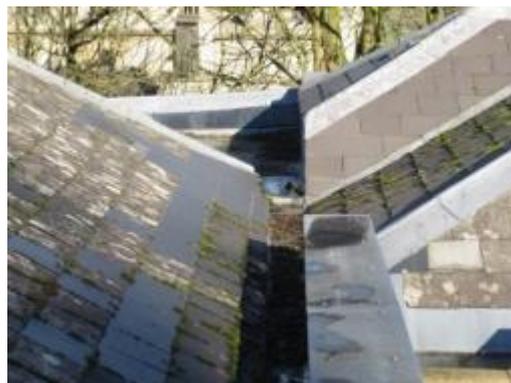
A parapet gutter is formed at the base of the main rear roof slope. This is constructed as previously described. A quantity of debris was noted within the valley gutter and the visible sections of the valley gutter lining are weather stained, but it appears otherwise to be sound and no evidence of water ingress internally was noted. We would recommend that the debris is cleared away to allow effective discharge of the rainwater.

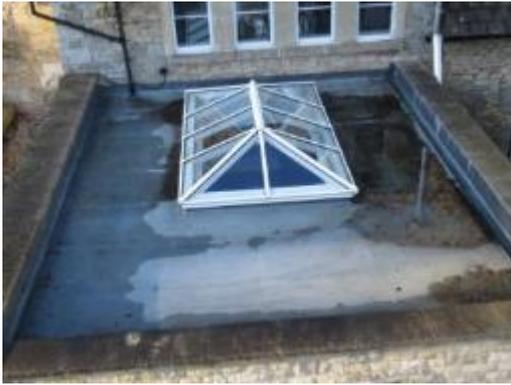
The roof to the single storey rear extension is flat and is provided with a single-ply membrane. Some ponding was noted to the right-hand side of the roof area, but this is not considered to be significant. The roof covering is weather stained, but is otherwise sound.

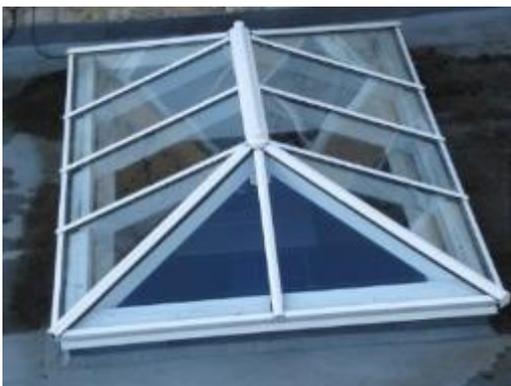
The roof covering is weathered to the upstand walls and the rear elevation with lead flashings. These are weather stained, but are otherwise sound.

A metal and PVCu framed lantern light is provided to the centre of the flat roof area. The lantern light is provided with sealed double-glazed fixed lights. The lantern light is slightly soiled, but is otherwise sound with no misting or condensation noted to the sealed units.

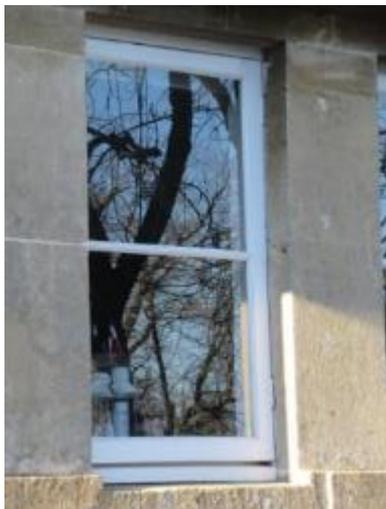
The windows are timber framed, single-glazed, casement type windows. The decorations to the windows are in fair condition only with some areas of flaking and otherwise defective paintwork. We would recommend that the windows are prepared and redecorated.

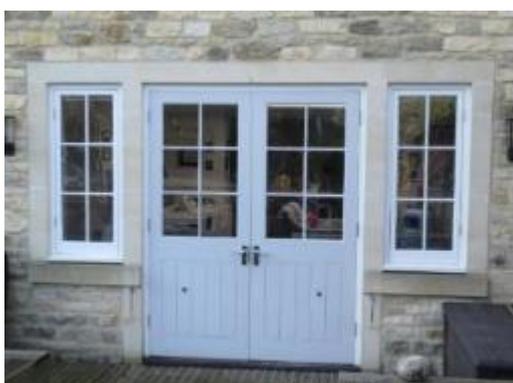
A pair of solid timber, multi-pane, half-glazed doors are provided to the rear elevation of the single storey rear extension. These are in satisfactory condition.

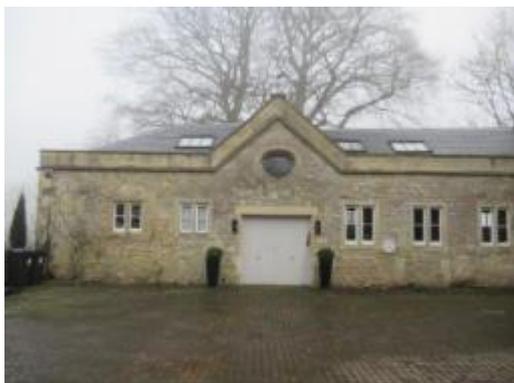
Front Elevation

The roof is pitched and hipped with a covering of natural slates and lead cappings to the ridge and hips. Some undulation was noted to both the ridge line and the roof slopes. This was not excessive and is not unusual in properties of this age and type of construction. The undulation to the ridge line and roof slopes is largely a function of the original construction of the roof. The roof covering has been renewed completely in recent years. The roof covering is sound and in satisfactory condition.

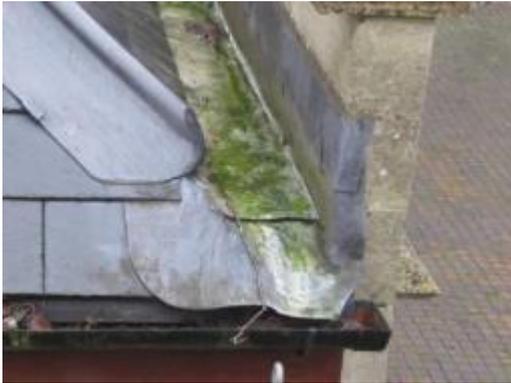
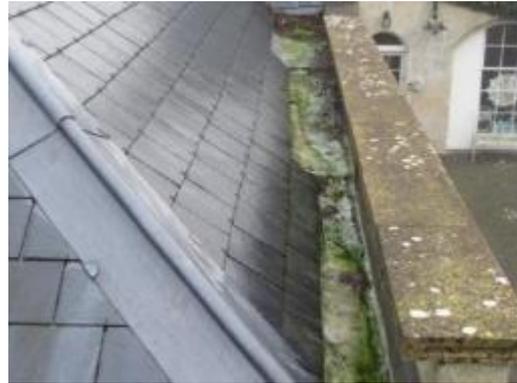
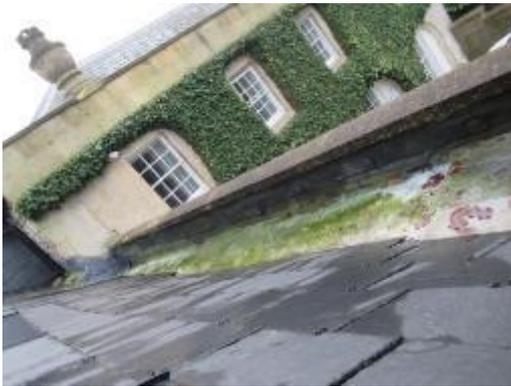
A parapet gutter is formed at the base of the roof slope. The parapet gutter is provided with a sheet lead lining. The parapet gutter lining is weather stained and a quantity of debris

was noted within the parapet gutter. We would recommend that the gutter is cleared out and cleaned down.

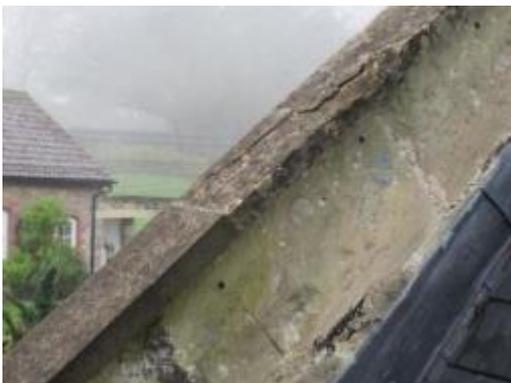
Some spalling was noted to the coping stones to the front parapet wall. We would recommend that the spalled copings are repaired and made good to prevent further deterioration of the stonework.

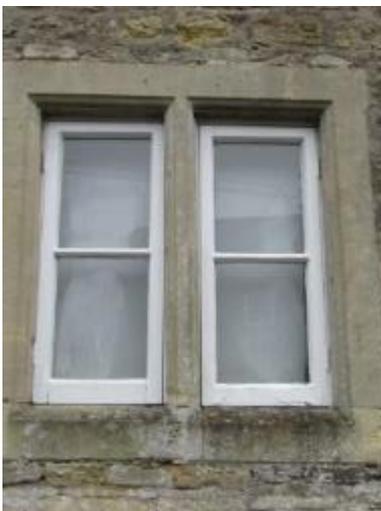
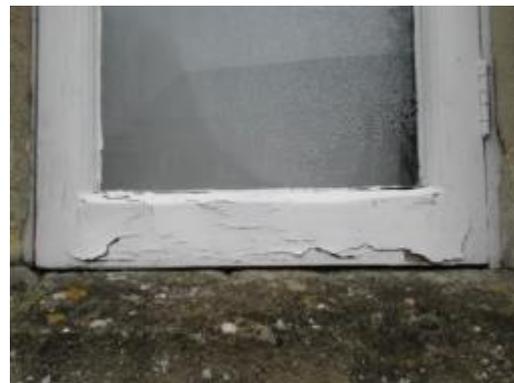
The windows are timber framed, single-glazed, casement type windows. The decorations to the windows are in fair condition only with some areas of flaking and otherwise defective paintwork. We would recommend that the windows are prepared and redecorated.

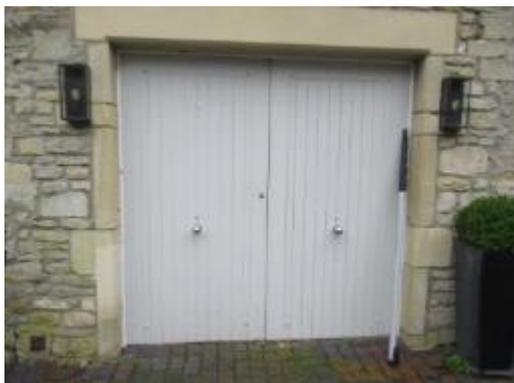
The external doors to the garage/gym are solid timber framed ledged and braced plank type doors. The decorations to the doors are slightly soiled, but they are otherwise sound.

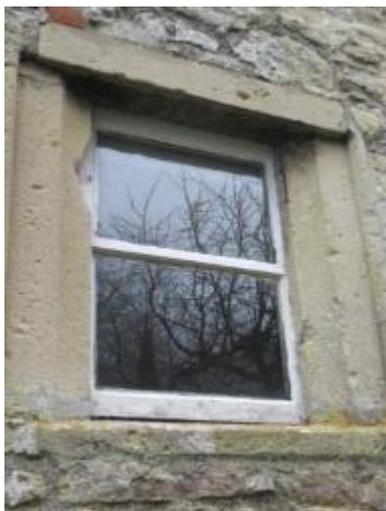
The window is a timber framed, single-glazed, fixed glazed light. The decorations to the window are in fair condition only with some areas of flaking and otherwise defective paintwork. We would recommend that the window is prepared and redecorated.

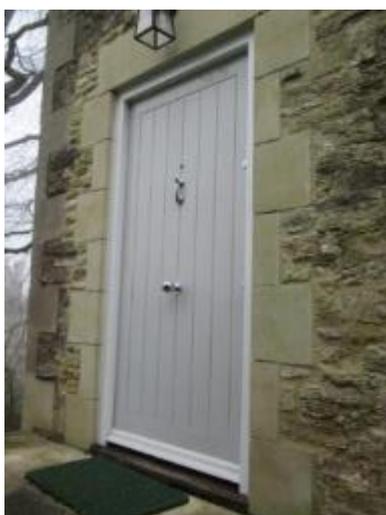
The external door is a solid timber framed ledged and braced plank type door. This is binding slightly in the frame, but is otherwise sound. We would recommend that the door is eased and adjusted.

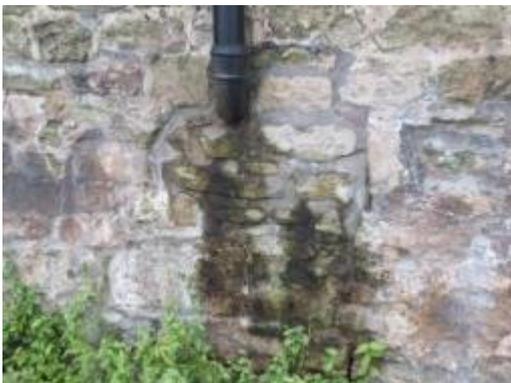
The gutter is half round PVCu with a circular downpipe. A brush leaf guard is fitted. A slight leak was noted to the lower part of the rainwater downpipe. We would recommend that this is resealed. The rainwater goods are otherwise in satisfactory condition.

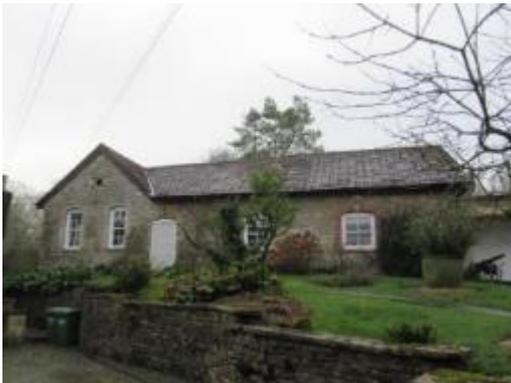
Front Elevation

The main roof is pitched with a covering of interlocking clay tiles and angled clay tiles to the ridge bedded in cement mortar. Some slight deflection was noted to the ridge line, but this was not excessive and is not considered to be significant. The deflection is likely to be a function of the original construction of the roof and is not unusual in properties of this age and type of construction. The ridge tiles are adequately bedded. The roof slope is flat. One or two spalled tiles were noted in isolated locations and we would recommend that these are replaced. The roof covering is heavily weather stained and is supporting a quantity of moss growth, but is otherwise sound. We would recommend that the moss growth is cleared off periodically to avoid a build-up of debris within the gutters.

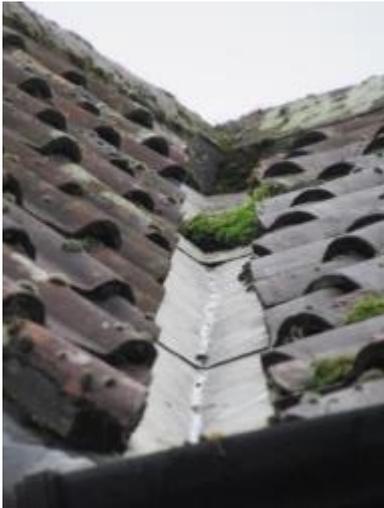
A valley gutter is formed at the intersection of the roof to the bay with the main roof slope. This is provided with a sheet lead lining. The valley gutter lining is weather stained and a small quantity of debris was noted within the valley gutter, but it is otherwise sound and no evidence of water ingress internally was noted. We would recommend that the valley gutter is cleared out to allow effective discharge of the rainwater.

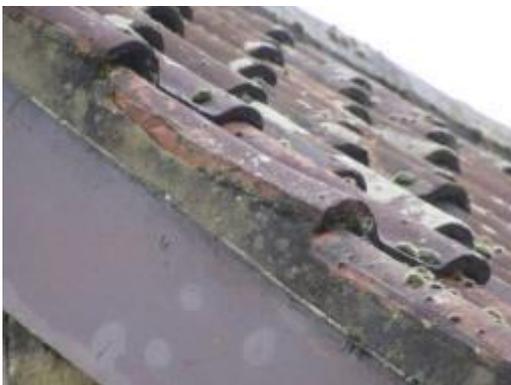
The verge to the bay is formed with a cement-fibre undercloak and the verge tiles are pointed in cement mortar. The verge detail is in satisfactory condition.

It should be noted that, given the age of the property, it is possible that the cement-fibre undercloak may contain asbestos. This presents minimal risk while this remains undisturbed, but should any significant maintenance, repair, or refurbishment works be carried out, we would recommend that the material is tested for the presence of asbestos and, depending upon the results obtained, that the appropriate safety precautions are taken.

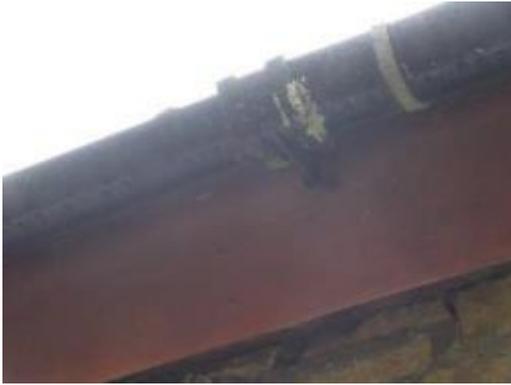
The gutter is half round PVCu with a circular downpipe that discharges into an open gully. The rainwater goods are soiled and there is evidence of some slight leaks to the joints in a number of locations. We would recommend that the rainwater goods are cleared out, cleaned down, and overhauled with any leaking joints made good as necessary.

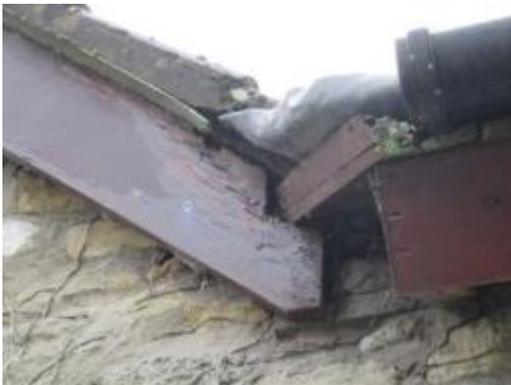
The verge boards and fascias are timber. The decorations to the verge boards and fascias are in fair condition only and some areas of defective timber were noted to the verge boards. We would recommend that the verge boards and fascias are repaired as necessary, prepared, and redecorated.

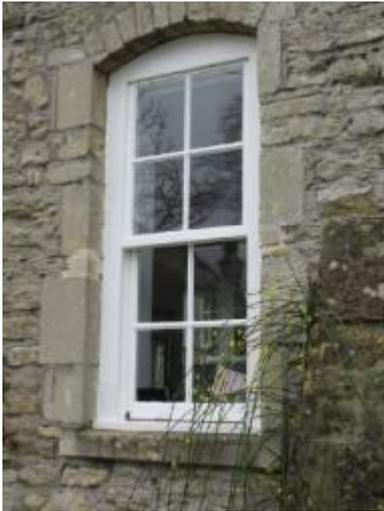
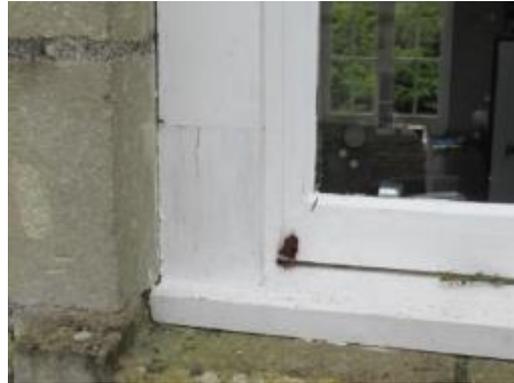
The windows are timber framed, single-glazed, double-hung, sliding sash windows. The decorations to the windows are in fair condition only with areas of flaking and otherwise defective paintwork. There is evidence of a number of previous repairs to the windows. We would recommend that the windows are repaired as required, eased, adjusted, overhauled, prepared, and redecorated.

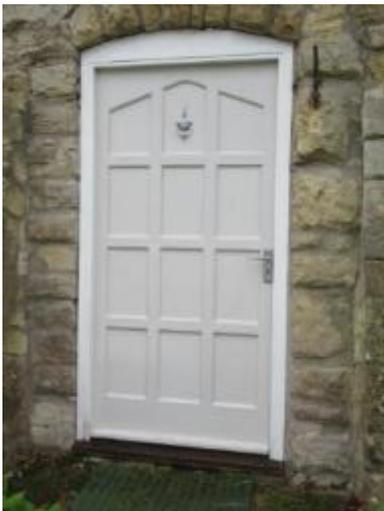
The external door is a solid timber panelled door with chrome effect lever latch type furniture. The decorations to the door are slightly soiled and some minor areas of defective timber were noted to the lower part of the doorframe. We would recommend that local repairs are carried out to the doorframe. The door is otherwise sound.

It should be noted that the door is locked out of use presently.

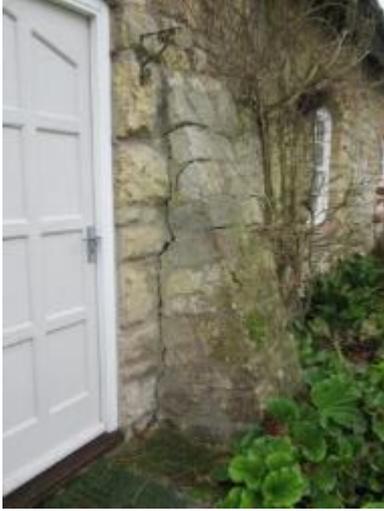
The elevation is constructed in solid masonry with random rubble stonework externally. Face brickwork detailing has been provided to some of the window surrounds. Some minor areas of defective pointing were noted to the stonework in isolated locations, particularly to the buttresses to either side of the entrance door. We would recommend that any areas of defective pointing are raked out and repointed.

A slight to moderate crack was noted to the stonework of the buttress to the right-hand side of the external door at the junction with the external wall. The movement appears to be historic, but we would recommend that this is monitored to confirm this. The masonry is slightly weather stained, but the elevation is otherwise sound.

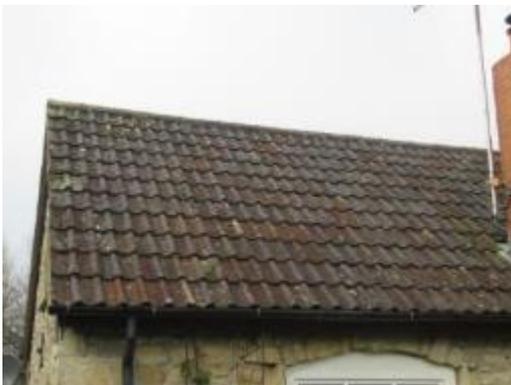
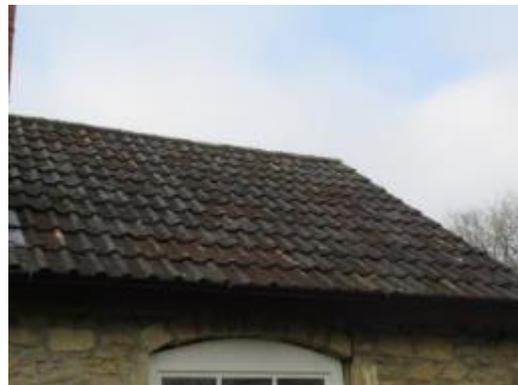
The roof is constructed as previously described. The ridge line is level and the ridge tiles are adequately bedded. The roof slope is flat. The roof covering is weather stained, but is otherwise sound.

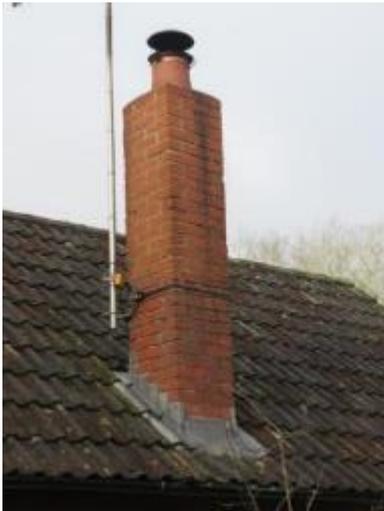
There is a chimneystack to the centre of the roof slope. This is constructed in solid masonry with face brickwork externally. The chimneystack has a single flue which is provided with a terracotta pot with a metal flue cowl over. The masonry is weather stained and some minor areas of defective pointing were noted, but these are not considered to be significant and can be remedied during the normal course of cyclical maintenance works. The chimneystack is otherwise sound with no significant cracks noted.

The chimneystack is weathered to the roof slope with a lead flashing. This is slightly weather stained, but is otherwise sound.

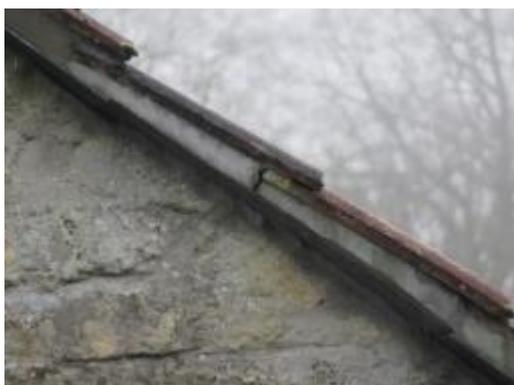
The verge to the main roof is constructed as previously described. Some slight cracks were noted to the verge pointing in isolated locations, but these are not considered to be significant and can be remedied during the normal course of cyclical maintenance works. The verge is otherwise sound.

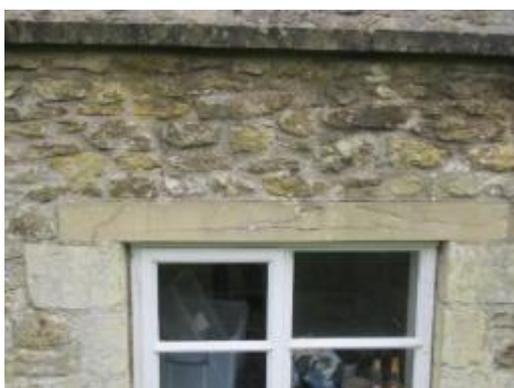
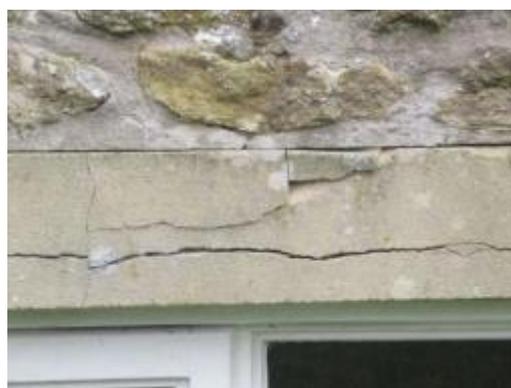
The lintels to the window and door openings are concrete that has been faced with reconstituted stone. Significant cracks and spalling were noted to the lintel of the ground floor window opening. No cracks or other defects were noted to the adjacent masonry, but it is likely that it will be necessary to replace the lintel. We would recommend that the stone facing is removed to confirm the condition of the lintel.

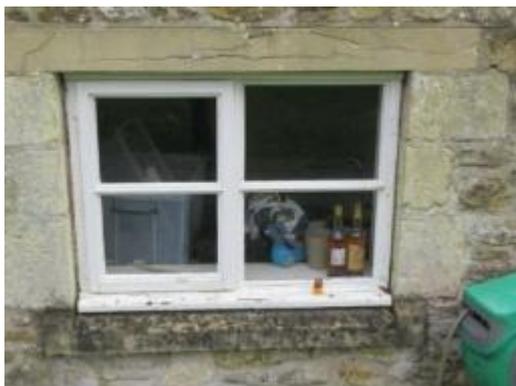
The windows are timber framed, single-glazed, casement type windows. The decorations to the windows are in poor condition generally with areas of flaking and otherwise defective paintwork, particularly to the ground floor window. There are also significant areas of defective timber to the cill of the ground floor window. We would recommend that the windows are repaired as necessary, prepared, and redecorated.

While it may be possible to repair and redecorate the ground floor window, you may wish to give consideration to replacing this window as this may be more cost-effective.

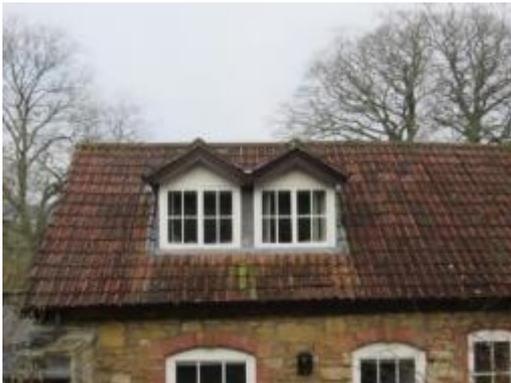
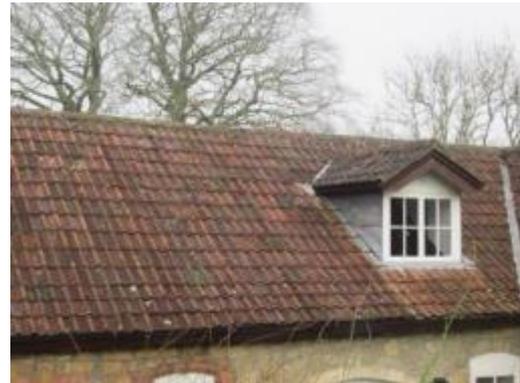
The main roof is constructed as previously described. Some slight deflection was noted to the ridge line, but this was not excessive and is not considered to be significant. The ridge tiles are adequately bedded. The roof slopes are flat. The roof covering is heavily weather stained and is supporting a quantity of moss growth, but the roof coverings are otherwise sound. We would recommend that the moss growth is cleared off periodically to avoid a build-up of debris within the gutters.

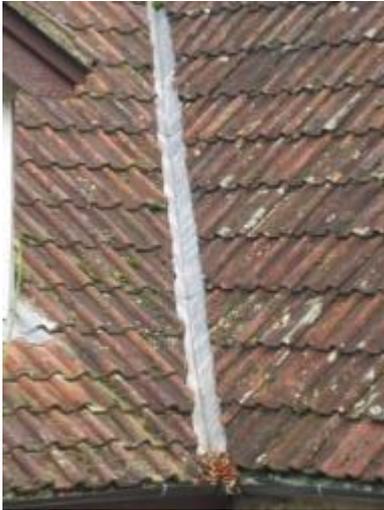
A valley gutter is formed at the intersection of the roof to the rear bay with the main roof slope. This is provided with a metal sheet lining. The valley gutter lining is weather stained and a small quantity of debris was noted at the base of the valley gutter, but it is otherwise sound and no evidence of water ingress internally was noted.

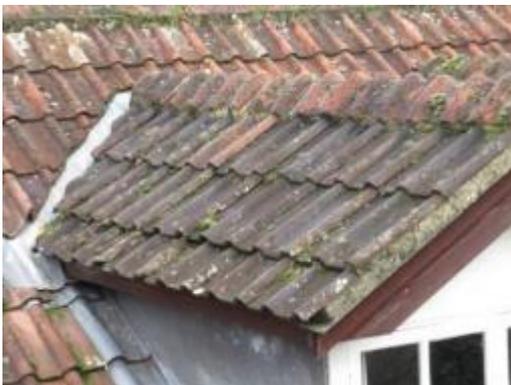
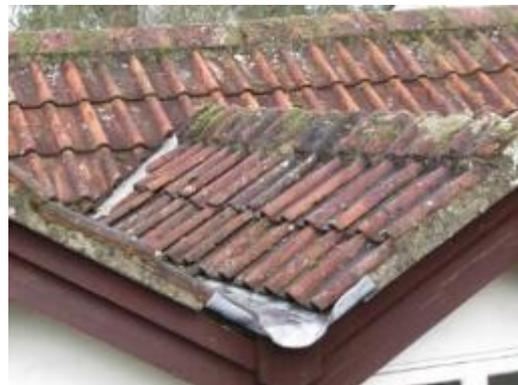
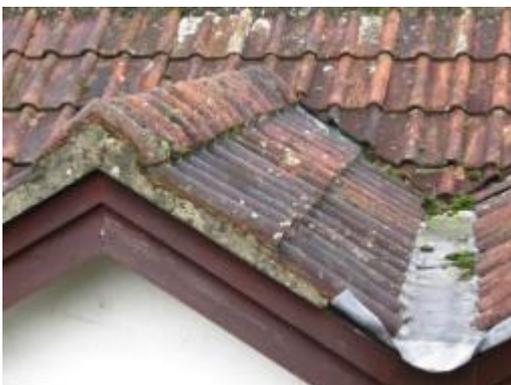
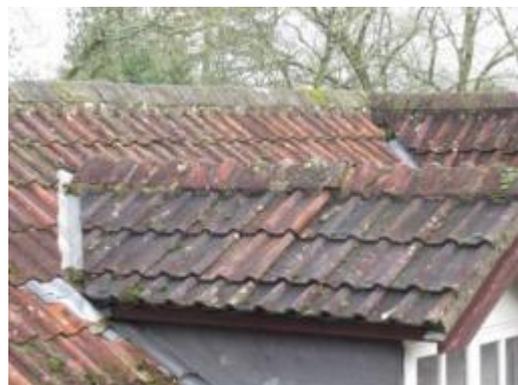
The roofs to the dormers are constructed as previously described. The ridge lines are level. Some minor areas of defective bedding mortar were noted to one or two of the ridge tiles to the right-hand side dormer, but this is not considered to be significant and can be remedied during the normal course of cyclical maintenance works. The roof slopes are flat. The roof coverings are weather stained, but are otherwise sound.

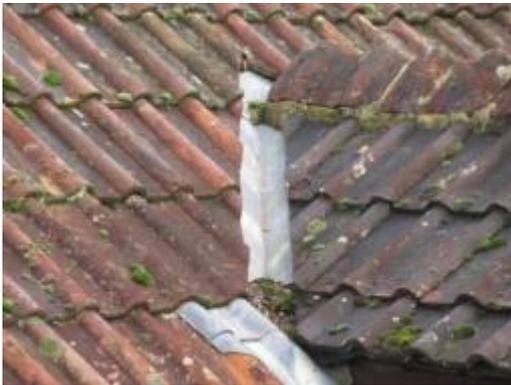
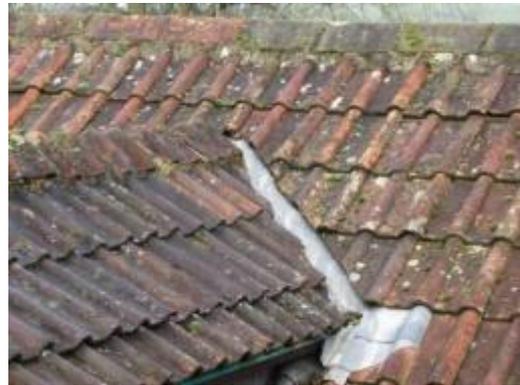
Valley gutters are formed at the intersection of the roof slopes to the dormers with the main roof slope. These are provided with sheet metal linings. The valley gutter linings are weather stained, but they are otherwise sound.

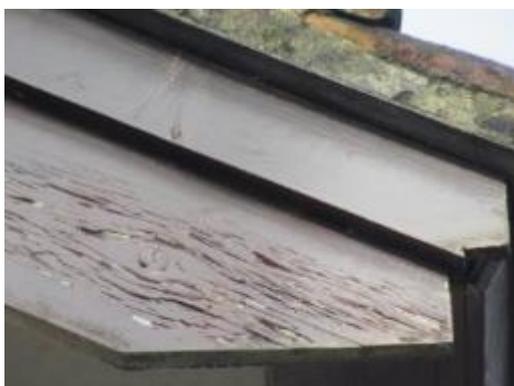
The fascias, verge boards, and soffits are timber. The decorations to the external joinery, particularly to the verge boards and dormers, are in fair condition only with areas of flaking and otherwise defective paintwork. We would recommend that all of the external joinery is prepared and redecorated.

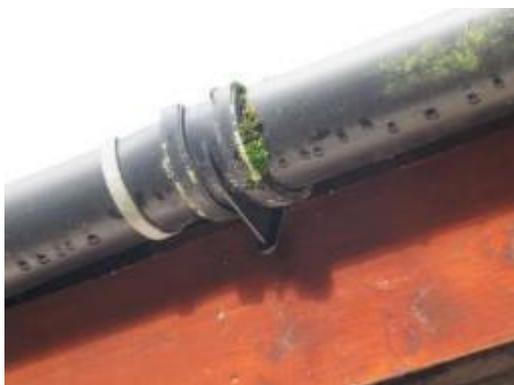
The gutter is half round PVCu with a circular downpipe that discharges onto the roof of the garage. The rainwater goods are soiled and weather stained and there is evidence of some slight leaks to the joints in a number of locations. We would recommend that the rainwater goods are cleared out, cleaned down, and overhauled with any leaking joints made good as necessary.

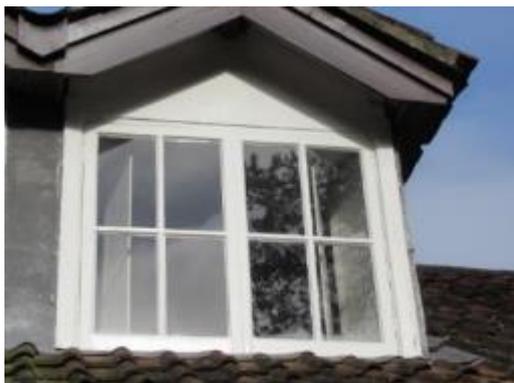
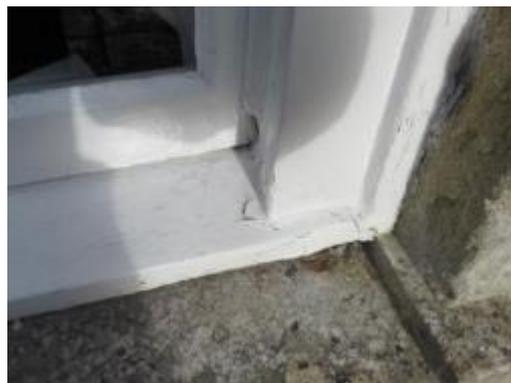
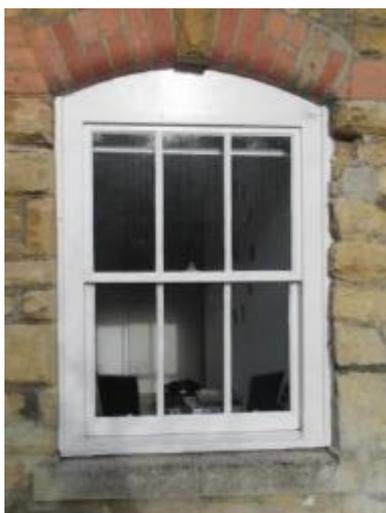
The windows are a combination of timber framed, single-glazed, casement and timber framed, single-glazed, double-hung sliding sash windows. The decorations to the windows are in fair condition only with some areas of flaking and otherwise defective paintwork, particularly to the dormer windows and the cills of the ground floor windows. We would recommend that the windows are prepared and redecorated.

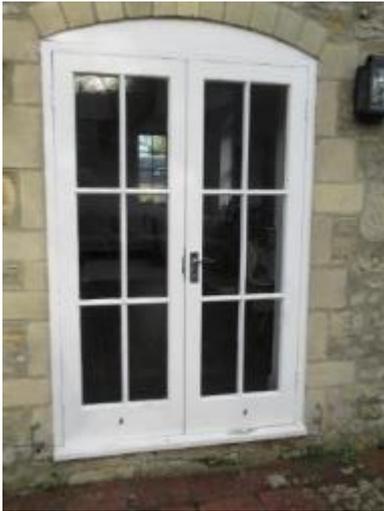
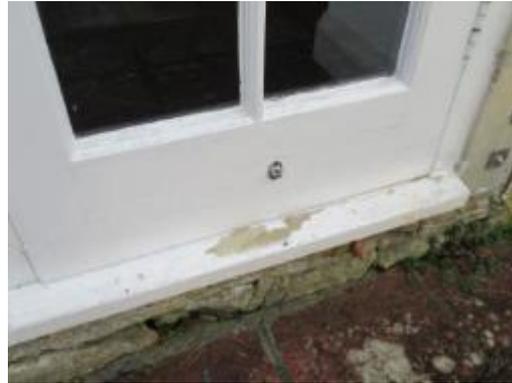
A pair of timber framed, multi-pane, glazed patio type doors are provided to the right-hand side of the elevation. The decorations to the doors are in fair to poor condition only with areas of flaking and otherwise defective paintwork and there is evidence of a number of previous repairs to the timber. We would recommend that the doors are repaired, prepared, and redecorated.

While it will be possible to repair and redecorate the doors in the short term, the previous repairs are quite extensive and you may wish to give consideration to replacing these doors in the medium term.

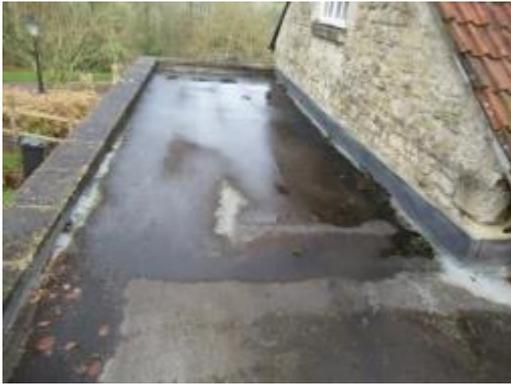
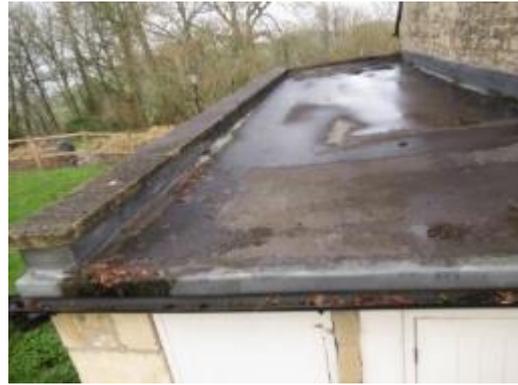
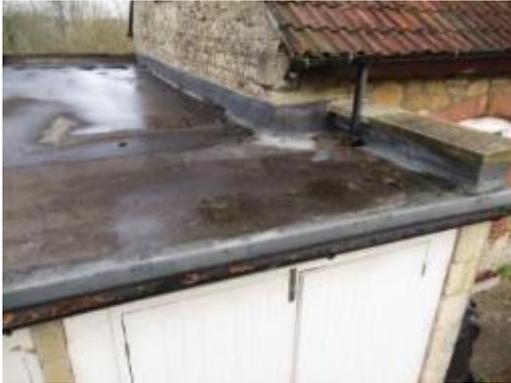
The roof to the garage is flat and is provided with a GRP covering. The roof covering is weather stained, and some ponding was noted in a number of areas, but this is not considered to be significant. The roof covering is otherwise sound and no evidence of water ingress internally was noted.

The roof covering is weathered to the elevations and the parapet walls with lead flashings. These are weather stained, but are otherwise sound.

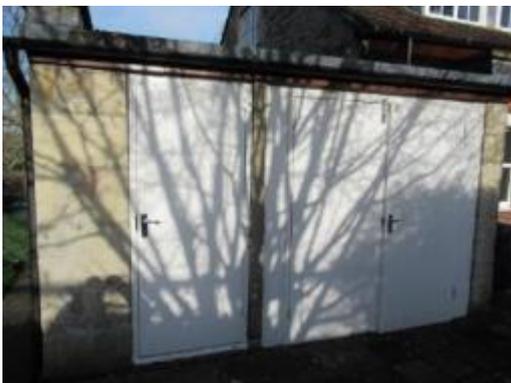
Garage – Rear Elevation

The gutter is half round PVCu with a circular downpipe that discharges onto the adjacent ground. Some minor mechanical damage was noted to the gutter and it is soiled and weather stained, but appears otherwise to be sound with no evidence of any significant leaks noted.

The external doors are framed ledged and braced timber plank type doors. The decorations to the doors are soiled and some areas of defective timber were noted, particularly to the cill of the left-hand side door. The doors are binding slightly. We would recommend that the doors are eased, adjusted, overhauled, prepared, and redecorated.

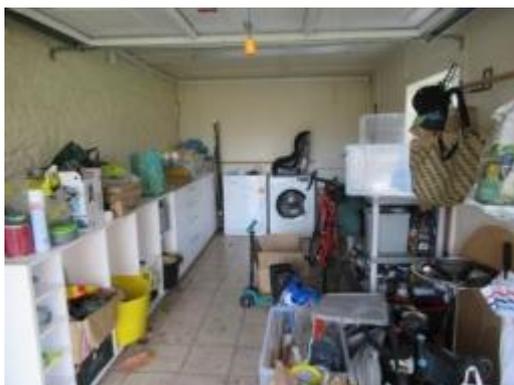
Garage – Internal

The ceiling is boarded and painted. The ceiling is sound and in satisfactory condition.

The walls are a combination of painted rubble stonework and painted boarding. The walls are sound and in satisfactory condition.

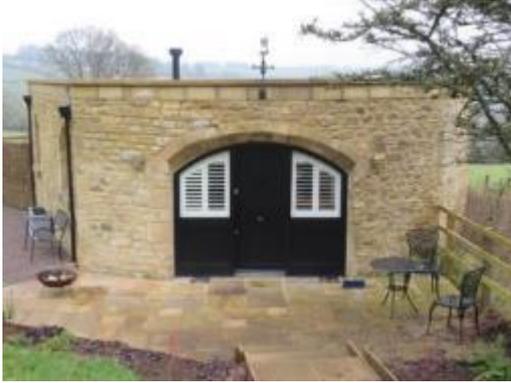
Cow Shed
Front Elevation

The roof is flat and is provided with a single-ply membrane covering. The roof covering is slightly weather stained, but is otherwise sound and no evidence of water ingress internally was noted.

The roof is weathered to the parapet walls with lead flashings. These are slightly weather stained, but are otherwise sound.

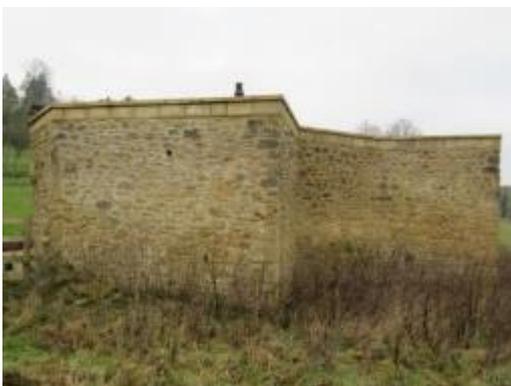
Right-Hand Side Elevation

The parapet wall is constructed as previously described. The parapet wall is sound and in satisfactory condition.

The outlet for the kitchen extract fan is not provided with a grille. We would recommend that a grille is provided to the outlet to prevent ingress by birds or vermin.
