BUILDING SURVEY

Level 3

This service is delivered in accordance with the Home Survey Standard (1st edition) RICS Professional Statement and is equivalent to Level 3.

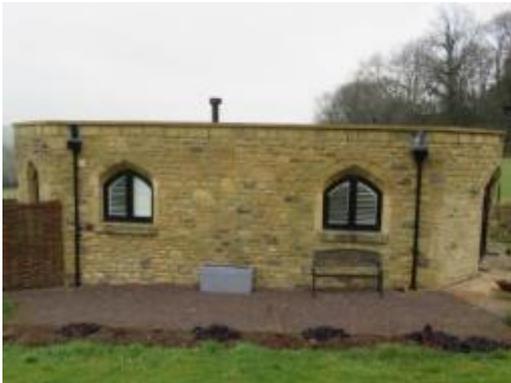
Left-Hand Side Elevation

The parapet wall is constructed as previously described. The parapet wall is sound and in satisfactory condition with no significant cracks or other defects noted.

The rainwater from the flat roof area discharges through to lead lined chutes within the parapet wall. These are sound and in satisfactory condition.

The rainwater discharges into cast-iron hoppers and downpipes that, in turn, discharge into open gulleys. The rainwater goods are sound and in satisfactory condition with no evidence of any significant leaks noted.

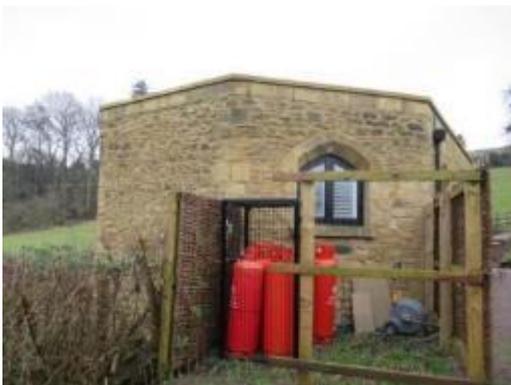
Rear Elevation

The parapet wall is constructed as previously described. The parapet wall is sound and in satisfactory condition with no significant cracks or other defects noted.

The lintel to the window opening is formed with a segmental stone arch. This is in satisfactory condition and no cracks or other defects were noted to the masonry that would indicate there are any issues with the lintel.

The window is a timber framed casement type window with sealed double-glazed units. The decorations to the window are slightly soiled, but it is otherwise sound.

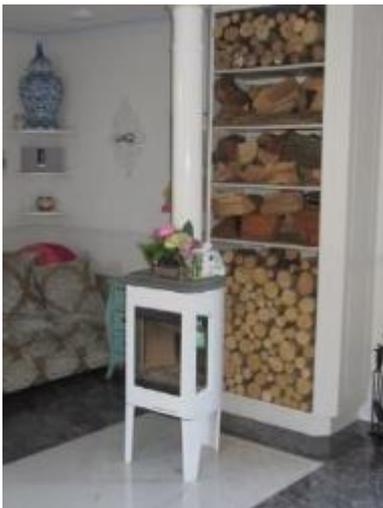
A free-standing wood burning stove is fitted to the rear of the reception room. This was not operating at the time of our inspection and we cannot therefore comment on its condition or effectiveness. We would recommend that the stove is inspected by a HETAS Approved installer.

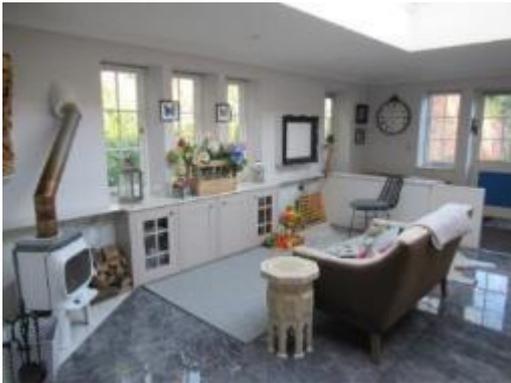
Dining/Family Room

The ceiling and walls are plastered and painted. A decorative coving detail has been provided to the perimeter of the ceiling. Some slight damp staining was noted to the coving above the right-hand side external wall and some corrosion was noted to the angle beads to the head of the window reveals. It appears that there has previously been some water ingress in this location.

Readings were taken with a hand held moisture meter to the affected area. The readings noted were low. This would indicate that the damage is historic. This is likely to be a consequence of a previous water leak from the flat roof area above.

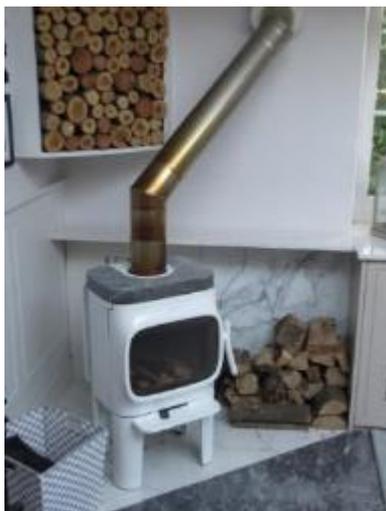
A free-standing wood burning stove is fitted to the left-hand side rear corner of the family room. This was not operating at the time of our inspection and we cannot therefore comment on its condition. We would recommend that the stove is inspected by a HETAS Approved installer.

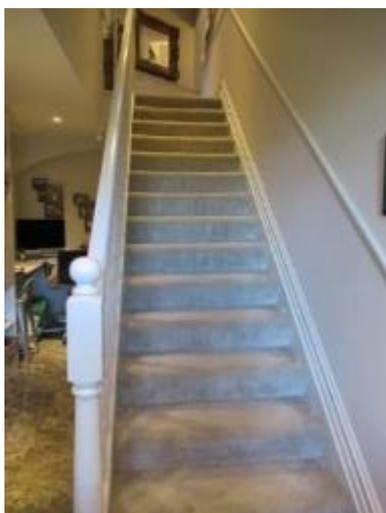
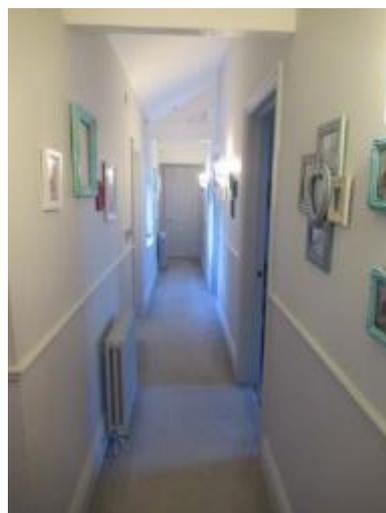
First Floor Staircase and Landing

There is a staircase that provides access from the ground floor hall/office to the first floor landing and hallway. This is constructed in timber and is overlaid with a fully fitted carpet. The staircase is sound and in satisfactory condition.

A timber balustrade and handrail are provided to the staircase and landing. These are sound and in satisfactory condition.

The ceiling and walls are plastered and painted. Some of the roof timbers are exposed. The ceiling, walls, and exposed roof timbers are sound and in satisfactory condition.

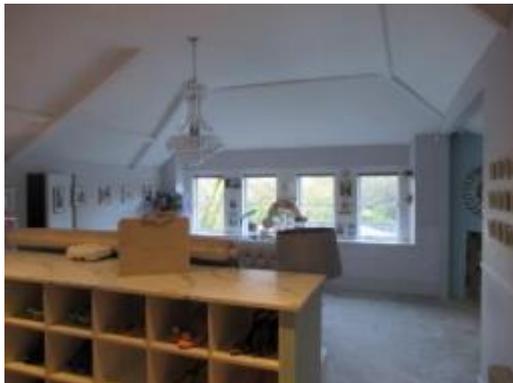
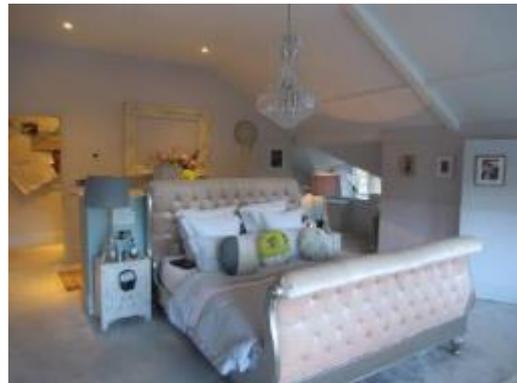
Master Bedroom

The ceiling and walls are plastered and painted. A number of the roof timbers are exposed. Slight drying out cracks were noted to the wall plaster on the rear elevation, but these are not considered to be significant and can be remedied during the normal course of cyclical redecoration works. The ceiling and walls are otherwise sound.

The floor is of suspended timber construction overlaid with a fully fitted carpet. The floor is slightly out of level and uneven in places, but is otherwise sound.

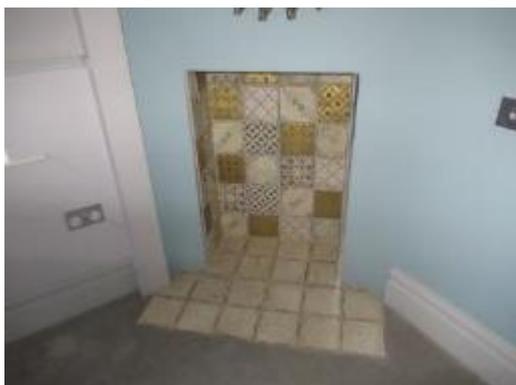
There is a chimneybreast to the right-hand side rear corner of the bedroom. The fireplace has been removed. The fireplace opening is for decorative purposes only.

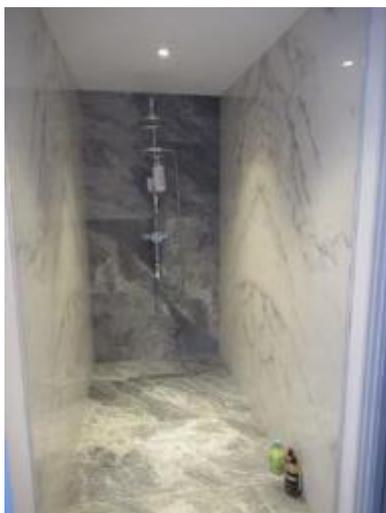
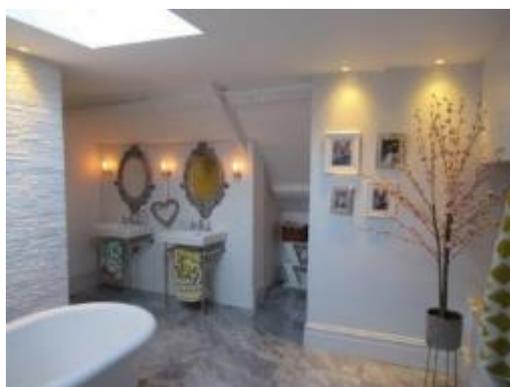
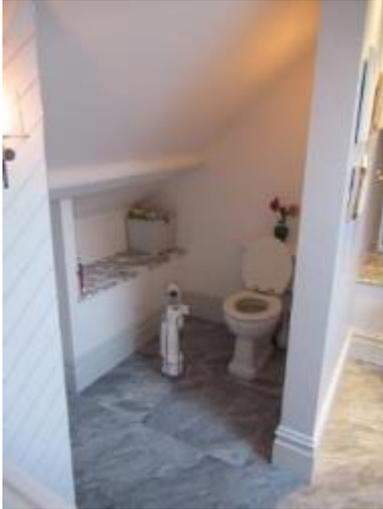
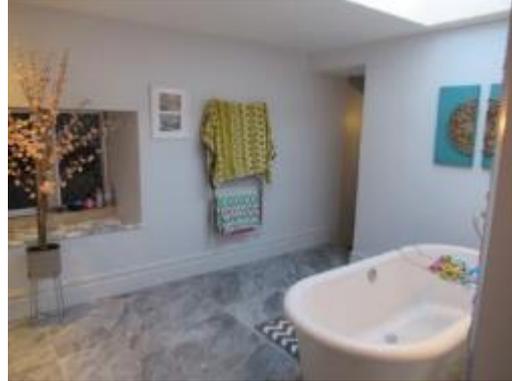
Bathroom

The ceiling and walls are plastered and painted. Some slight decorating cracks were noted to the junctions of the walls and ceiling in isolated locations, but these are not considered to be significant and can be remedied during the normal course of cyclical redecoration works. The ceiling and walls are otherwise sound.

The floor is of suspended timber construction overlaid with polished marble floor tiles. The floor is sound, flat, and level.

The sanitaryware is white ceramic and comprises: a close coupled WC pan and cistern, two wall mounted wash hand basins with chrome stands, a free-standing double ended stone resin bath, and a wet room type shower enclosure. A shower mixer valve with fixed and flexible overhead shower attachments is fitted to the shower enclosure. The brassware is chrome finished. The sanitaryware is sound and in satisfactory condition.

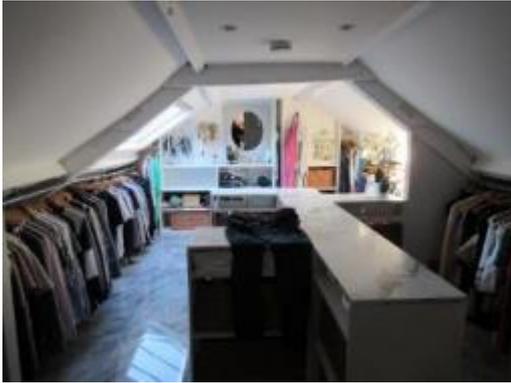
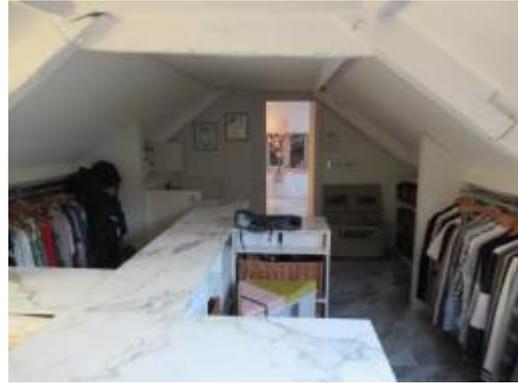
Dressing Room

The ceiling and walls are plastered and painted. The ceiling is vaulted and a number of the roof timbers are exposed. The ceiling and walls are sound and in satisfactory condition with no significant cracks or other defects noted.

The floor is of suspended timber construction overlaid with polished marble floor tiles. The floor is sound, flat, and level.

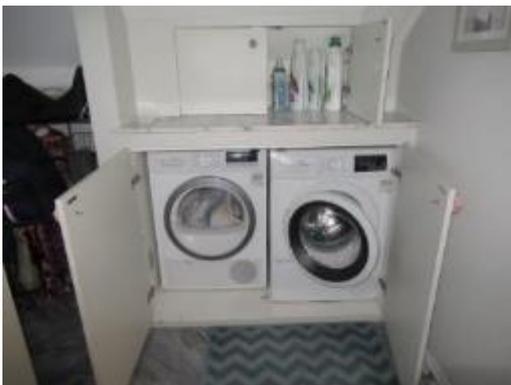
There is a built-in cupboard to the left-hand side external wall of the dressing room. This has been provided with appropriate plumbing and electrical supplies for a washing machine and tumble dryer.

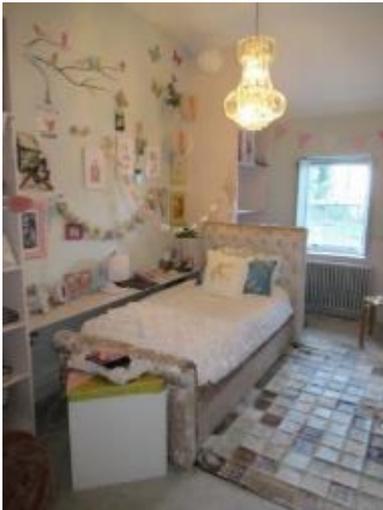
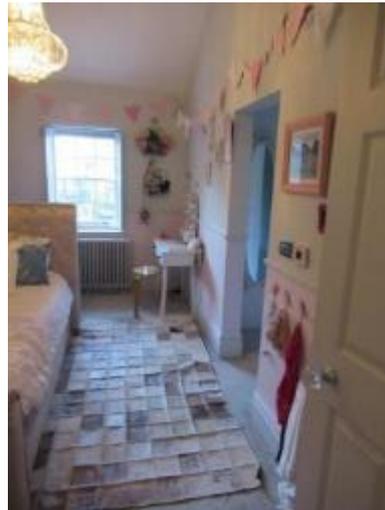
Bedroom One

The ceiling and walls are plastered and painted. Some slight decorating cracks were noted to the perimeter of the ceiling, but these are not considered to be significant and can be remedied during the normal course of cyclical redecoration works. The ceiling and walls are otherwise sound.

The floor is of suspended timber construction overlaid with a fully fitted carpet. The floor is slightly out of level, but is otherwise sound and flat.

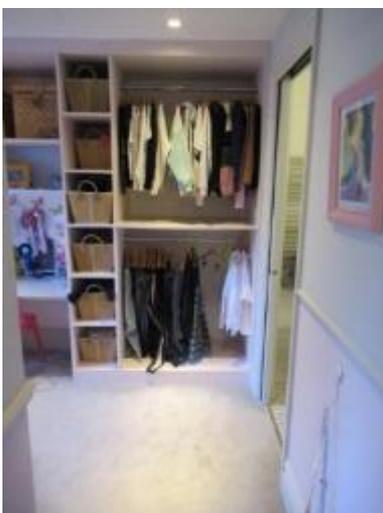
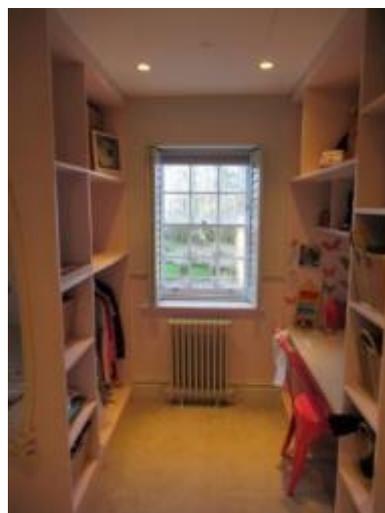
Dressing Room

The ceiling and walls are plastered and painted. The ceiling and walls are sound and in satisfactory condition with no significant cracks or other defects noted.

The floor is of suspended timber construction overlaid with a fully fitted carpet. The floor is slightly out of level, but is otherwise sound and flat.

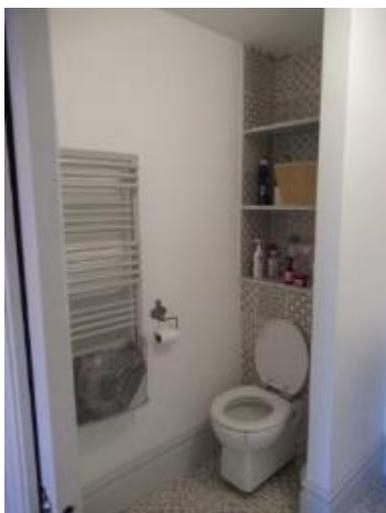
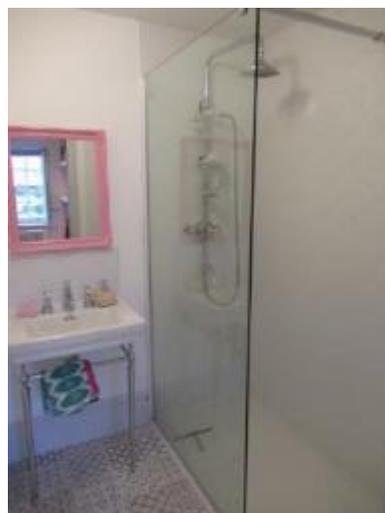
En-Suite Shower Room

The ceiling and walls are plastered and painted. The ceiling and walls are sound and in satisfactory condition with no significant cracks or other defects noted.

The sanitaryware is white ceramic and comprises: a back to wall WC pan with concealed cistern, wall mounted wash hand basin with chrome stand, and shower enclosure with acrylic tray and fixed glass screen. A shower mixer valve with fixed and flexible overhead shower attachments is fitted to the shower enclosure. The brassware is chrome finished. The sanitaryware is sound and in satisfactory condition.

A ladder type towel radiator with a grey epoxy finish is fitted. This is in satisfactory condition. The splashback areas are provided with ceramic wall tiling. Some staining was noted to the grouting of the wall tiling, particularly at low level within the shower enclosure, but the wall tiling is otherwise sound. We would recommend that the affected areas of grouting are raked out and re-grouted.

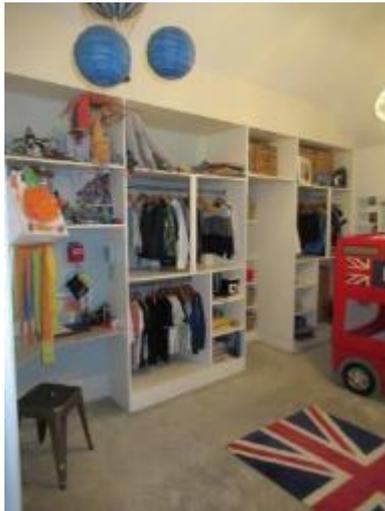
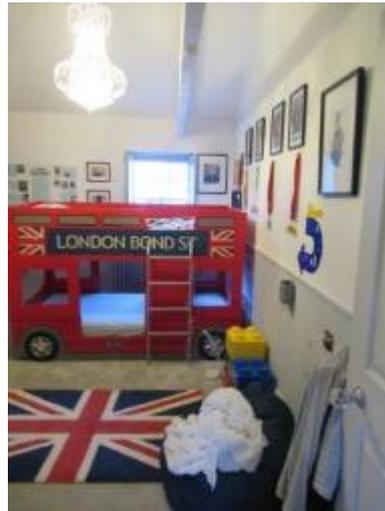
Bedroom Two

The ceiling and walls are plastered and painted. A number of the roof timbers are exposed. Some slight decorating cracks were noted to the junctions of the ceiling and walls, but these are not considered to be significant and can be remedied during the normal course of cyclical redecoration works. The ceiling and walls are otherwise sound.

The floor is of suspended timber construction overlaid with a fully fitted carpet. The floor is slightly out of level and uneven in places, but is otherwise sound.

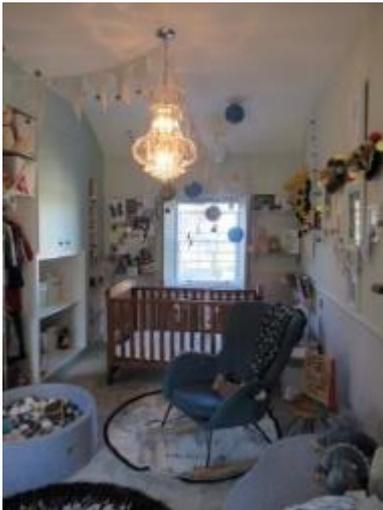
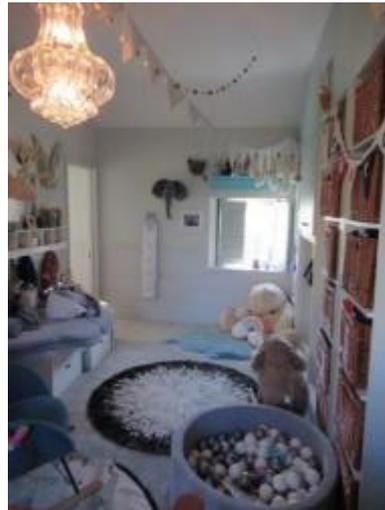
Bedroom Three

The ceiling and walls are plastered and painted. The ceiling and walls are sound and in satisfactory condition with no significant cracks or other defects noted.

The floor is of suspended timber construction overlaid with a fully fitted carpet. The floor is slightly out of level, but is otherwise sound and flat.

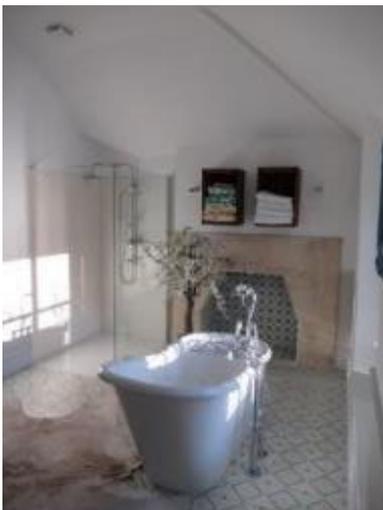
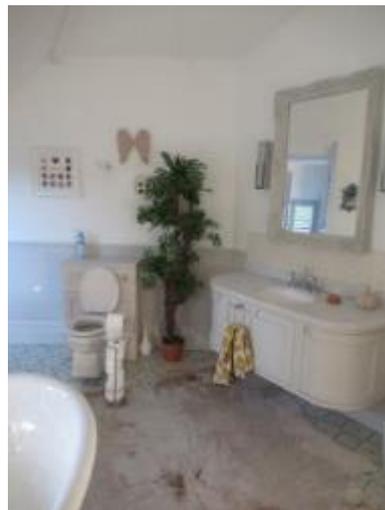
Bathroom

The ceiling and walls are plastered and painted. Some slight drying out cracks were noted to the ceiling and wall plaster, but these are not considered to be significant and can be remedied during the normal course of cyclical redecoration works. The ceiling and walls are otherwise sound.

The floor is of suspended timber construction overlaid with ceramic floor tiles. The floor is slightly out of level and uneven in places, but is otherwise sound.

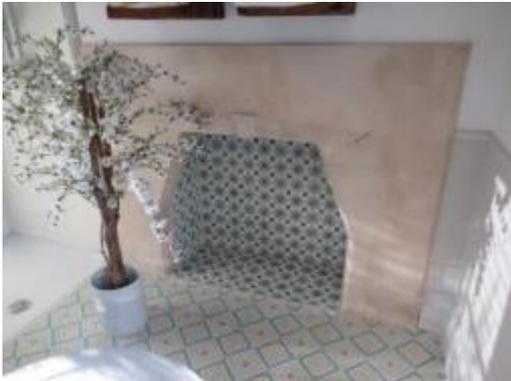
There is a chimneybreast to the rear external wall. The fireplace has been removed and the fireplace opening is for decorative purposes only.

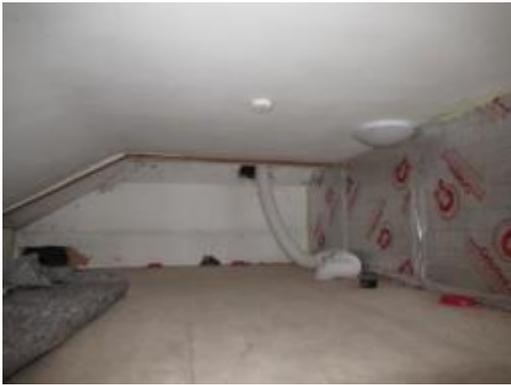
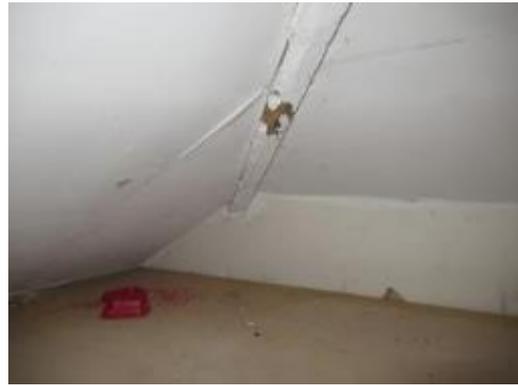
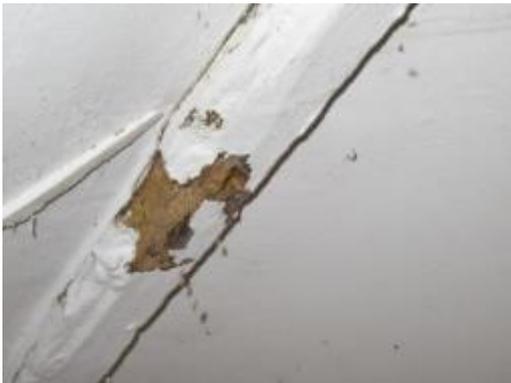
Roof Void

The majority of the roof void is inaccessible. A small section of the roof void above the dressing room to bedroom one is accessible. The roof structure is enclosed with painted plasterboard and rigid insulation batts. The majority of the roof structure is enclosed, but a small section of the hip rafter is exposed. There is evidence of some wood boring insect infestation to this roof timber. It appears that this may be active. We would recommend that the exposed roof timbers are inspected by a specialist timber and damp treatment firm with a view to obtaining quotations for any possible remedial works that may be required.

The roof void is boarded for storage. It is anticipated that some insulation has been provided, but we are not able to comment on whether this is of sufficient thickness to comply with current Building Regulation requirements.

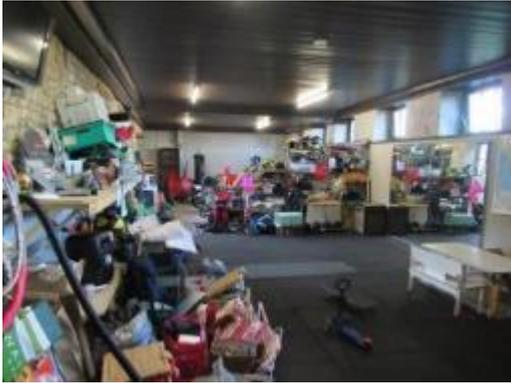
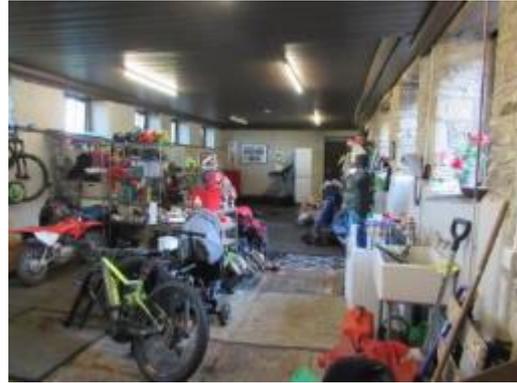
Annex

The ceiling is provided with timber butt and bead type panelling. Some slight deflection was noted to the panelling, but this was not excessive and the ceiling is otherwise sound.

The floor is of solid construction overlaid with clay stable block pavements that have, in turn, been overlaid with rubber matting and other floor coverings. The floor is out of level and uneven in places and was largely obscured by the occupier's goods at the time of our inspection, but the visible areas appear to be sound.

The internal walls are of solid masonry construction that has been partially rendered and painted. Plasterboard panelling has been provided to the left-hand side external wall. The walls are sound and in satisfactory condition.

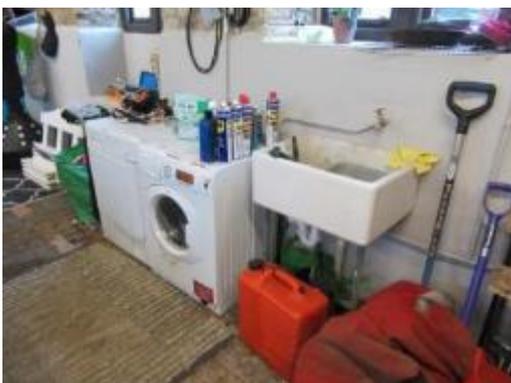
There is a wall mounted butlers' sink to the right-hand side external wall. A brass bibcock is provided. There are plumbing and electrical supplies for washing machine and tumble dryer.

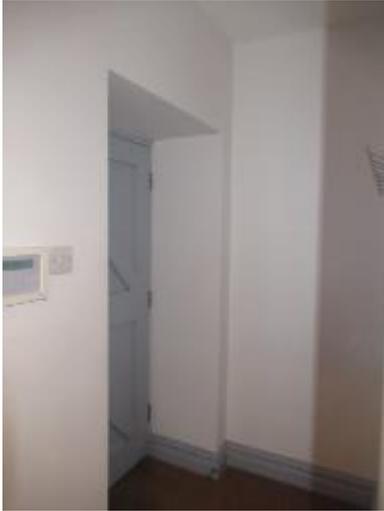
Flat/Annex
Ground Floor
Entrance Hallway

The ceiling and walls are plastered and painted. The ceiling and walls are sound and in satisfactory condition with no significant cracks or other defects noted.

The floor is of solid construction overlaid with coconut type entrance matting. The floor is sound, flat, and level.

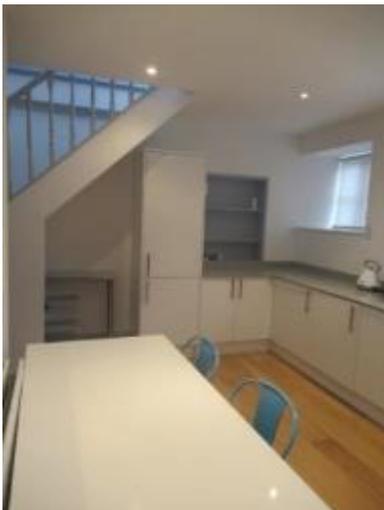
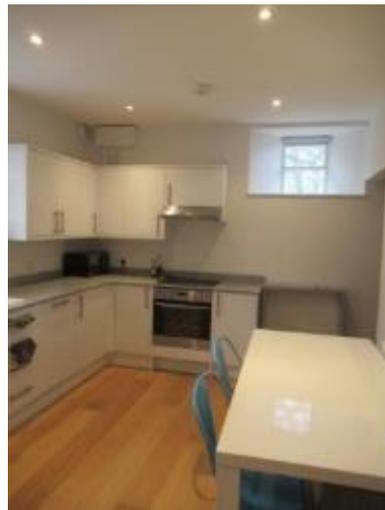
Kitchen/Dining Room

The ceiling and walls are plastered and painted. Some slight decorating cracks were noted to the perimeter of the ceiling, but these are not considered to be significant and can be

remedied during the normal course of cyclical redecoration works. The ceiling and walls are otherwise sound.

A stainless-steel recirculating type extract hood is fitted above the hob. While no evidence of a significant build-up of condensation within the kitchen was noted, we would recommend that consideration be given to ducting the fan to exhaust externally. This would minimise the possibility of a build up of condensation and any subsequent damage to the decorations.

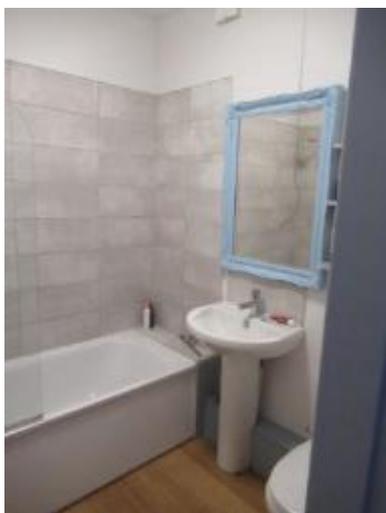
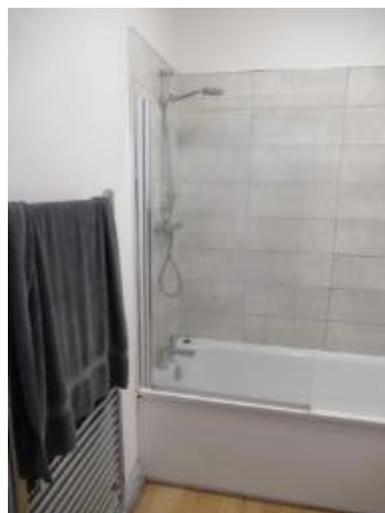
Bathroom

The ceiling and walls are plastered and painted. Some slight decorating cracks were noted to the perimeter of the ceiling and the junctions of the walls, but these are not considered to be significant and can be remedied during the normal course of cyclical redecoration works. The ceiling and walls are otherwise sound.

The floor is of solid concrete construction overlaid with a timber laminate type flooring. The floor is slightly out of level, but is otherwise sound.

The silicone seal to the perimeter of the bath is soiled and defective in places. We would recommend that the silicone seal is raked out and resealed.

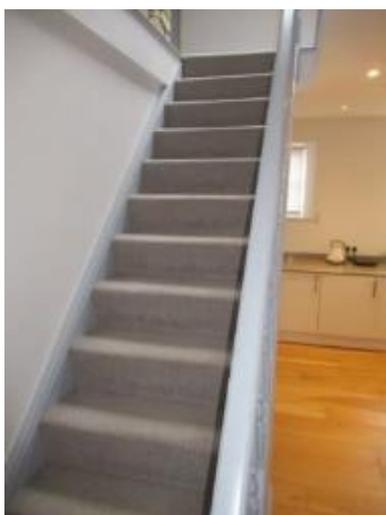
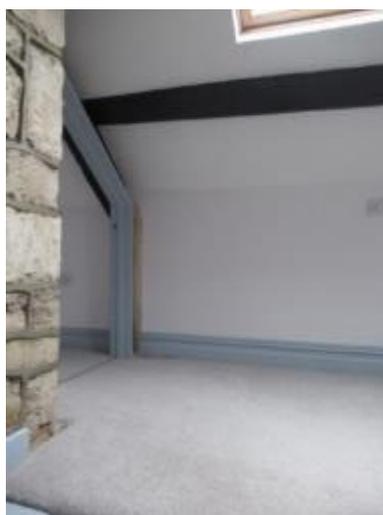
Staircase and Landing

There is a staircase that provides access from the ground floor kitchen/dining room to the first floor landing and reception room. This is constructed in timber and is overlaid with a

fully fitted carpet. Some slight creaking was noted to the staircase treads, but this was not excessive and the staircase is otherwise sound.

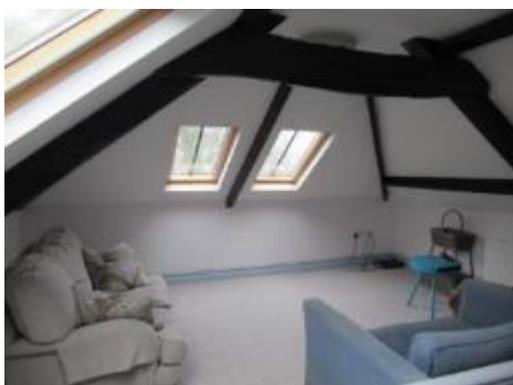
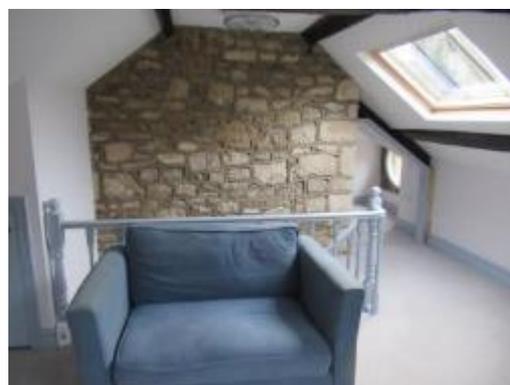
Living Room

The ceiling is vaulted and a number of the roof timbers are exposed. The ceiling is plastered and painted. The ceiling is sound and in satisfactory condition with no significant cracks noted.

It should be noted that headroom is restricted within the living room.

The walls are plastered and painted. Some slight board cracks were noted to the walls, but these are not considered to be significant and can be remedied during the normal course of cyclical redecoration works. The walls are otherwise sound.

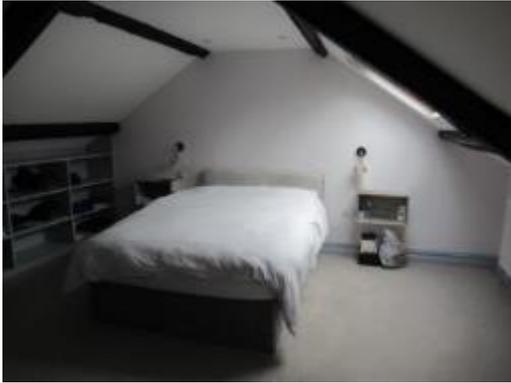
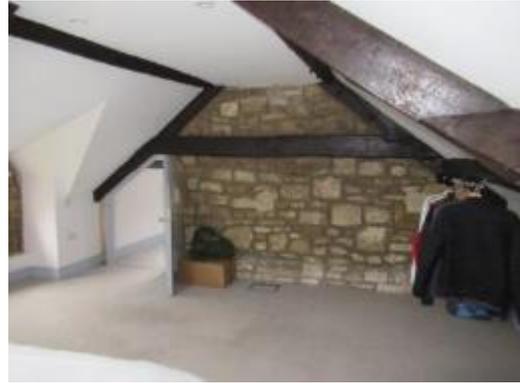
Bedroom

The ceiling is vaulted and a number of the roof timbers are exposed. The ceiling is plastered and painted. The ceiling is sound and in satisfactory condition with no significant cracks or other defects noted.

It should be noted that headroom is restricted within the bedroom.

The walls are plastered and painted. A section of the front internal wall and the left-hand side internal wall are exposed stonework. The decorations to the walls are slightly marked and soiled in places, but they are otherwise sound with no significant cracks noted.

It should be noted also that the door opening into the bedroom is not full height and access is restricted.

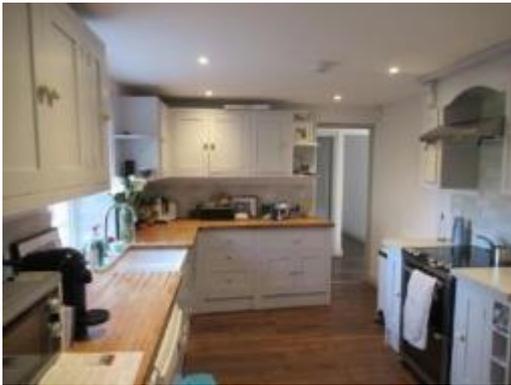
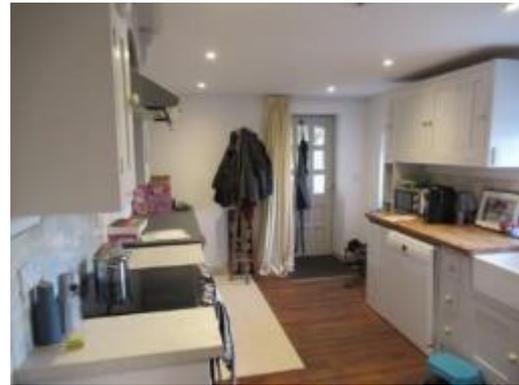
Kitchen

The ceiling and walls are plastered and painted. The decorations to the walls are slightly marked and soiled in places and some slight decorating cracks were noted to the wall plaster adjacent to the external door, but these are not considered to be significant and can be remedied during the normal course of cyclical redecoration works. The ceiling and walls are otherwise sound.

A stainless-steel recirculating type extract hood is fitted above the cooker. While no evidence of a significant build up of condensation within the kitchen was noted, we would recommend that consideration be given to ducting the fan to exhaust externally. This would minimise the possibility of a build-up of condensation in the kitchen and any subsequent damage to the decorations.

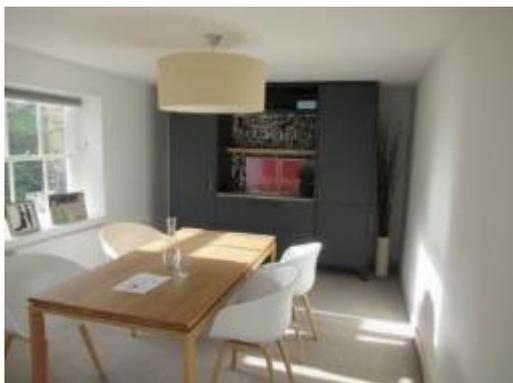
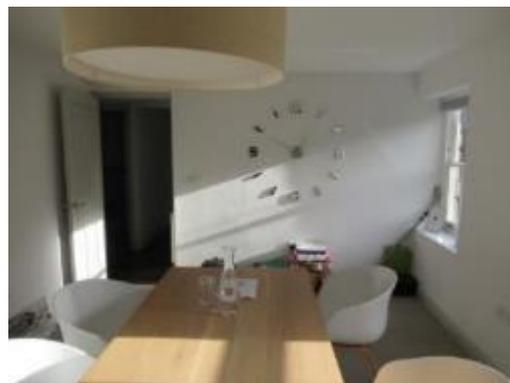
Bedroom One

This room is presently being used as a dining room. The ceiling and walls are plastered and painted. The finish to the wall plaster is slightly inconsistent in places, but this is not considered to be significant and the ceiling and walls are otherwise sound with no significant cracks noted.

Readings were taken with a hand held moisture meter to the internal faces of the external walls where these were accessible. The readings noted were low. This would indicate that there are no significant issues with damp in this location.

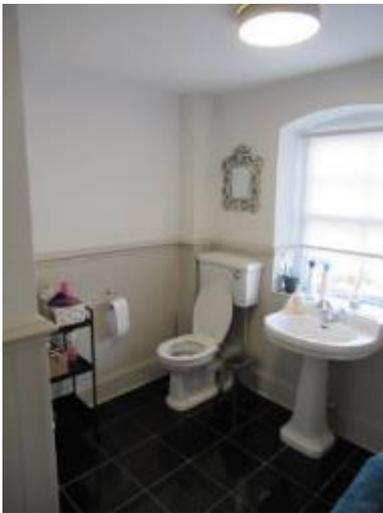
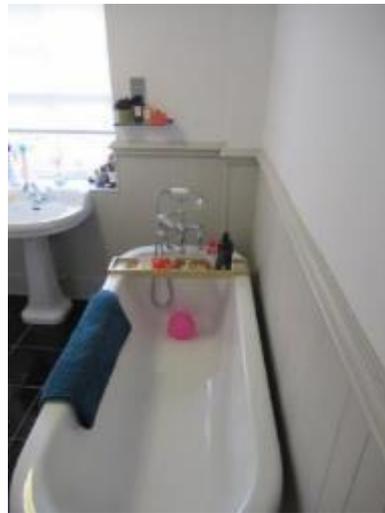
Bathroom

The ceiling and walls are plastered and painted. Decorative timber panelling has been provided to the dado area of the walls. Some slight board cracks were noted to the ceiling, but these are not considered to be significant and can be remedied during the normal course of cyclical redecoration works. The ceiling and walls are otherwise sound.

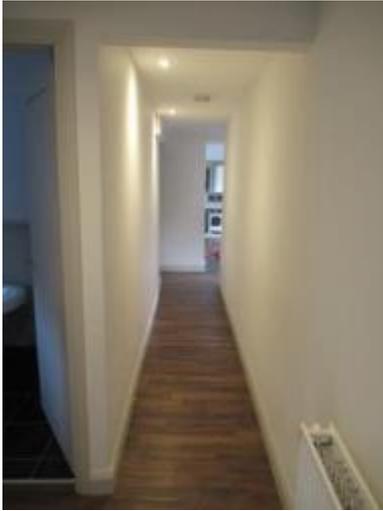
Inner Hallway

The ceiling and walls are plastered and painted. The ceiling and walls are sound and in satisfactory condition with no significant cracks or other defects noted.

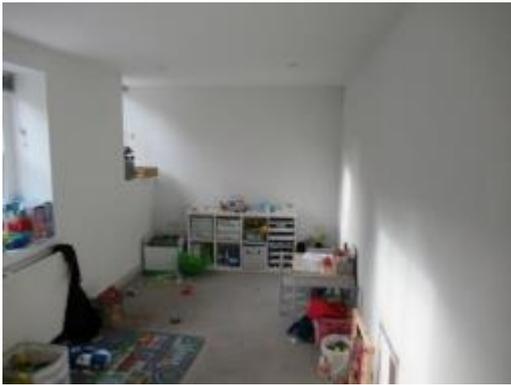
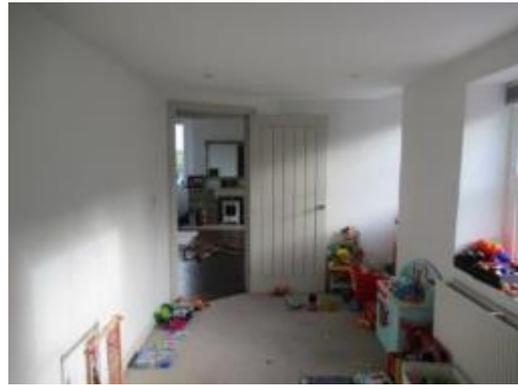
Bedroom Two

The ceiling and walls are plastered and painted. The ceiling and walls are sound and in satisfactory condition with no significant cracks or other defects noted.

Readings were taken with a hand held moisture meter to the internal faces of the external walls where these were accessible. The readings noted were low. This would indicate that there are no significant issues with damp in this location.

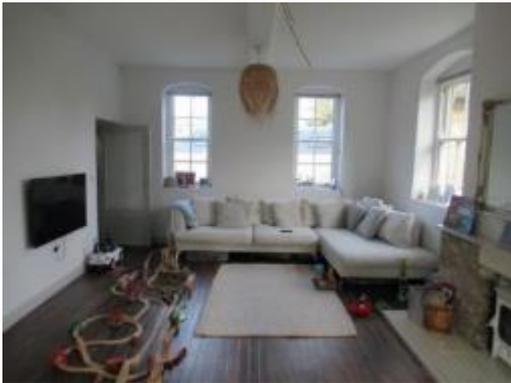
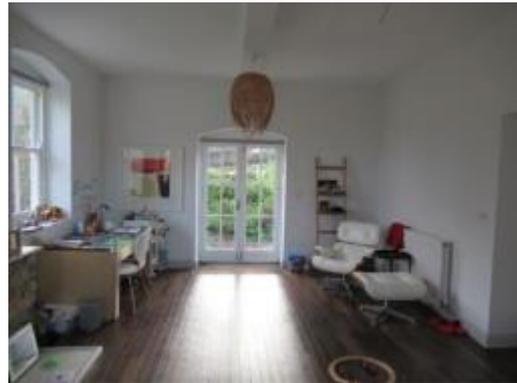
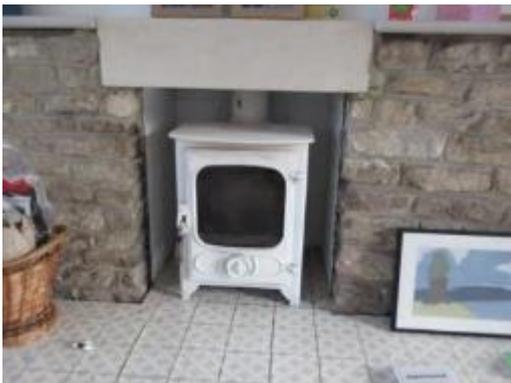
Living/Dining Room

There is a chimneybreast to the left-hand side external wall. A stone fireplace with timber mantle and tiled hearth are provided. A woodburning stove is fitted to the fireplace opening. A cement-fibre flitch plate is fitted. The stove was not operating at the time of our inspection and we cannot therefore comment on its condition or effectiveness. We would recommend that the stove is inspected by a HETAS Approved Installer.

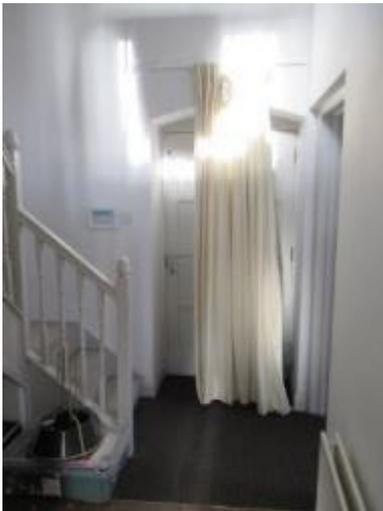
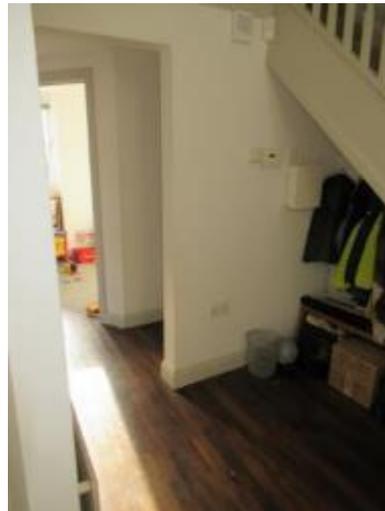
Entrance Hallway

The ceiling and walls are plastered and painted. The decorations to the walls are slightly marked and soiled in places, but the ceiling and walls are otherwise sound with no significant cracks or other defects noted.

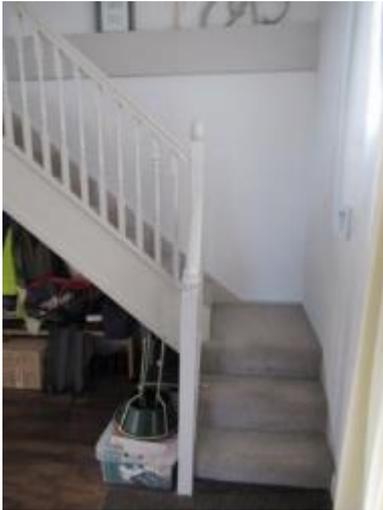
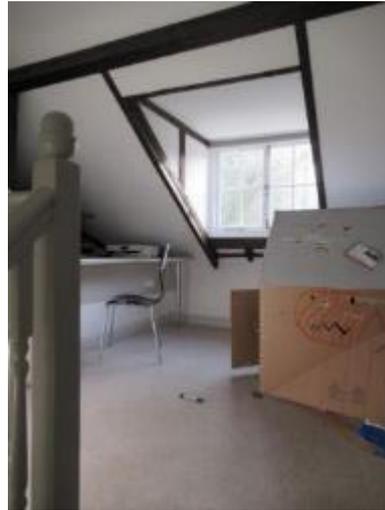
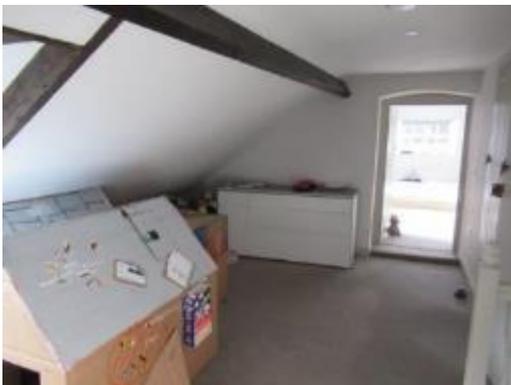
Staircase and Landing

There is a staircase that provides access from the ground floor entrance hallway to the first floor landing. This is constructed in timber and is overlaid with a fully fitted carpet. The staircase is sound and in satisfactory condition.

The ceiling and walls are plastered and painted. The ceiling is vaulted and a number of the roof timbers are exposed. The ceiling, walls, and exposed timbers are sound and in satisfactory condition.

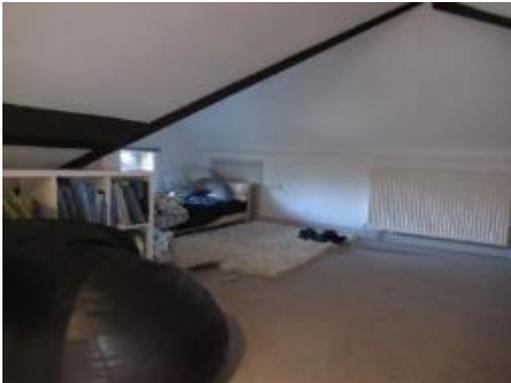
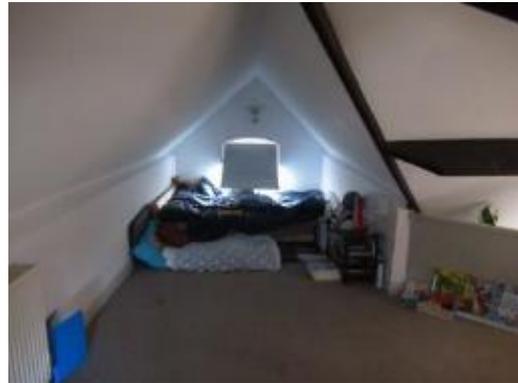
Bedroom Four

The floor is of suspended timber construction overlaid with a fully fitted carpet. The floor is slightly out of level and uneven in places, but is otherwise sound.

It should be noted that headroom is significantly restricted within this room.

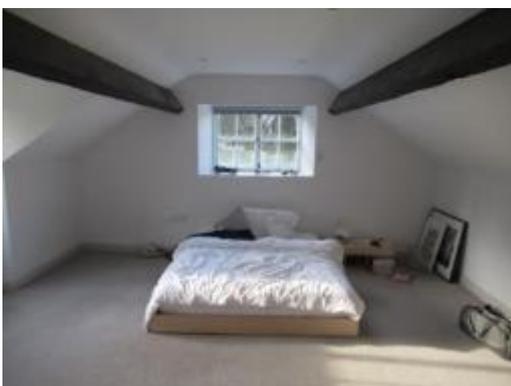
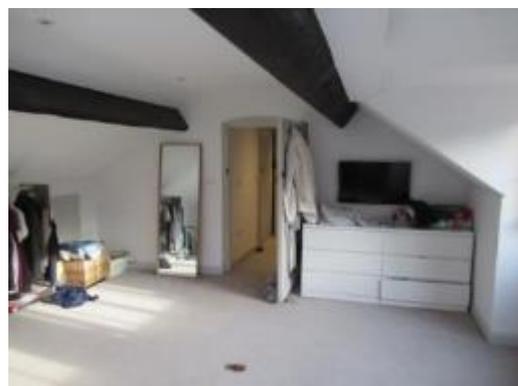
Bedroom Three

The floor is of suspended timber construction overlaid with a fully fitted carpet. The floor is slightly out of level and uneven in places, but is otherwise sound.

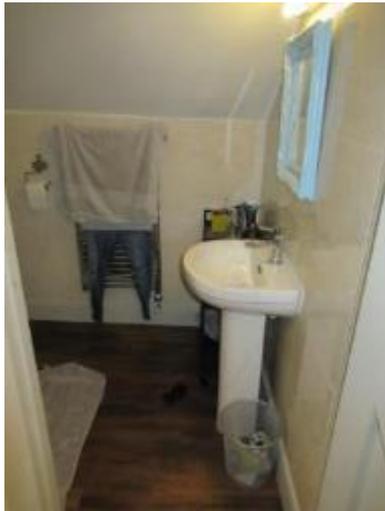
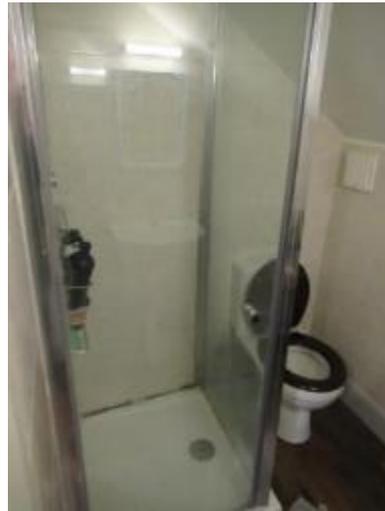
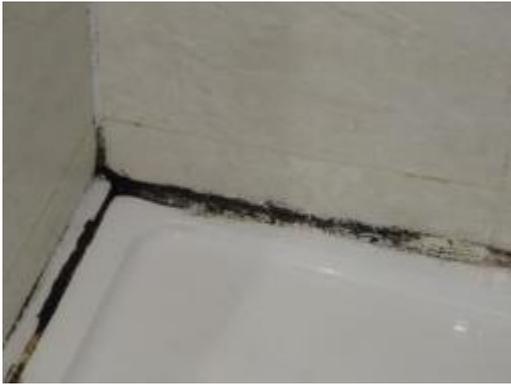
Shower Room

The sanitaryware is white ceramic and comprises: a close coupled WC pan and cistern, pedestal wash hand basin, and corner shower enclosure with acrylic tray and hinged glass screen. A shower mixer valve with flexible overhead shower attachment and fixed riser rail is fitted to the shower enclosure. The brassware is chrome finished. The sanitaryware is slightly soiled, but is otherwise sound.

The silicone seal to the perimeter of the shower tray is extensively soiled and defective in places. We would recommend that this is raked out and resealed.

Some mould staining was noted to the ceiling, particularly above the shower enclosure. Mechanical extract ventilation is provided to the shower room, but this does not appear to be effective. We would recommend that the overrun time to the fan is extended. It is possible that it may be necessary to install a more effective fan.

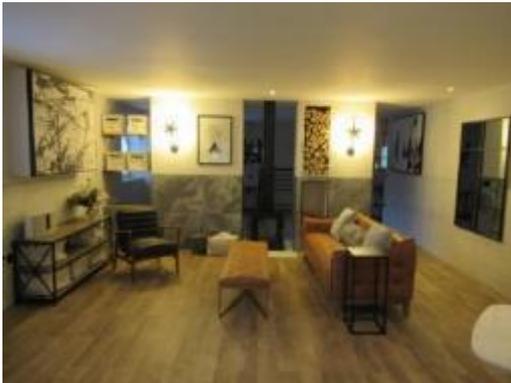
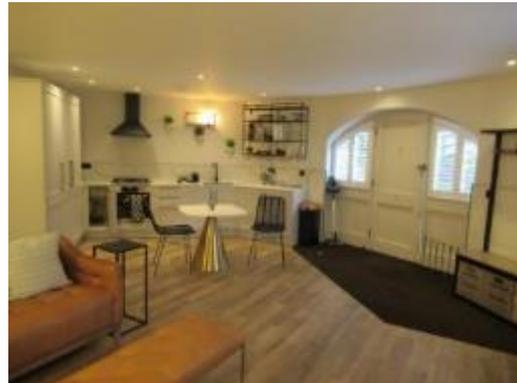
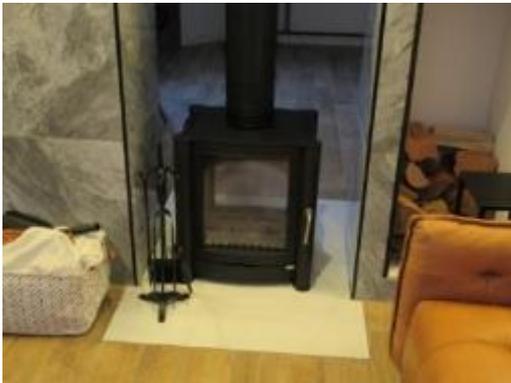
Living/Dining Room/Kitchen

The ceiling and walls are plastered and painted. Some slight decorating cracks were noted to the perimeter of the ceiling, but these are not considered to be significant and can be remedied during the normal course of cyclical redecoration works. The ceiling and walls are otherwise sound.

A free-standing woodburning stove is fitted adjacent to the rear internal wall of the living area. The stove was not operating at the time of our inspection and we cannot therefore comment on its condition of effectiveness. We would recommend that the stove is inspected by a HETAS Approved Installer.

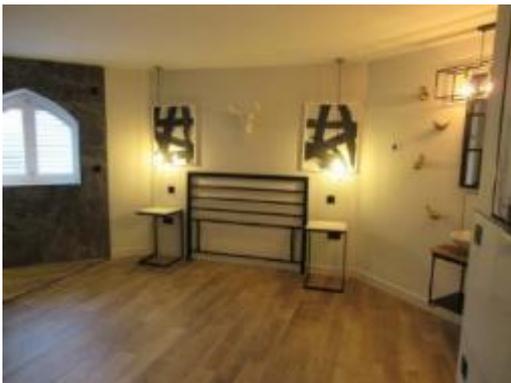
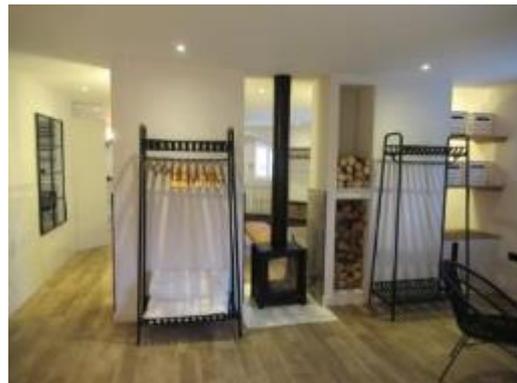
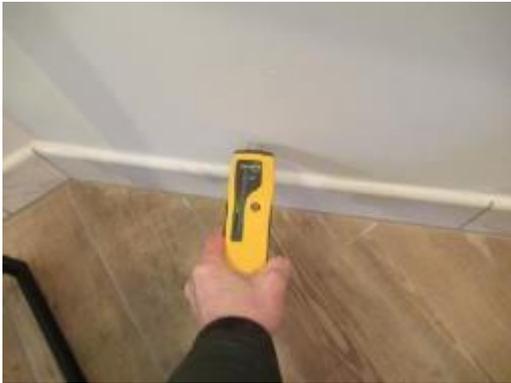
Bedroom

The ceiling and walls are plastered and painted. Some slight board cracks were noted to the ceiling, but these are not considered to be significant and can be remedied during the normal course of cyclical redecoration works. The ceiling and walls are otherwise sound.

Readings were taken with a hand held moisture meter to the internal faces of the external walls where these were accessible. The readings noted were low. This would indicate that there are no significant issues with damp in this location.

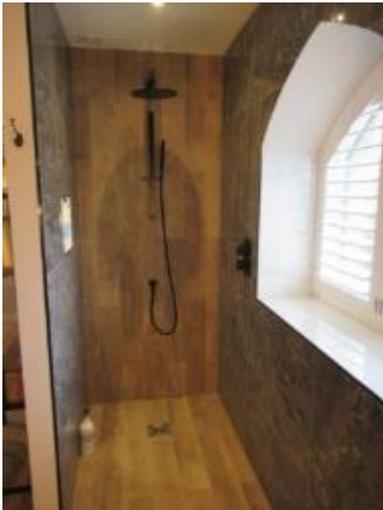
Shower Room

The shower is configured as a wet room. The floor is of solid concrete construction overlaid with timber effect ceramic floor tiles. The floor is in satisfactory condition.

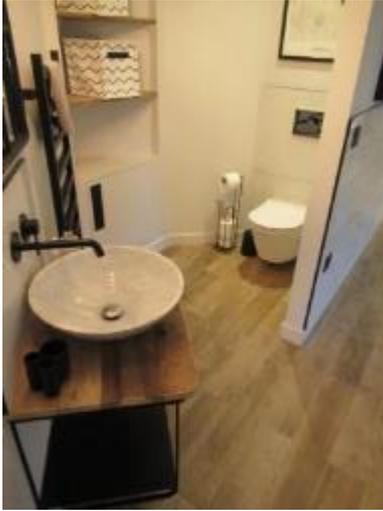
Cloakroom

The ceiling and walls are plastered and painted. The ceiling and walls are sound and in satisfactory condition with no significant cracks or other defects noted.

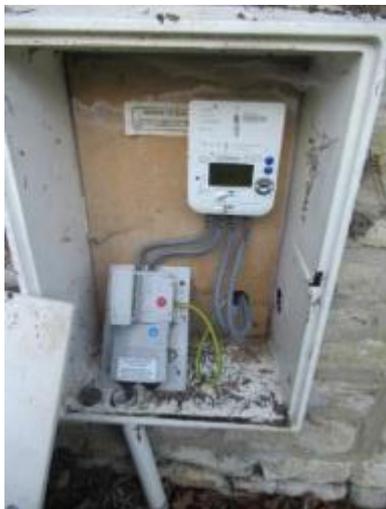
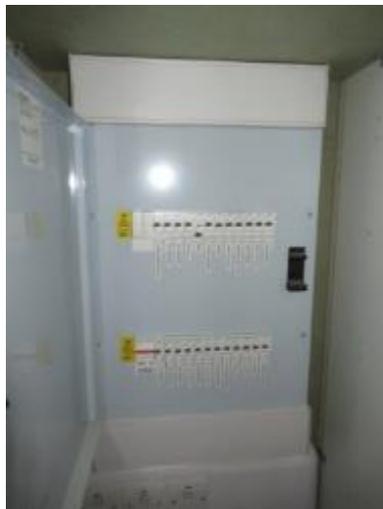
The consumer unit is fitted within a cupboard in the utility room. The consumer unit is fitted with miniature circuit breakers, but no RCD protection appears to have been provided. The electrical installation to the property appears to be relatively recent and we noted no obvious defects or significant disrepair to the electrical installation during our brief visual inspection.

We are advised that an NICEIC test Certificate is available for the installation and we would recommend that your legal advisers make enquiries to obtain a copy of the Certificate. If this is not available, we would recommend that the electrical installations throughout the property are inspected and tested by a suitably qualified NICEIC Approved Electrical Engineer and that any recommended remedial or upgrading works are carried out.

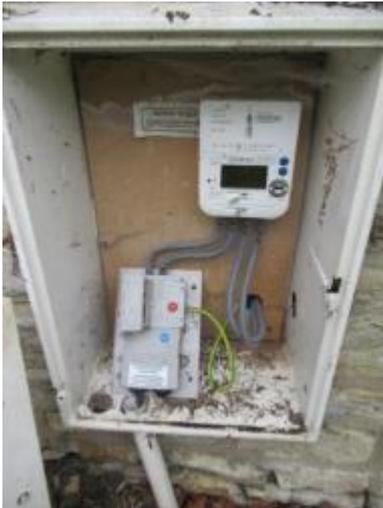
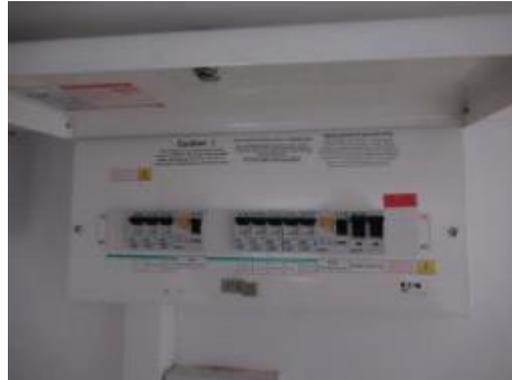
The consumer unit is located at high-level on the left-hand side external wall of the kitchen. The consumer unit is fitted with miniature circuit breakers and RCD protection is provided. There are several spare ways in the consumer unit.

We understand that the property is let presently and it is anticipated that a current NICEIC electrical test Certificate will be available for the electrical installation. We would recommend that your legal advisers make enquiries to obtain a copy of the test Certificate. If this is not available, we would recommend that the electrical installation throughout the property is inspected and tested by a suitably qualified NICEIC Approved Electrical Engineer and that any recommended remedial or upgrading works are carried out.
