BUILDING SURVEY

Level 3

This service is delivered in accordance with the Home Survey Standard (1st edition) RICS Professional Statement and is equivalent to Level 3.

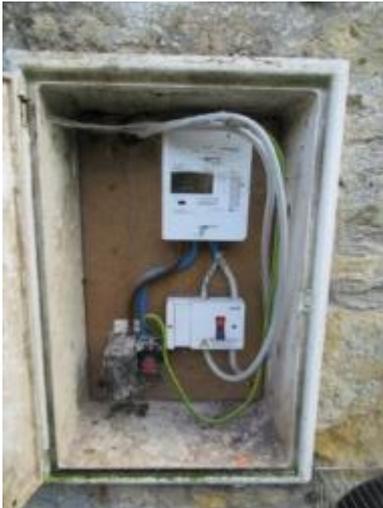
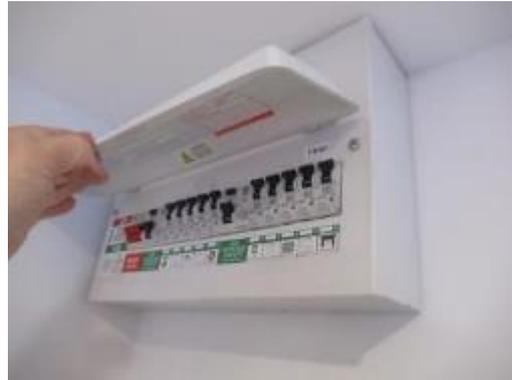
Chapel Cottage

The incoming electrical supply, service head, and meter are located within a proprietary cabinet that is fitted to the right-hand side external wall of the garage. The incoming supply is a single phase 100amp supply. There is evidence of earth bonding. The visible wiring is in PVCu sheathed cable.

The consumer unit is fitted at high-level on the right-hand side external wall of the kitchen. The consumer unit is fitted with miniature circuit breakers and RCD protection is provided. There are no spare ways within the consumer unit.

We understand that the property is let presently and it is anticipated that an NICEIC electrical test Certificate will be available for the electrical installation. We would recommend that your legal advisers make enquiries to obtain a copy of this Certificate. If a copy of the test Certificate is not available, we would recommend that the electrical installation to the property is inspected and tested by a suitably qualified NICEIC Approved Electrical Engineer and that any recommended remedial or upgrading works are carried out.

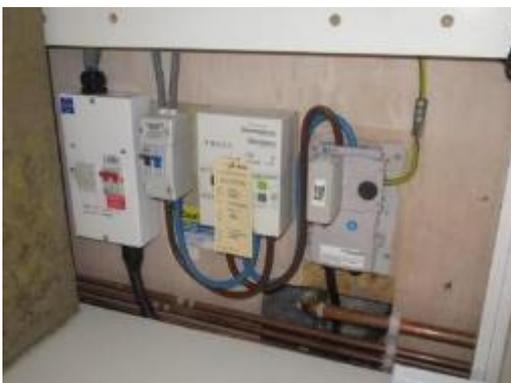
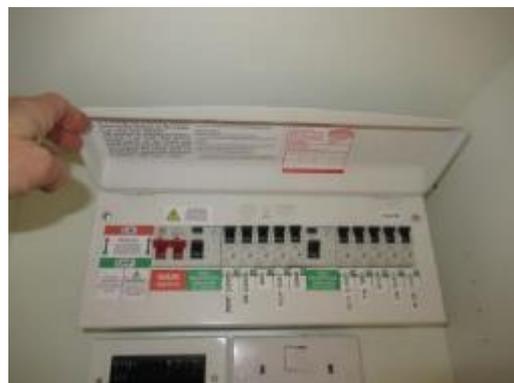
Cow Shed

The incoming electrical supply, service head, and meter are located within a cupboard in the kitchen next to the cooker. The incoming supply is a single phase 80amp supply. There is evidence of earth bonding. The visible wiring is in PVCu sheathed cable.

The consumer unit is located at high-level within a cupboard to the rear of the kitchen. The consumer unit is fitted with miniature circuit breakers and RCD protection is provided. There are no spare ways in the consumer unit.

The property is let presently and it is anticipated that a current NICEIC electrical test Certificate will be available for the installation. We would recommend that your legal advisers make enquiries to obtain a copy of the current NICEIC electrical test Certificate for the property. If this is not available, we would recommend that the electrical installation to the property is inspected and tested by a suitably qualified NICEIC Approved Electrical Engineer and that any recommended remedial or upgrading works are carried out.

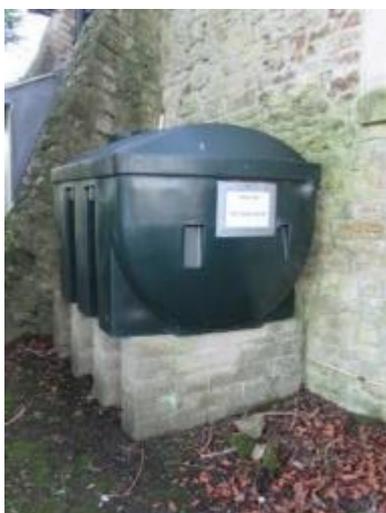
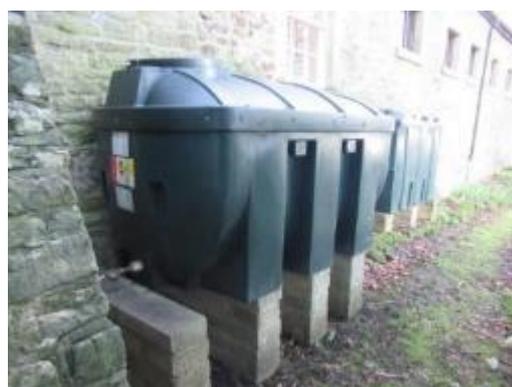
The central heating is oil fired. The storage tank for the heating system is located to the left-hand side external wall of the main house. The oil tank is a double bunded plastic tank and is sited on a stand that is constructed with concrete blockwork plinths with a concrete paving flag base over.

The location of the oil tank does not appear to comply with the current Regulations. The Regulations are not retrospective, but we would recommend that the oil tank installations throughout the property are inspected by a suitably qualified OFTEC Registered Engineer. It is possible that some remedial works may be required.

We would recommend that your legal advisors make enquiries to obtain the current Oil Test Certification for the property. If this is not available, we would recommend that the oil installations throughout the property are tested and inspected by a suitably qualified OFTEC Registered Engineer.

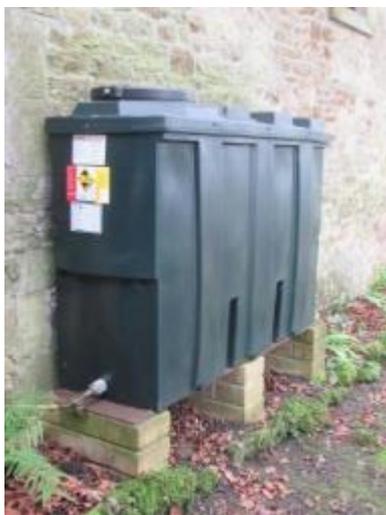
The central heating boiler is oil fired. There is a double bunded plastic oil tank located to the rear elevation of the property. This is mounted on concrete plinths with a metal sheet over to support the oil tank. The oil tank appears to be a relatively recent installation and is generally in satisfactory condition.

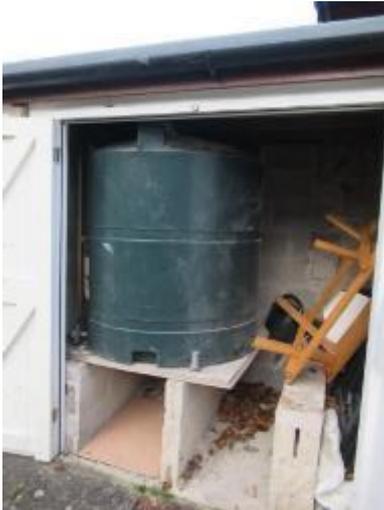
Chapel Cottage

The central heating system is oil fired. The oil tank that supplies the central heating boiler is located within a small plant room to the rear of the garage. The oil tank is sited on a stand that is constructed with concrete blockwork plinths with a timber deck over. The tank is a double bunded plastic tank. The oil tank installation appears to be in satisfactory condition.

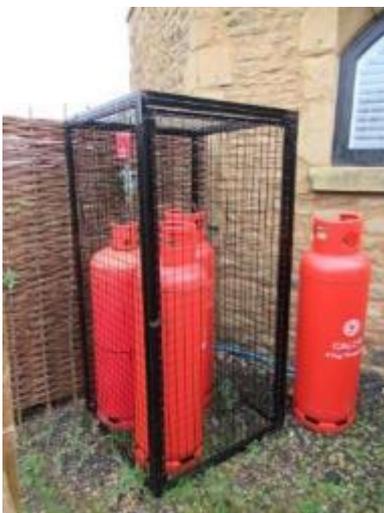
Cow Shed

Gas for the central heating system and cooker is supplied by means of bottled propane gas. The gas bottle installation is located within a purpose-built wire cage to the rear elevation of the property. The installation appears to be relatively recent and generally in satisfactory condition.

We would recommend that your legal advisers make enquiries to obtain a copy of the current gas test certification for the property. If this is not available, we would recommend that the gas installations throughout the property are inspected and tested by a suitably qualified Gas Safe Registered Engineer.

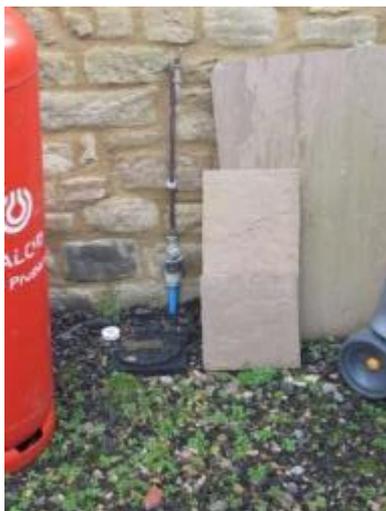
The incoming water supply and stop valve are located at the base of the rear elevation of the property.

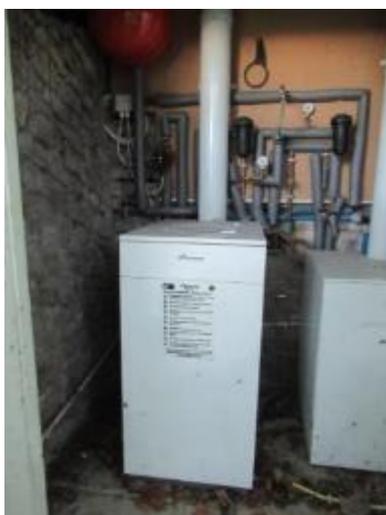
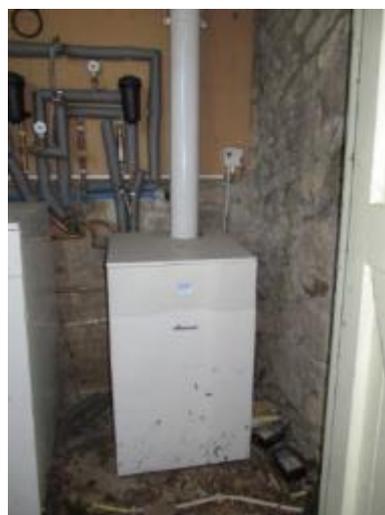
The central heating is provided by means of the floor mounted, oil fired, boilers that are located within the plant room to the left-hand side elevation of the property. The boilers were operating at the time of our inspection and appear to be effective and provide adequate levels of heating to the property.

We noted no obvious defects or significant disrepair to either the boilers or the associated pipework and controls where these were visible.

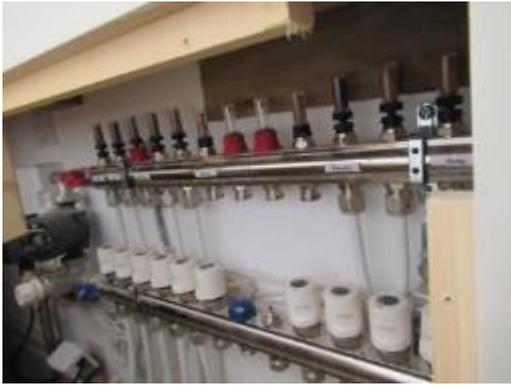
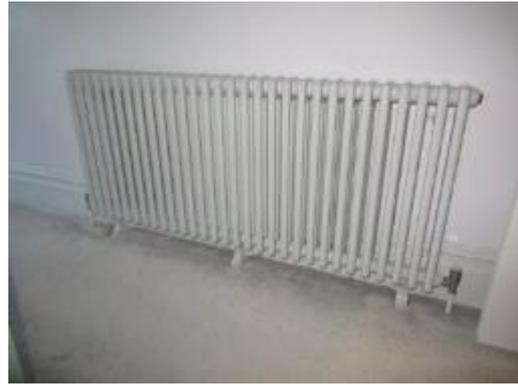
The boilers serve a range of modern metal column radiators to the first floor. Heating to the ground floor is provided by means of a wet underfloor heating system. The manifolds for the heating system are located within the understairs cupboard.

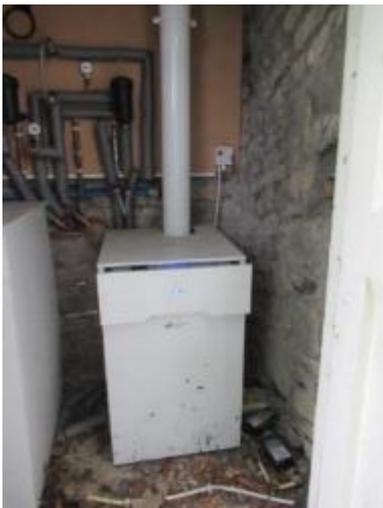
Flat/Annex

The central heating is provided by the floor mounted, oil fired, combination boiler that is located within the plant room to the left-hand side elevation of the Coach House. The boiler was operating at the time of our inspection and appears to provide adequate levels of heating to the property. The boiler installation appears to be relatively recent and we noted no obvious defects or significant disrepair to either the boiler or the associated pipework and controls where these were visible.

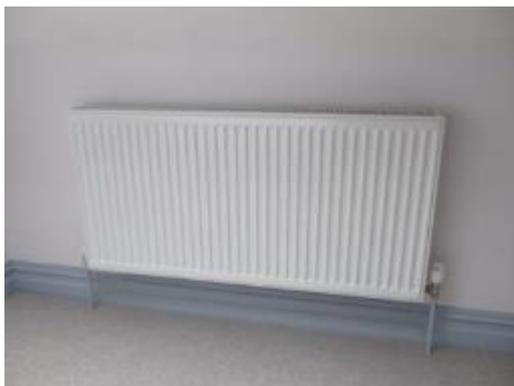
The boiler serves a range of modern metal panel radiators located throughout the property. These are generally in satisfactory condition.

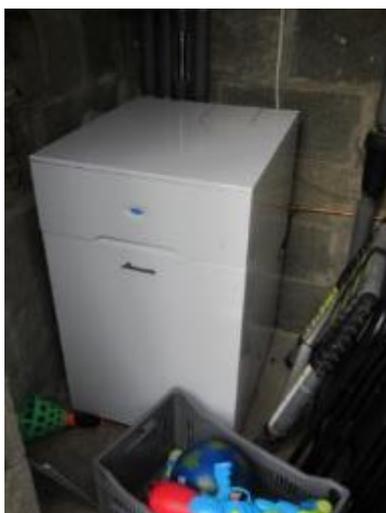
Chapel Cottage

The central heating is provided by the floor mounted, oil fired, combination boiler that is located within the plant room to the rear of the garage. The boiler was not operating at the time of our inspection and we cannot therefore comment on its effectiveness. The boiler installation appears to be relatively recent and we noted no obvious defects or significant disrepair to the boiler or the associated pipework and controls where these were visible.

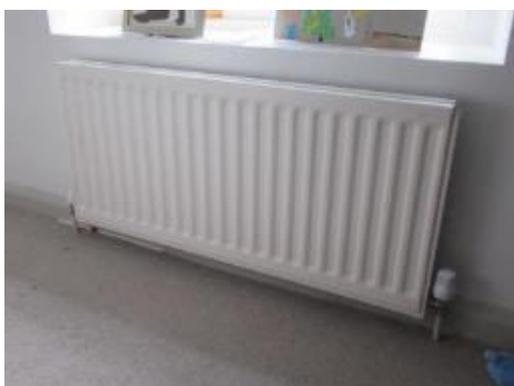
The boiler serves a range of modern metal panel radiators located throughout the property. These are generally in satisfactory condition.

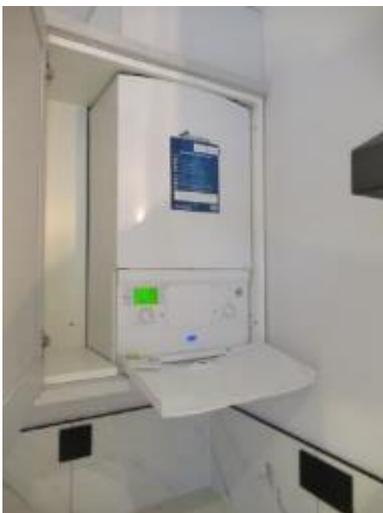
Cow Shed

Heating to the property is provided by means of the wall mounted, gas fired, combination boiler that is located within a cupboard on the rear internal wall of the kitchen. The boiler was not operating at the time of our inspection and we cannot therefore comment on its effectiveness.

The boiler installation appears to be relatively recent and we noted no obvious defects or significant disrepair to either the boiler or the associated pipework and controls where these were visible.

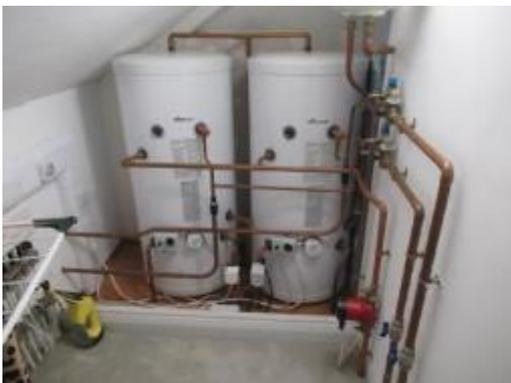
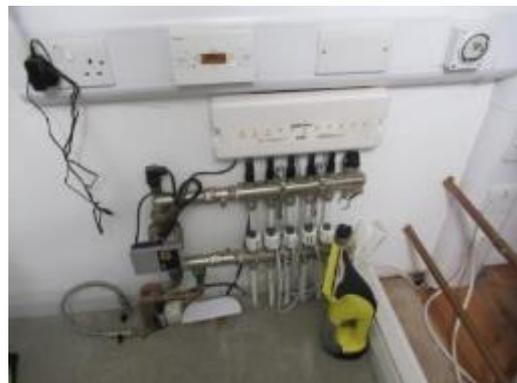
Hot water is supplied from the unvented hot water cylinders that are located within a cupboard off the master bedroom. The hot water cylinders are each provided with integral insulation jackets. The hot water cylinder installation appears to be relatively recent and is generally in satisfactory condition.

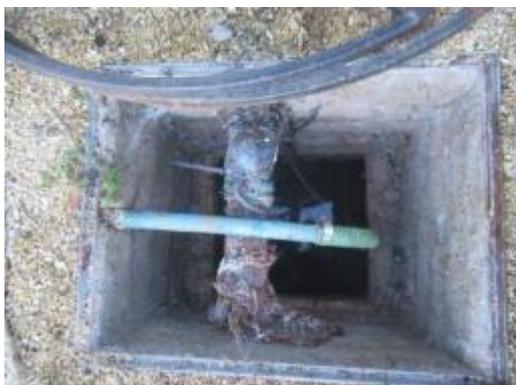
The property is connected to a cesspit. The cesspit is located within the walled garden area to the rear of the property. We are advised that the cesspit is emptied annually and that invoices are available to confirm this.

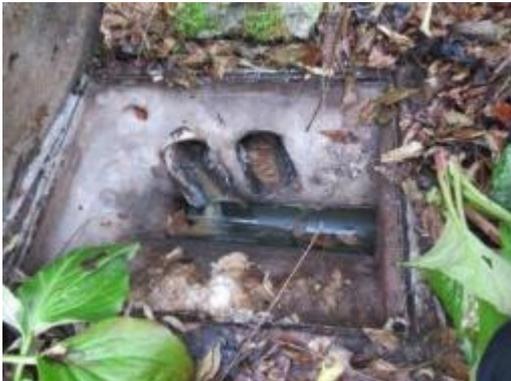
There are three inspection chambers located at the base of the front elevation of the property. We were able to lift the cover to the inspection chamber to the left-hand side of the elevation. The inspection chamber is constructed in solid masonry and the benching is formed in cement mortar. The drainage pipework is PVCu. A metal frame and cover are fitted. A quantity of effluent was noted within the inspection chamber. We would recommend that the drains are rodded and flushed through to confirm that they are operating effectively.

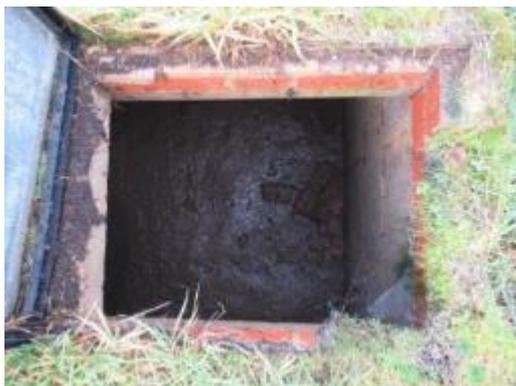
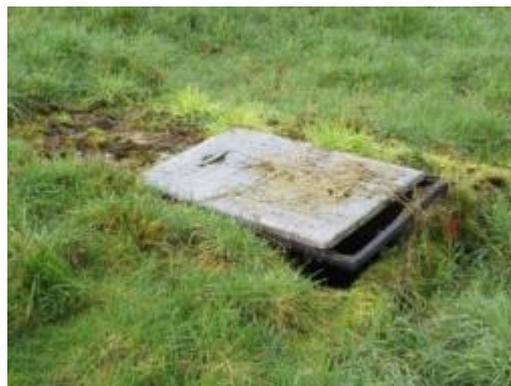
Cow Shed

The property is connected to a cesspit that is located to the rear of the property. A quantity of debris was noted within the cesspit and the cover is loose and displaced presently. This presents a risk to health and safety. We would recommend that the cover to the cesspit is repaired and reinstated.

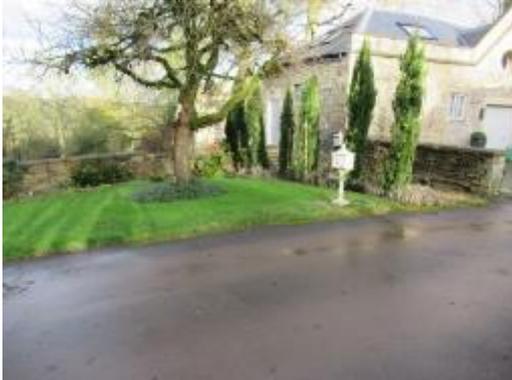
The courtyard area is bounded to the left-hand side by the front elevation of the Annexe. The front and right-hand side boundaries are formed with solid masonry walls that are constructed in random rubble stonework with a stone coping over. A number of areas of loose and displaced stonework were noted and there are a number of areas of defective pointing. We would recommend that any areas of loose and displaced stonework are

There is a small garden area to the front of the courtyard. This is mainly laid to lawn with a mature tree to the centre of the lawn and decorative borders to the perimeter.

repaired and re-bedded as required and that any areas of defective pointing are raked out and repointed.

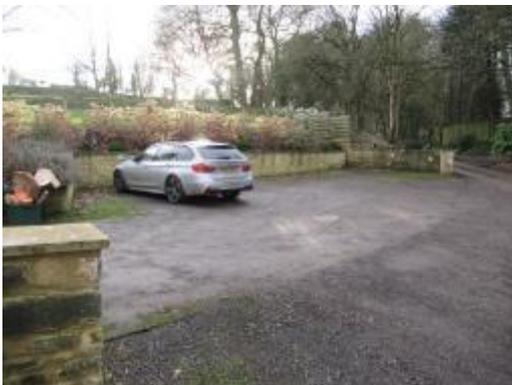
There is a shared parking area to the right-hand side of the main entrance driveway. The parking area is bounded by a solid masonry wall that is constructed in reconstituted stone blockwork with a concrete coping over. The parking area is surfaced in compacted MoT Type One. The masonry is weather stained, but the wall is of relatively recent construction and is in satisfactory condition. Some degradation was noted to the surfacing and some isolated repairs are required, but the parking area is generally sound.

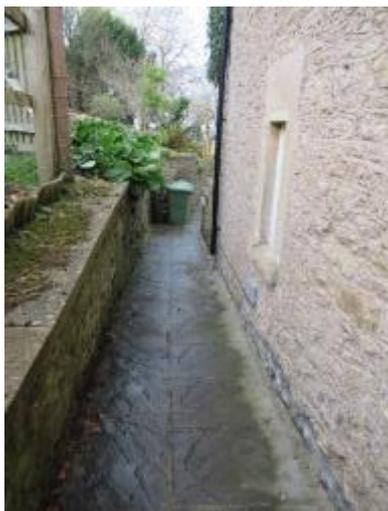
Access to the rear garden is controlled by means of a timber paling type gate. The finish to the timber is denatured, but the gate is otherwise sound.

There is a pedestrian path at the base of the right-hand side elevation of the property. This is surfaced with riven stone paving flags. The surface of the paving is weather stained, but it is otherwise sound.

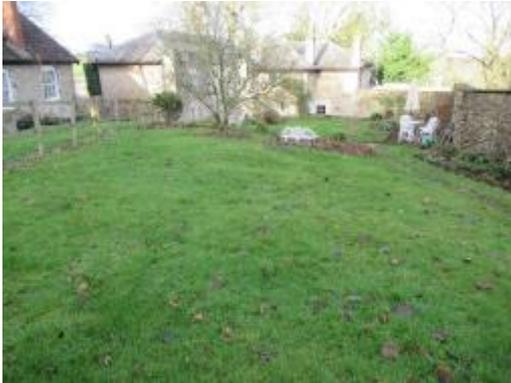
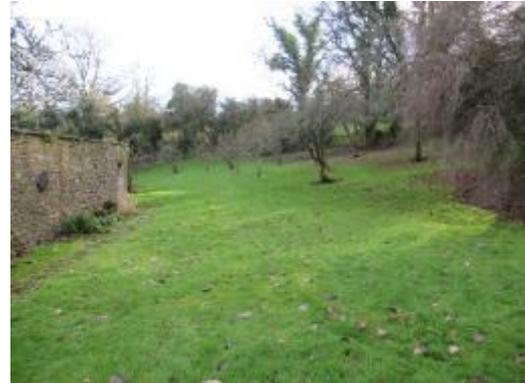
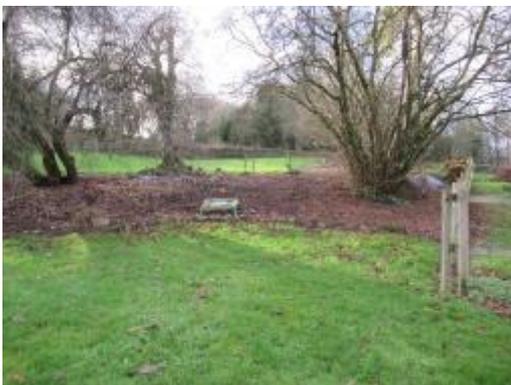
The rear garden is bounded by the wall of the Walled Garden. This is constructed in solid masonry with random rubble stonework and a stone coping over. A number of areas of loose, displaced, and otherwise defective stonework were noted and there are a number of areas of defective pointing. We would recommend that any areas of loose, displaced and defective stonework are repaired and re-bedded as required and that any areas of defective pointing are raked out and repointed.

The garden area is raised above the ground floor of the property and is retained by solid masonry walls. These are constructed as described for the Walled Garden and are in similar condition. We would recommend that any areas of loose, displaced and defective stonework are repaired and re-bedded as required and that any areas of defective pointing are raked out and repointed.

The majority of the garden is laid to lawn. This is generally level and flat. There are pedestrian paths running across the lawn areas that are surfaced with loose laid random paving flags. The paths are in fair condition only and some repairs are required.

There is an orchard to the south of the rear garden. This is grassed and planted with a range of mature fruit trees. The orchard is bounded by timber post and rail fences. These are in satisfactory condition. There is also a further grassed area to the west of the orchard that is presently used as a children's play area.

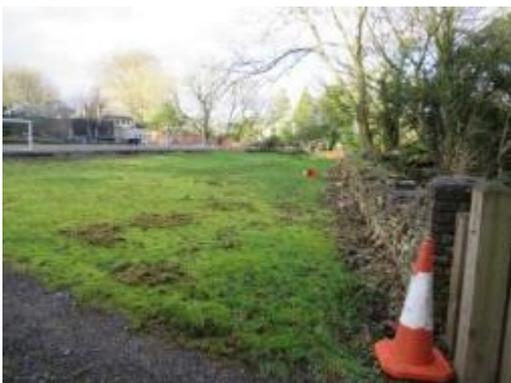
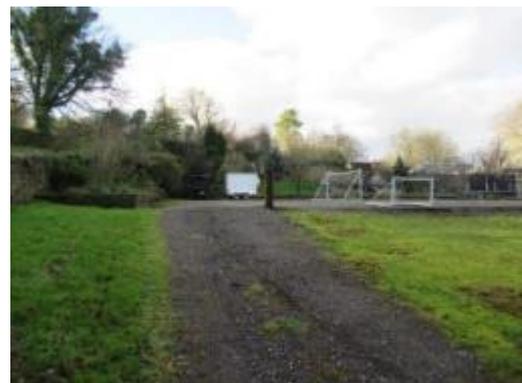
The Walled Garden

There is a walled garden to the rear of the main house. The walls to the garden are constructed in a combination of random rubble, coursed dressed stonework and face brickwork. A stone coping is provided to the stonework sections of the wall. The main wall to the rear of the main house is largely intact and is generally sound, although some maintenance and repair works are required as described above. However, the remaining

boundary walls to the walled garden are in a very poor state of repair and require complete reconstruction.

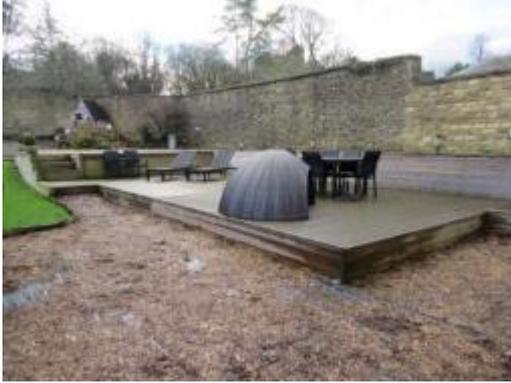
There is an area of timber decking at the base of the front wall to the walled garden. This appears to be a relatively recent installation and although the decking is weather stained the decking area appears to be generally sound.

We are advised that there is a swimming pool beneath the decking area, although this is clearly not in use presently and it is anticipated that significant refurbishment works would be required to reinstate the swimming pool.

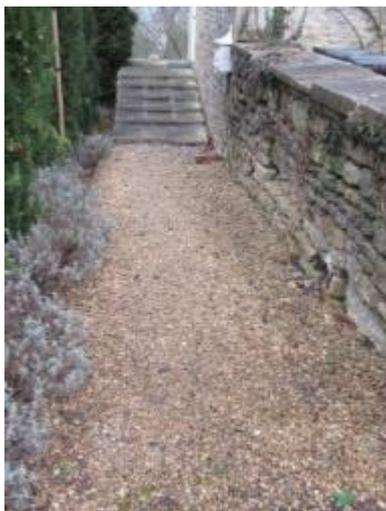
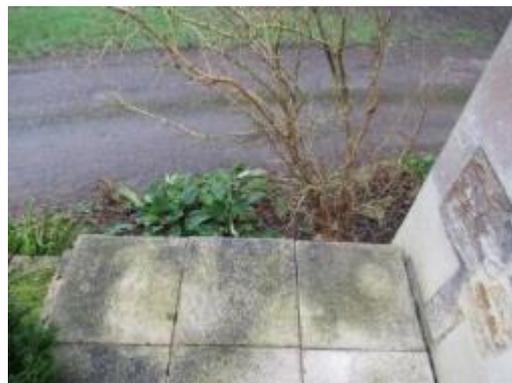
Access to the property is by means of a shared driveway and a pedestrian path provides access from the driveway to the front external door of the property. The path is surfaced in decorative stone chippings. A set of steps are provided at the left-hand side elevation of the property. These are surfaced in concrete paving flags. The surface of the paving flags is weather stained, but the steps are otherwise and serviceable.

No balustrade or handrail are provided to the landing area or the steps. This presents a slight risk of falls from the landing area. We would recommend that consideration be given to the installation of a handrail and balustrade.

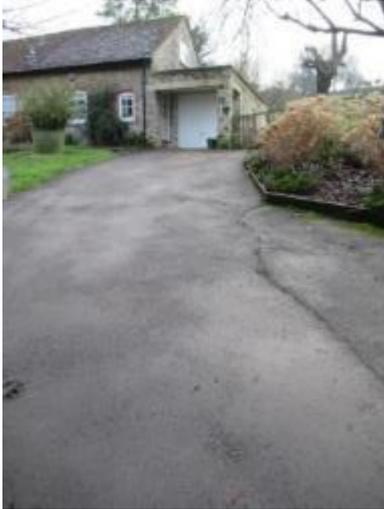
There is a driveway to the right-hand side of the front garden. The lower part of the driveway is shared. The driveway is surfaced in asphalt. The surface of the driveway undulates slightly and a number of slight cracks and construction joints were noted. The driveway surface is sound and serviceable presently, but is anticipated that some local repair works will be required in the short to medium term.

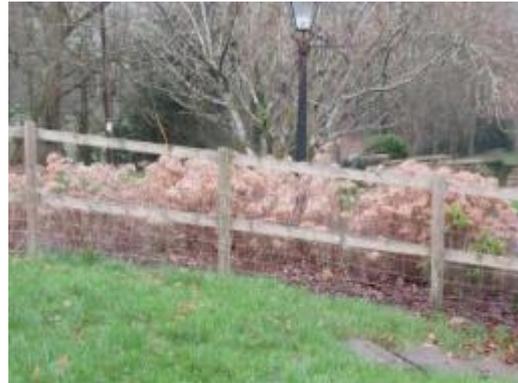
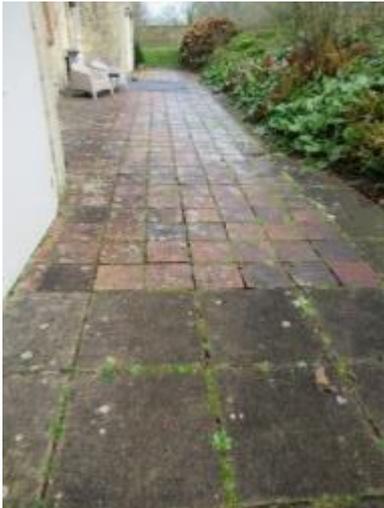
There is a hardstanding area at the base of the rear elevation of the property. This is surfaced in a combination of plain concrete and terracotta paving flags. The surface of the paving is generally out of level and uneven and some vegetation growth was noted to the joins in the paving. The surface of the paving is weather stained generally, but it is otherwise sound and serviceable.

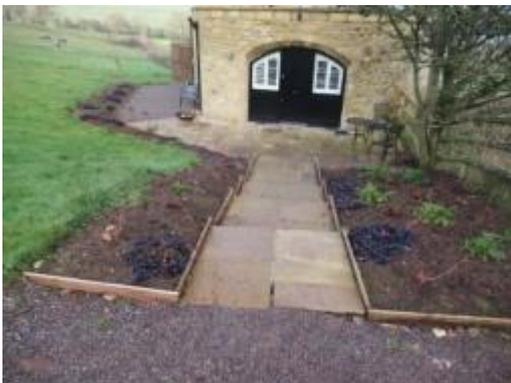
There is a set of steps to the front of the property that provide access from the access track to the front elevation of the property. These are surfaced in riven stone paving flags. Two of the paving flags to the upper step are loose and displaced presently. We would recommend that these are re-fixed and re-bedded. The steps are otherwise sound.

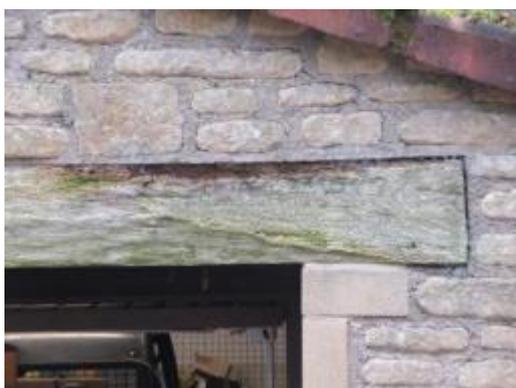
The lintel to the main garage door opening is timber. There is evidence of extensive historic wood boring insect infestation to the outer face of the lintel. The lintel is weather stained and there is also some evidence of previous decay. However, the wood boring insect infestation appears to have been treated previously and is not active presently. There is some evidence of ongoing timber decay to the lintel. We would recommend that any areas of defective timber are cut out and treated. The lintel appears to be sound presently and it should be possible to arrest the decay, but if these works are not carried out it is possible that it would be necessary to replace the lintel completely in the medium term.

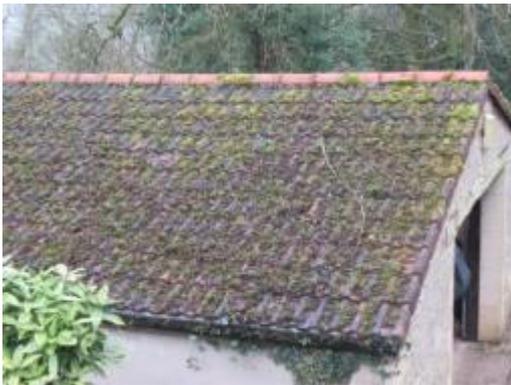
The gutter is half round PVCu with a circular downpipe. A brush leaf guard is fitted. The rainwater goods are soiled and weather stained and the downpipe is displaced presently. This is allowing rainwater to discharge over the face of the external masonry which will lead to water penetration internally in time. We would recommend that the rainwater goods are cleared out, cleaned down, and overhauled with any leaking joints made good as necessary and the displaced downpipe reinstated.

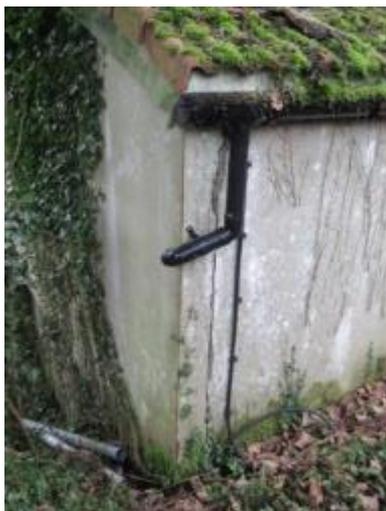
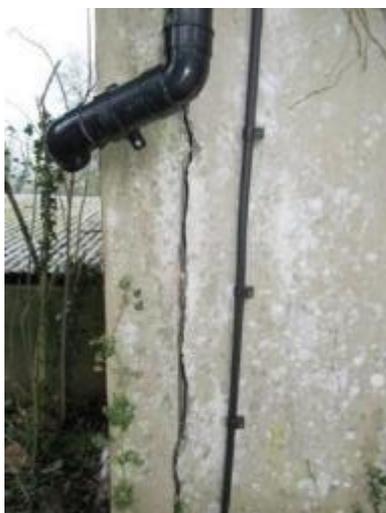
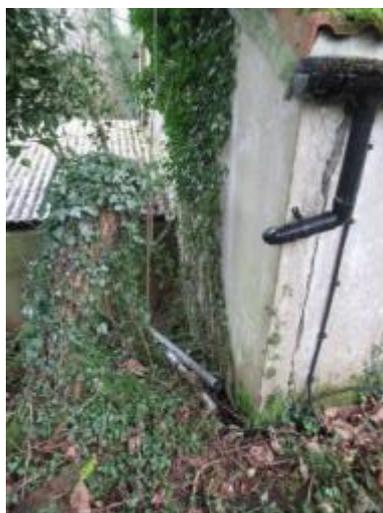
The elevation is constructed in solid masonry with a smooth render finish externally. The masonry is extensively weather stained and a moderate vertical crack was noted to the left-hand side of the elevation. A slight to moderate raking crack was noted internally. This was not visible externally as the rear elevation of the property is largely obscured by ivy growth. It appears that there has been some slight settlement of the foundations to the left-hand side rear corner of the building. This is likely to be a consequence of damage to the foundations by the roots of the trees that are immediately adjacent to the rear elevation of the building and the fact that rainwater is discharging over the face of the masonry and directly onto the soil at the base of the elevation. It is not clear whether the masonry to the rear elevation of the building is properly tied in to the masonry on the side elevation.

We would recommend that the cracks are monitored to confirm whether they are progressive. It is considered likely that it will be possible to introduce remedial ties to the masonry to restrain the block and stonework and arrest any further movement without undertaking significant underpinning works. However, this would depend upon the outcome of the monitoring.

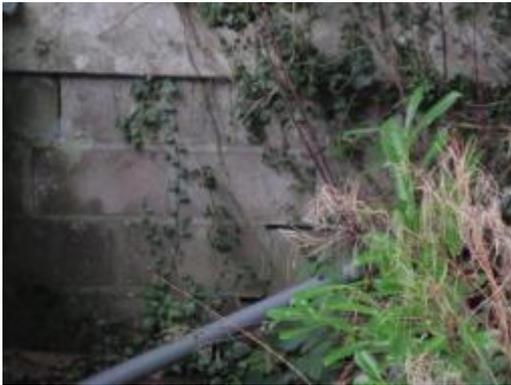
The elevation is constructed as previously described. Slight to moderate raking cracks were noted to the masonry to the right-hand side of the elevation. This is likely to be a consequence of damage to the foundations by the roots of the trees immediately adjacent to the rear elevation of the garage as described previously. We would refer you to our previous comments regarding this issue.

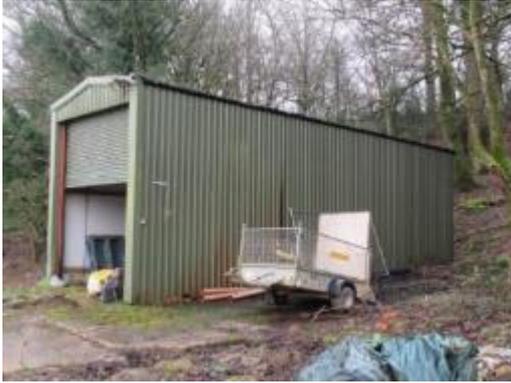
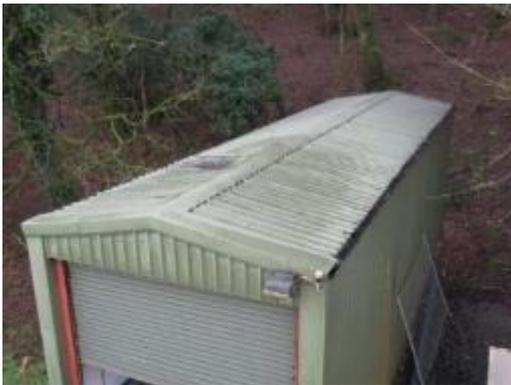
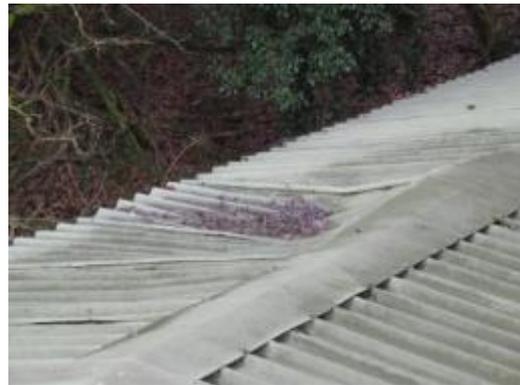
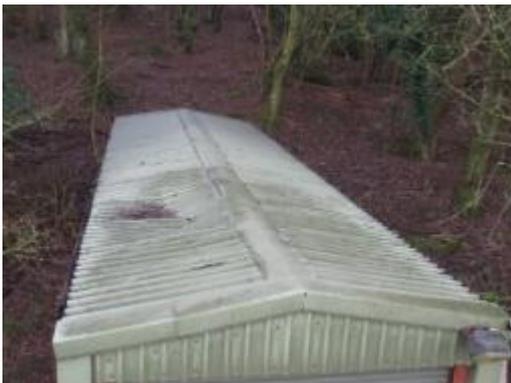
The roof is pitched with a covering of profiled metal sheets and a proprietary metal capping to the ridge. The finish to the profiled metal sheets is denatured and they are heavily weather stained. There is significant mechanical damage to the front part of the left-hand side roof slope. This is likely to be a consequence of a branch from one of the adjacent trees falling onto the roof. We would recommend that the damaged roof sheets are replaced. The roof covering is otherwise sound.

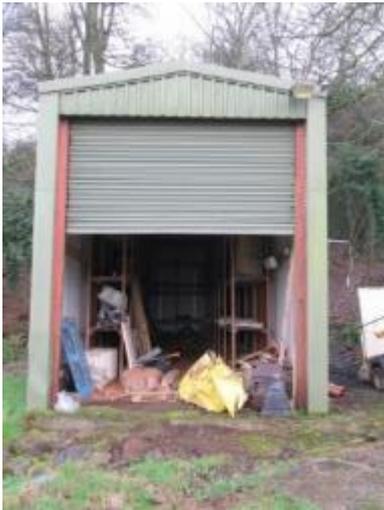
Helicopter Hangar – Front Elevation

An electrically operated roller shutter door is provided. This did not appear to be operating at the time of our inspection and some minor mechanical damage was noted to the lower part of the roller shutter door. The finish to the roller shutter door is denatured and weather stained. It is anticipated that significant maintenance and repair works will be required to the roller shutter door.

The building is of steel frame construction. Some corrosion was noted to the roller shutter doorframe and the steel columns, but this is superficial and is not considered to be significant. We would recommend that any exposed structural members are prepared and redecorated.

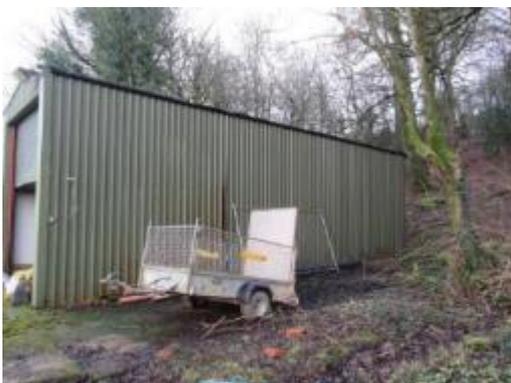
Helicopter Hangar – Right-Hand Side Elevation

The gutter is half round PVCu. A brush leaf guard is fitted to the gutter. The rainwater goods are soiled and weather stained and there is evidence of some leaks to the joints in a

The elevation is constructed with a steel framework with profiled metal sheet cladding externally. The finish to the profiled sheet cladding is denatured and heavily weather stained. Some corrosion was noted in some areas. This corresponds with the leaks to the rainwater goods noted above. We would recommend that the cladding panels are cleaned down and local redecoration works are carried out.

number of locations. We would recommend that the rainwater goods are cleared out, cleaned down, and overhauled with any leaking joints made good as required.

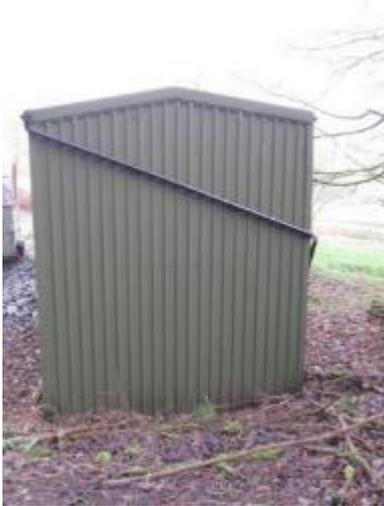
Helicopter Hangar – Rear Elevation

The verge is provided with a proprietary metal capping. This is in satisfactory condition.

The elevation is constructed as previously described. The profiled metal sheet cladding is soiled and weather stained, but is otherwise sound.

The rainwater downpipe traverses the elevation. This is in satisfactory condition.

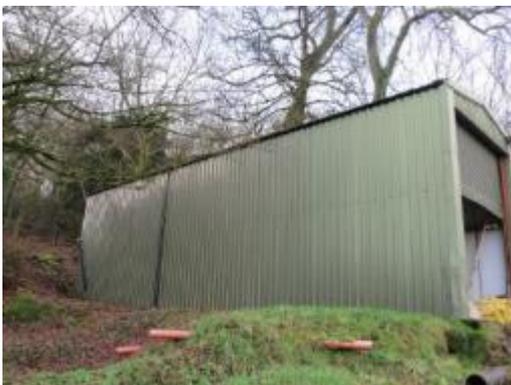
Helicopter Hangar – Left-Hand Side Elevation

The gutter is half round PVCu with a circular downpipe that discharges onto the adjacent ground. A brush leaf guard is fitted. The rainwater goods are soiled and weather stained and there is evidence of some slight leaks to the joints in a number of locations. We would recommend that the rainwater goods are cleared out, cleaned down, and overhauled with any leaking joints made good as necessary.

The rainwater downpipe from the rear elevation discharges onto the adjacent ground at the left-hand side of the left-hand side elevation. The lower part of the rainwater downpipe is missing and rainwater is presently discharging over the face of the profiled metal sheets. We would recommend that the rainwater downpipe is extended.

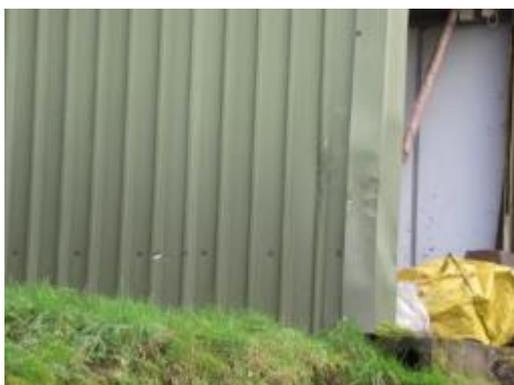
The elevation is constructed as previously described. The finish to the profiled metal sheet cladding is denatured and weather stained and some mechanical damage was noted to the profiled metal sheets and the corner capping to the right-hand side of the elevation. We would recommend that the damaged sheets and cappings are replaced as required.

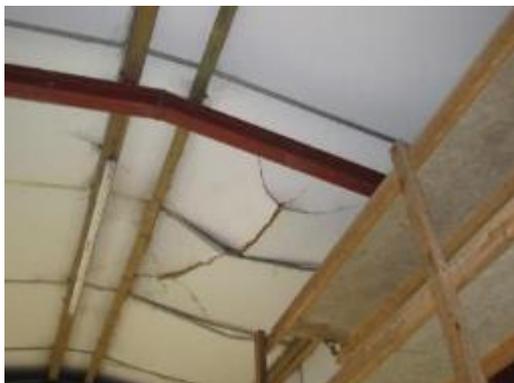
Insulated cladding panels are provided to the soffit of the roof. These are soiled generally and some mechanical damage was noted to the panels beneath the section of damaged roofing. We would recommend that these are replaced.

The walls are provided with insulated cladding panels. The helicopter hangar is presently being used for log storage, and there is significant mechanical damage to the cladding panels, particularly at low level. We would recommend that consideration be given to providing protection to the cladding panels to minimise further damage.

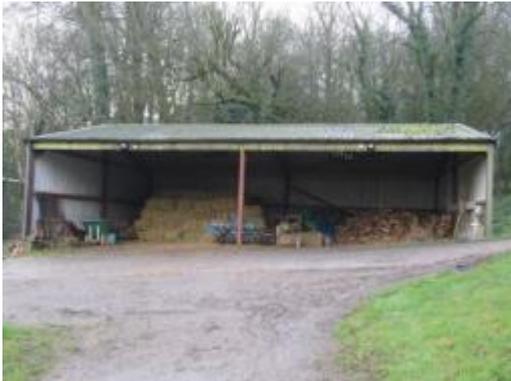
Small Barn

The roof is pitched with a covering of profiled metal sheets with a proprietary metal capping to the ridge. The finish to the profiled metal sheets is denatured and they are extensively weather stained. Significant moss growth was noted to the rear roof slope. The roof to the barn is in fair condition only and there is evidence of water ingress internally through the fixings to the cladding sheets. Some mechanical damage was noted to the verge cappings to the right-hand side rear roof slope. We would recommend that the roof is cleared off and cleaned down and that the fixings and caps to the roofing sheets are replaced to minimise the possibility of water ingress through the roof covering.

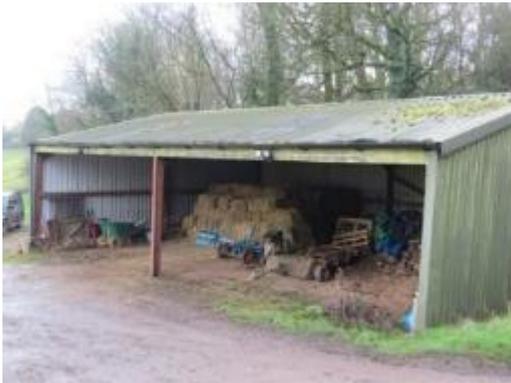
Small Barn – Front Elevation

The gutter is half round PVCu with a circular downpipe that discharges into an open gully which appears to discharge onto the adjacent ground within the wooded area behind the barn. A brush leaf guard is fitted. The rainwater goods are heavily soiled and weather stained and there is evidence of some slight leaks to the joints in a number of locations. We would recommend that the rainwater goods are cleared out, cleaned down, and overhauled with any leaking joints made good as necessary.

The lintels to the bays are timber. The finish to the timber is denatured and the beams are heavily weather stained, but they are otherwise sound.

The barn is of steel portal frame construction. Some corrosion was noted to the surface of the majority of the steel members, but this is not considered to be significant. We would recommend that the steel work is prepared and redecorated. The steel frame is otherwise sound.

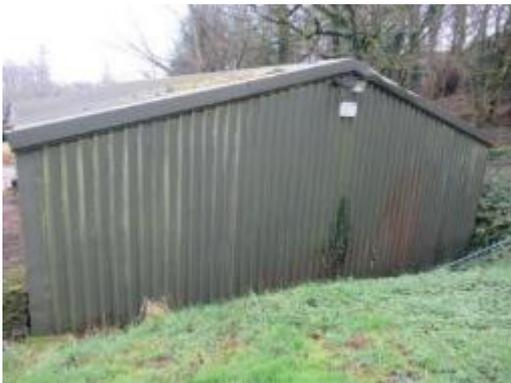
Small Barn – Right and Left-Hand Side Elevations

The verge capping to the right-hand side elevation is damaged as previously described. We would recommend that the damaged sections of capping are replaced.

The elevations are provided with profiled metal sheet cladding. The finish to the profiled metal sheet cladding is denatured and heavily weather stained. Some minor areas of mechanical damage were noted to the cladding sheets to the left-hand side elevation. There is evidence of corrosion internally to a number of the cladding panels, particularly on the right-hand side elevation. This is largely a consequence of the fact that the external ground levels are noticeably above the base of the elevation. The cladding panels are serviceable presently, but it will be necessary to undertake some replacements in the medium term.

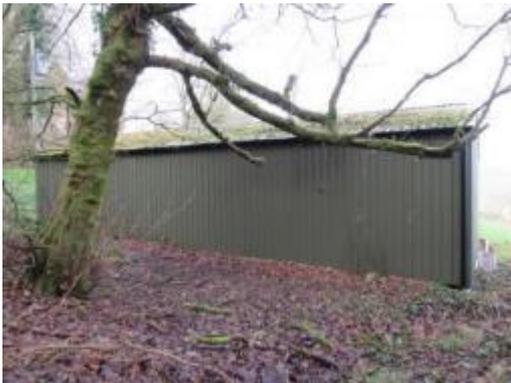
Small Barn – Rear Elevation

The gutter is half round PVCu with a circular downpipe that discharges into an open gully. A brush leaf guard is fitted. The rainwater goods are soiled and weather stained and there is evidence of some slight leaks to the joints in a number of locations. We would recommend that the rainwater goods are cleared out, cleaned down, and overhauled with any leaking joints made good as necessary.

The elevation is constructed as previously described. The finish to the cladding panels is weather stained and denatured and some minor mechanical damage was noted to the right-hand side of the elevation, but the elevation is otherwise sound.

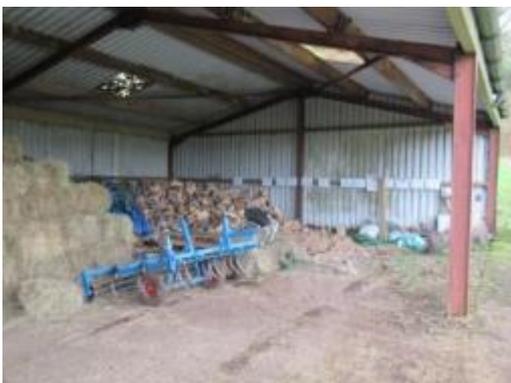
Small Barn – Internal

The cladding rails and purlins are timber. As noted above, there is evidence of water ingress internally through the fixings to the roof cladding panels and there is some water staining to a number of the purlins. The purlins and cladding rails are sound and serviceable presently, but if the water ingress to the roof covering is not addressed in the near future this will lead to decay to the purlins and a loss of structural strength.

The internal face of the cladding panels is heavily soiled and weather stained and as noted above, there is some corrosion to the lower part of the panels on the right-hand side elevation.

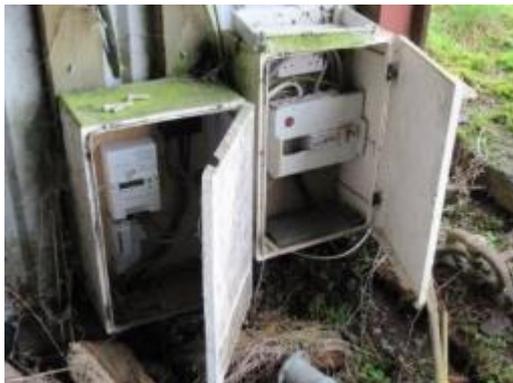
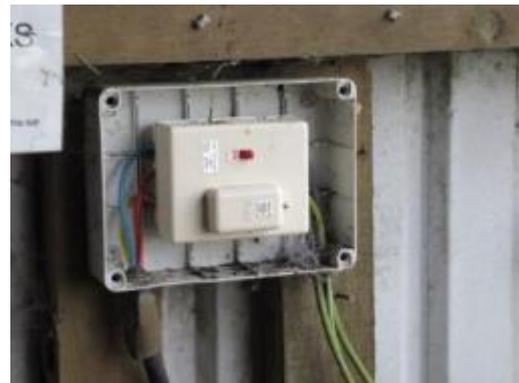
The incoming electrical supply, service head, meter and consumer units are located within proprietary cabinets that are fixed to the right-hand side internal wall of the barn. The incoming supply is a single phase 100amp supply. There is evidence of earth bonding. The visible wiring is in PVCu sheathed cable.

The consumer unit is fitted with miniature circuit breakers, but no RCD protection is provided. There are a number of spare ways in the consumer unit. Significant corrosion was noted to the consumer unit housing and the electrical installation appears to be in a slightly dilapidated condition generally. We would recommend that the electrical installation to the barn is inspected and tested as part of the overall inspection of the electrical installations to the property.

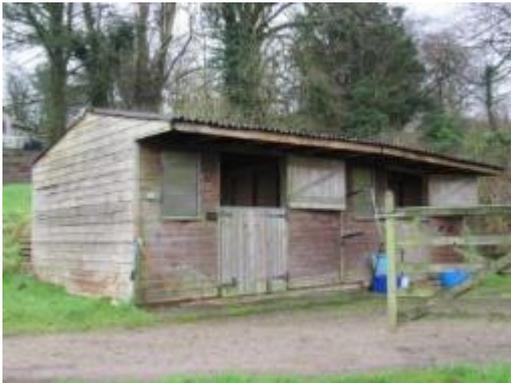
Small Stable Block

The roof to the stable is pitched with a covering of bitumen-fibre profiled sheets with profiled plastic rooflights. A proprietary capping is provided to the ridge. Significant deflection was noted to the ridge capping and the roof panels. This is likely to be a consequence of distortion caused by sunlight. There is evidence of some water ingress internally. The roof covering is in fair condition only.

No rainwater goods are provided and the rainwater is presently discharging over the face of the rear elevation of the building. This is causing some decay to the timber cladding.

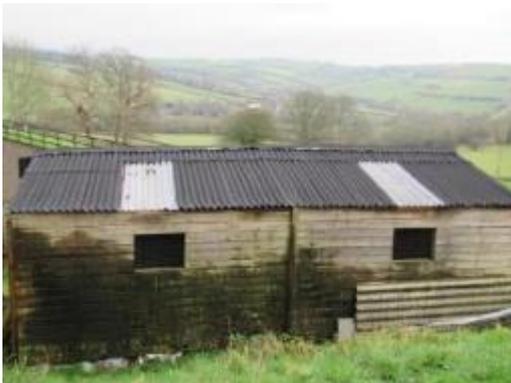
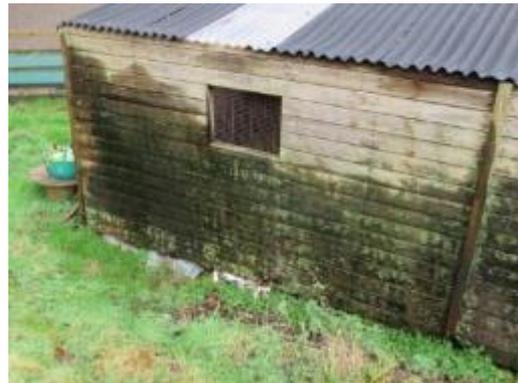
The stable block is of timber frame construction with timber shiplap type cladding externally. The finish to the timber cladding is extensively weather stained and denatured and some areas of defective timber were noted, particularly to the rear elevation.

Ledged and braced timber plank type stable doors are provided to the front elevation. These are heavily weather stained, but appear to operate satisfactorily.

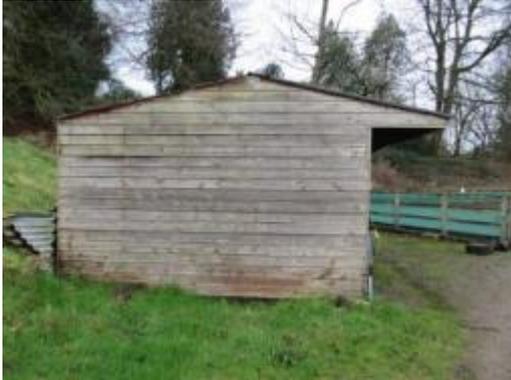
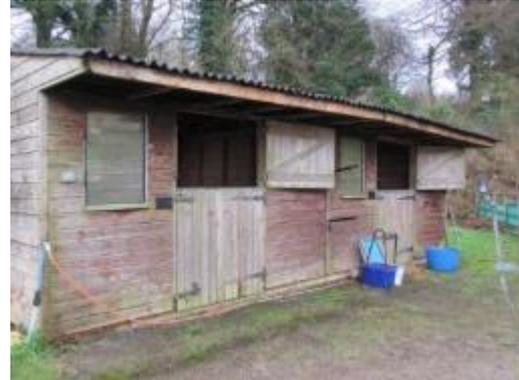
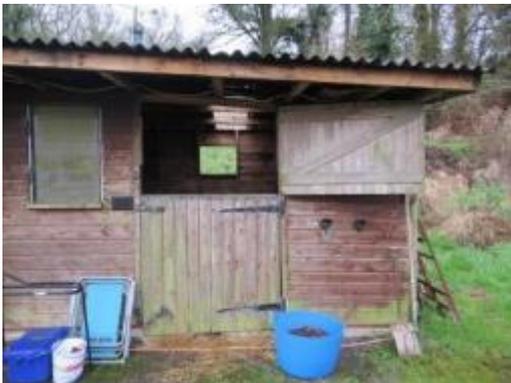
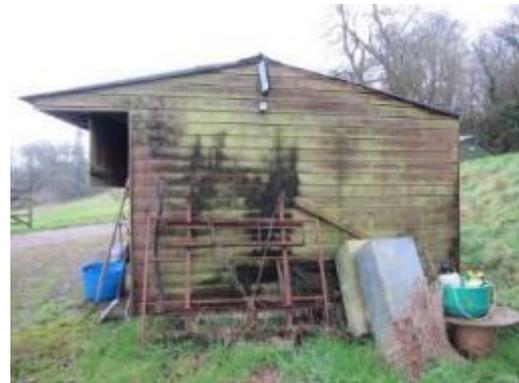
The stable block is constructed on a concrete hardstanding. Significant cracks were noted to the concrete hardstanding. It is likely that there has been some settlement of the sub-base.

The stable block is in a dilapidated condition generally and significant maintenance, repair, and redecoration works are required.

The settlement of the sub-base has caused some deflection of the roof covering and the structural frame to the right-hand side of the front elevation.

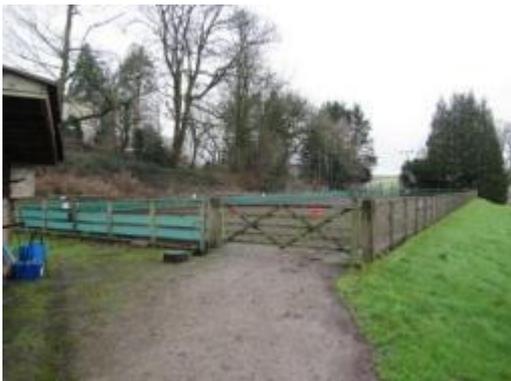
Ménage

The ménage is enclosed with a timber post and horizontal rail fence. The fence is in fair condition only. The timber is extensively weather stained and denatured and significant areas of defective timber were noted, particularly to the gravel boards. A number of the posts are loose and displaced. The fence is serviceable presently, but significant maintenance and repair works are required in the short to medium term.

The ménage is surfaced with a combination of sand and rubber chippings. The surface of the ménage is generally level and flat and it appears to be reasonably well drained.

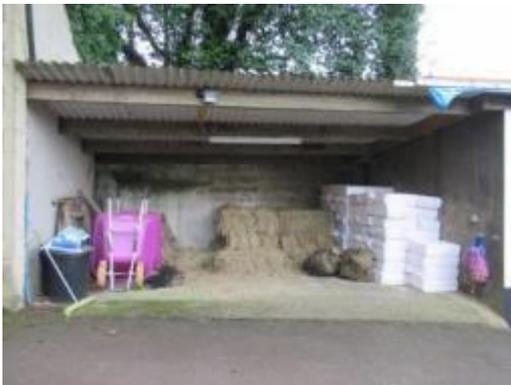
Feed Store

The roof is a shallow pitched roof with a covering of profiled metal sheets supported on timber rafters that span across the width of the building. The roof covering is heavily soiled and weather stained and is presently supporting a quantity of debris. There is evidence of water ingress internally. We would recommend that the roof covering is cleared off and cleaned down and that the fixings to the cladding panels are sealed to prevent water ingress.

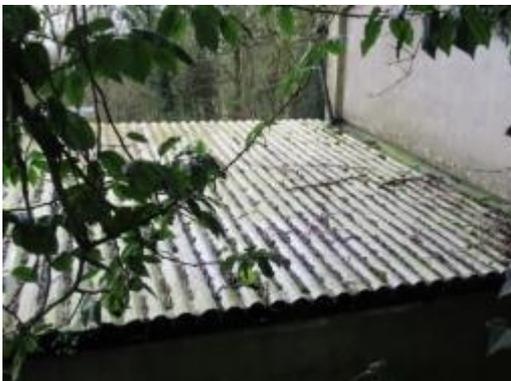
The roof is weathered to the elevation of the adjoining garage with a lead flashing. This is heavily weather stained, but appears otherwise to be sound.

The gutter to the rear of the roof slope is half round PVCu. A brush leaf guard is fitted. The rainwater goods are soiled and weather stained, but appear otherwise to be sound with no evidence of any significant leaks noted.

The majority of the roof structure appears to have been renewed in previous years, but some sections of the original timber rafters remain. Some decay was noted to the older sections of the timber and these will require replacement.
