BUILDING SURVEY

Level 3

This service is delivered in accordance with the Home Survey Standard (1st edition) RICS Professional Statement and is equivalent to Level 3.

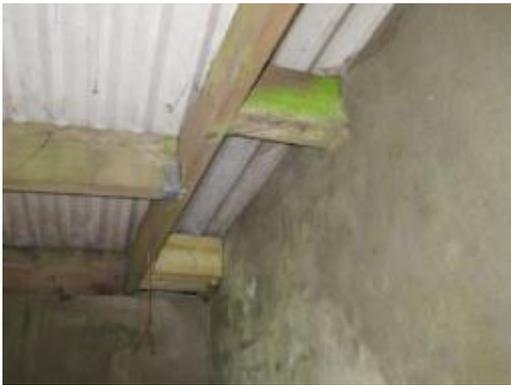
The right-hand side and rear elevations of the building are constructed in solid masonry with a smooth render finish externally. The finish to the render is heavily soiled and weather stained, but the elevations are otherwise sound with no significant cracks noted.

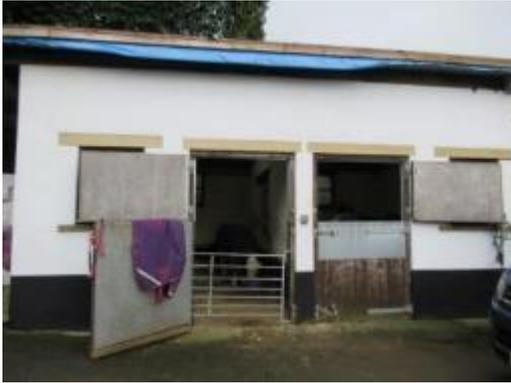
Stables – Centre (Right-hand Side)

The roof is constructed as previously described. However, there has previously been significant water ingress to the roof covering and additional protection has been provided. We are advised that this comprises a single-ply membrane covering that has, in turn, been overlaid with a tarpaulin which is presently restrained with timber battens. While the roof covering appears to be weathertight presently, we would recommend that consideration be given to renewing the roof covering completely in the medium term.

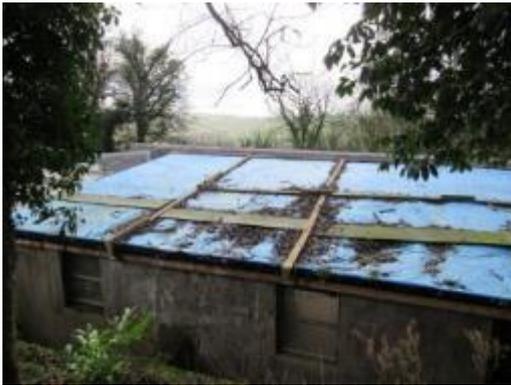
The gutter is half round PVCu with a circular downpipe that discharges into the gutter of the adjacent building. A brush leaf guard is fitted. The rainwater goods are heavily soiled and weather stained and there is evidence of some leaks to the joints in a number of locations. We would recommend that the rainwater goods are cleared out, cleaned down, and overhauled with any leaking joints made good as necessary.

The fascia is timber. The finish to the fascia is denatured, but it is otherwise sound.

The roof covering is supported on timber rafters that span across the width of the building. A number of the rafters are in poor condition with significant areas of decay. Some temporary works have been carried out to strengthen the rafters, but the roof timbers will require replacement in the medium term.

The lintels to the window and door openings appear to be concrete faced with reconstituted stone. These are in satisfactory condition and no cracks or other defects were noted to the masonry that would indicate there are any issues with the lintels.

The windows are timber framed fixed glazed lights. The decorations to the timber frames are in poor condition with extensive areas of flaking and otherwise defective paintwork. We would recommend that the window frames are prepared and redecorated.

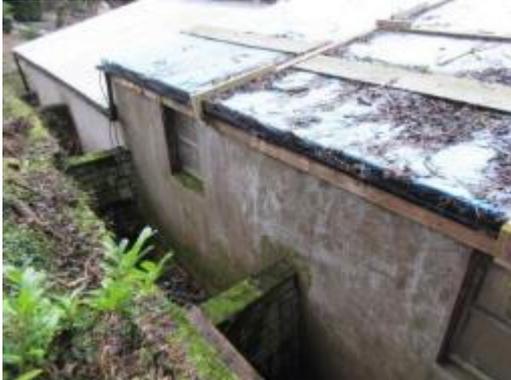
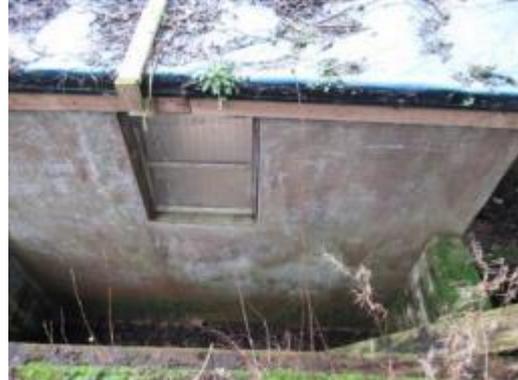
There is evidence of water ingress through the external walls at low level to the rear of the building. The stable block abuts a steep embankment and it is considered likely that surface or ground water is penetrating through the blockwork at low level.

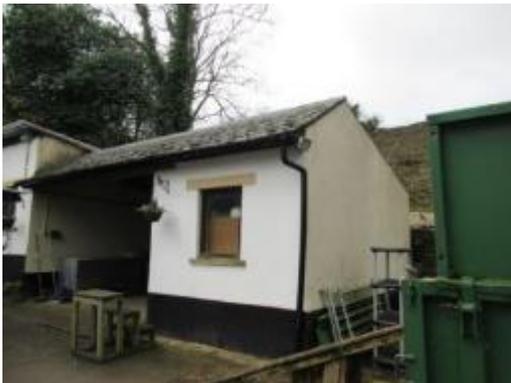
Stables - Blanket Store and Storeroom

The roof is pitched. The front roof slope is provided with a covering of cement-fibre slates. The rear roof slope is provided with a covering of profiled metal sheets. A lead capping is provided to the ridge. Both the front and rear roof slopes are heavily soiled and weather stained and a number of cracked, broken, and slipped slates were noted to the front roof slope. We would recommend that any cracked, broken, or slipped slates are replaced to minimise the possibility of water ingress in these locations.

Significant mechanical damage was noted to the profiled metal sheet roof covering to the right-hand side of the rear roof slope. The area was partly obscured by debris at the time of the inspection, but it appears that there is a hole in the roof covering which will be allowing water ingress. We would recommend that the damaged roof sheets are replaced.

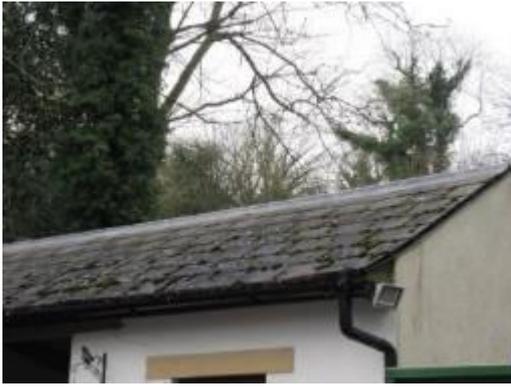
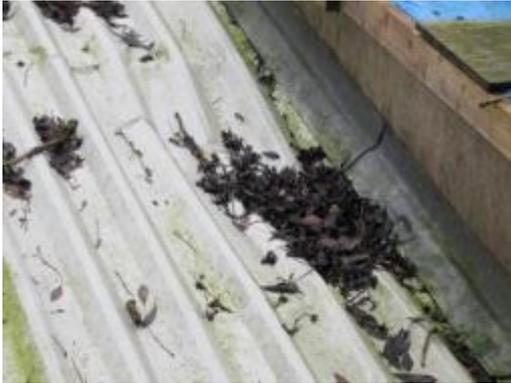
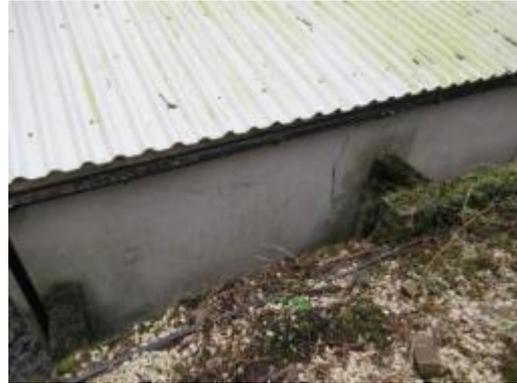
The gutter is half round PVCu with a circular downpipe that discharges onto the adjacent ground. The rainwater goods are soiled and weather stained and there is evidence of some slight leaks to the joints in a number of locations. We would recommend that the rainwater goods are cleared out, cleaned down, and overhauled with any leaking joints made good as necessary.

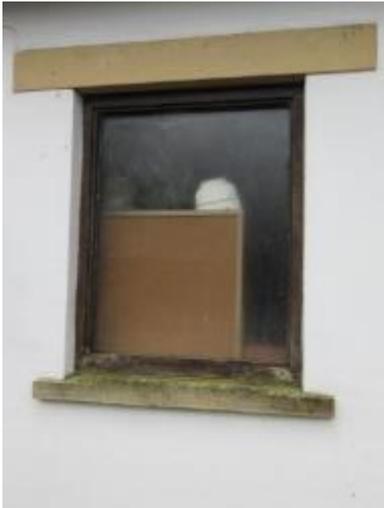
The windows are timber framed fixed glazed lights. The decorations to the window frames are in poor condition with extensive areas of flaking and otherwise defective paintwork. We would recommend that the windows are prepared and redecorated.

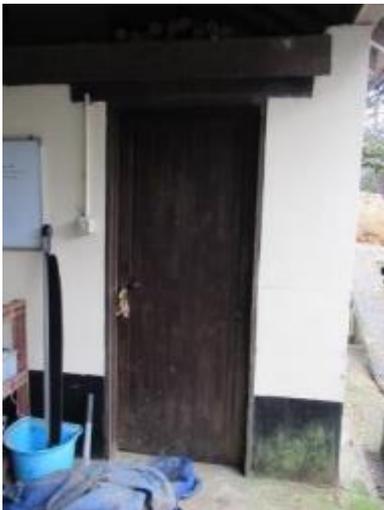
The internal doors are solid timber plank type doors. The decorations to the doors are soiled, but they are otherwise sound.

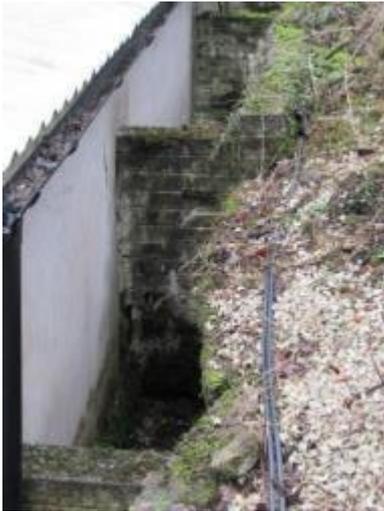
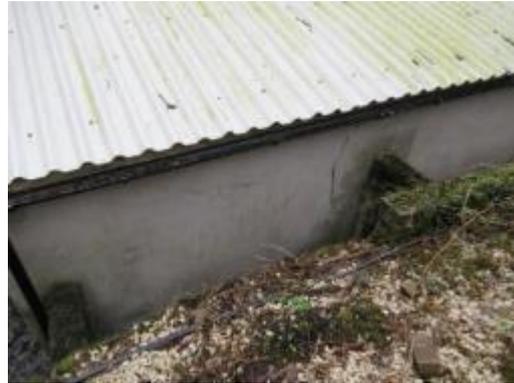
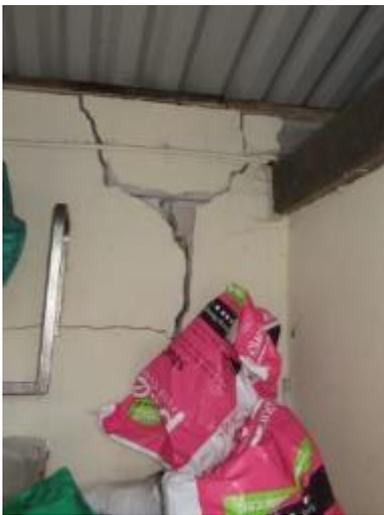
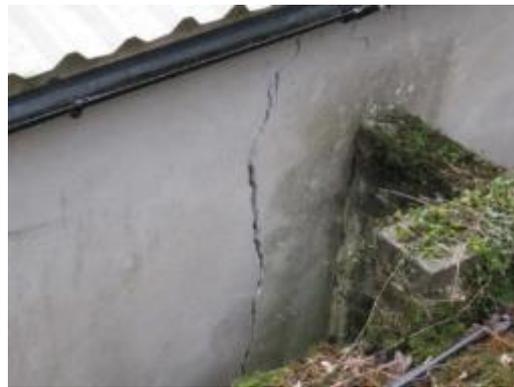
The elevations are constructed in solid masonry with a smooth render finish externally. The front, right-hand side and internal faces of the external walls are painted. The decorations to the render are soiled and weather stained. A very significant vertical crack was noted to the centre of the rear external wall. This appears to be a consequence of some slippage of the earth to the embankment behind the building. This has pushed the concrete blockwork retaining wall into the masonry of the rear external wall. It is considered likely that it will be necessary to carry out significant earthworks to the embankment to stabilise it and subsequently reconstruct both the retaining wall and the external wall of the stable building.

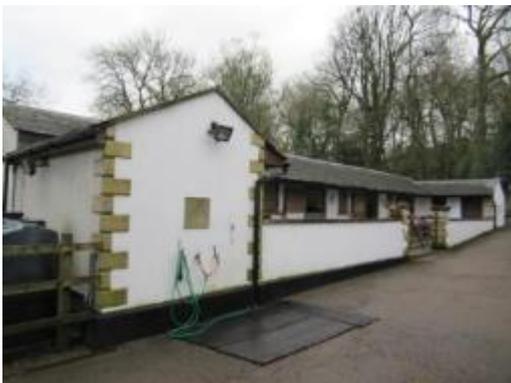
Stable Block (Left-Hand Side)

The roof is pitched with a covering of cement-fibre slates and lead cappings to the ridge. There are two bays to the front elevation, one to each end of the stable block. Some slight deflection was noted to the ridge line, but this was not excessive and is not unusual in properties of this age and type of construction. The roof slopes are generally flat. The roof

coverings are heavily soiled and weather stained and are supporting significant quantities of moss growth. We would recommend that the moss growth is cleared off periodically to avoid a build of debris within the gutters.

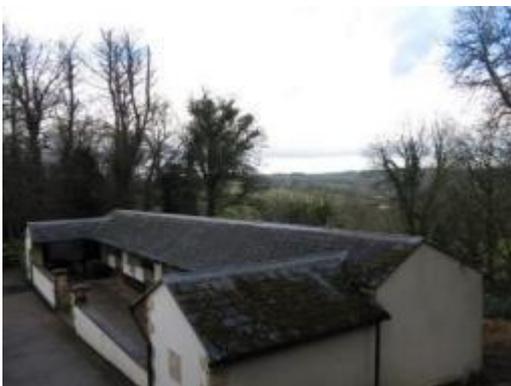
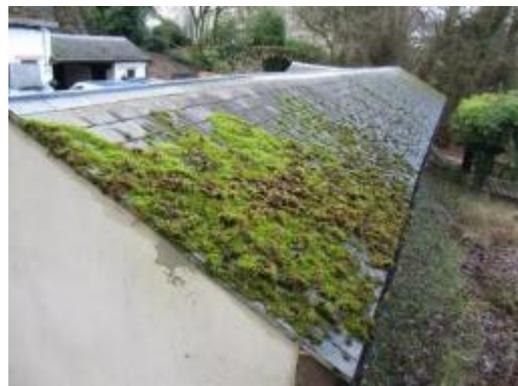
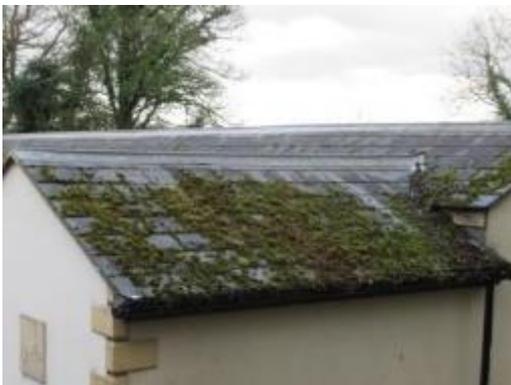
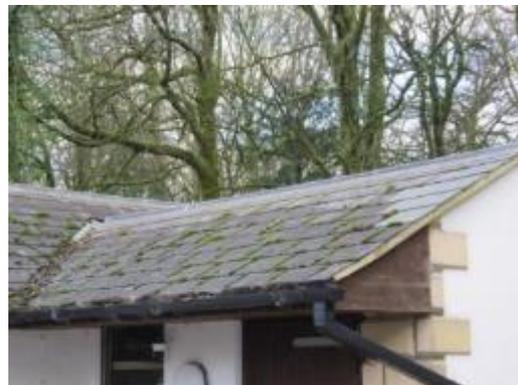
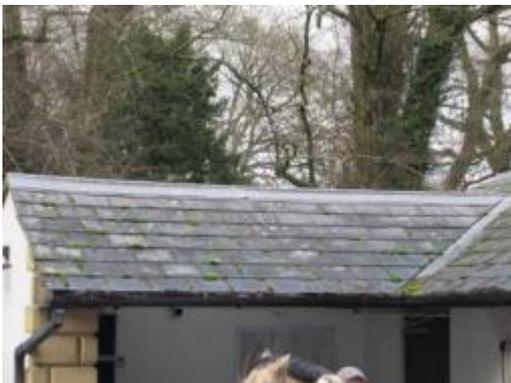
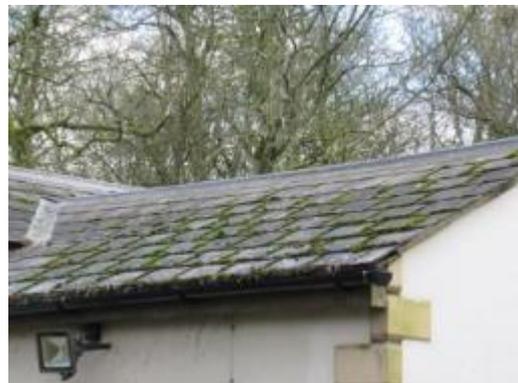
Our inspection of the right-hand side and rear roof slopes was limited due to the quantity of moss growth on the roof coverings, but they appear to be sound.

It should be noted that, given the age of the property, it is possible that the cement-fibre slates may contain asbestos. This presents minimal risk while they remain undisturbed, but should any significant maintenance, repair, or refurbishment works be carried out we would recommend that the material is tested for the presence of asbestos and, depending upon the results obtained, that the appropriate safety precautions are taken.

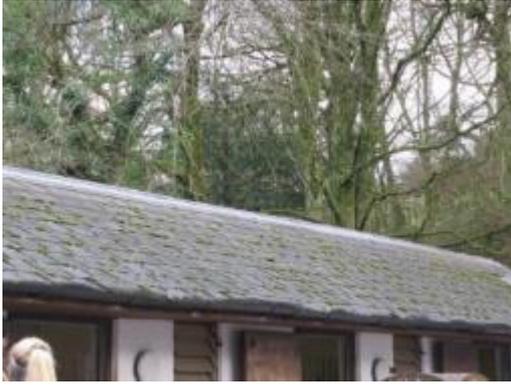
Valley gutters are formed at the intersection of the roofs to the bays with the main roof slope. These are provided with sheet metal linings. The valley gutter linings are weather stained and a significant quantity of debris was noted within the majority of the valley gutters. This limited our inspection. The valley gutters appear to be sound and no evidence of significant water ingress internally was noted.

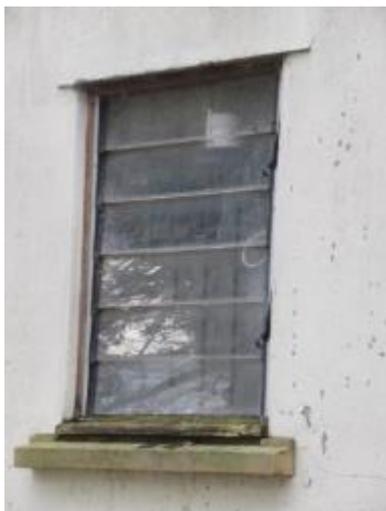
The windows are timber framed glazed lights with opening louvres. The windows are heavily soiled and weather stained and the decorations to the frames are in poor condition with extensive areas of flaking and otherwise defective paintwork. We would recommend that the windows are cleaned down, prepared, and redecorated.

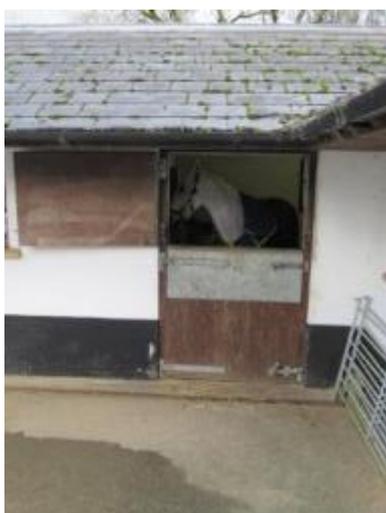
The stable doors are constructed as previously described. The decorations to the timber sections of the doors are soiled and weather stained and some minor areas of defective timber were noted, but the doors generally appear to be sound and serviceable.

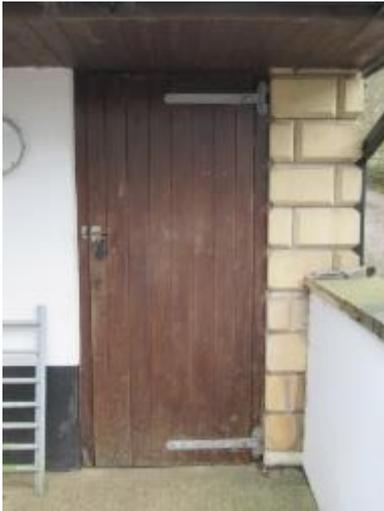
The external doors to the store room and rug room are solid timber ledged and braced plank type doors. The decorations to the doors are in fair to poor condition only with areas of flaking and otherwise defective paintwork. We would recommend that the doors are prepared and redecorated.

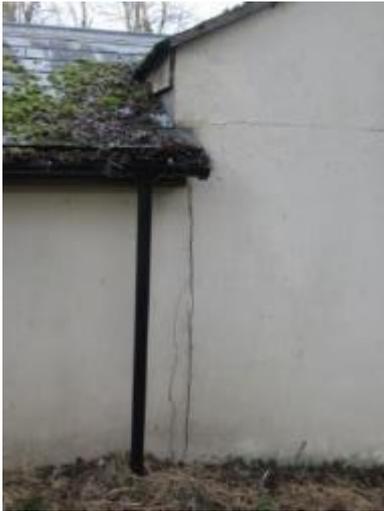
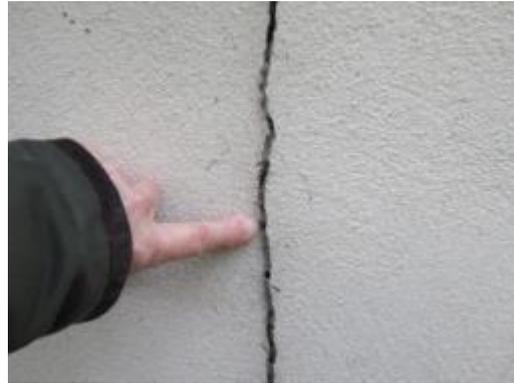
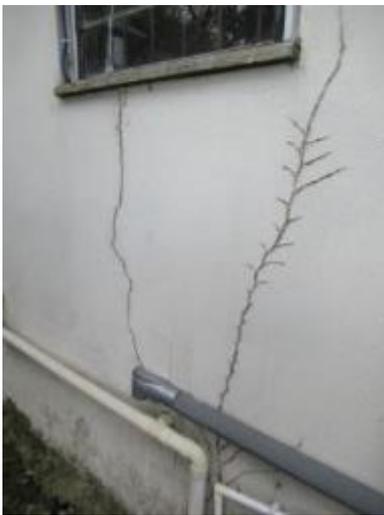
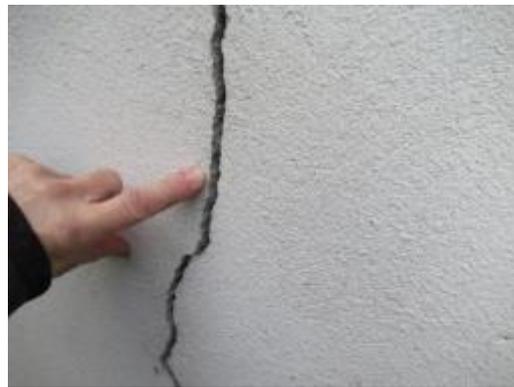
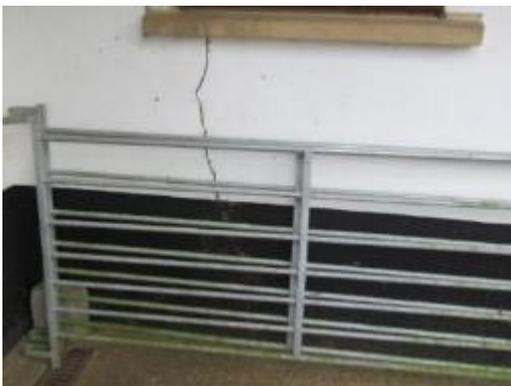
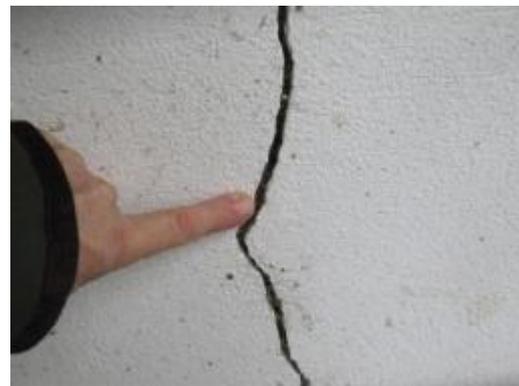
The elevations are constructed in solid masonry with a painted render finish externally. A number of vertical and raking cracks were noted to the external walls, particularly to the left-hand side return wall of the right-hand side bay, the right-hand side elevation, the left-hand side of the rear elevation and the right-hand side of the rear elevation.

It appears that the building has been constructed on a concrete raft that has, in turn, been cast on compacted hardcore, but no trench fill or strip concrete foundations have been provided. It appears that there has been some settlement of the ground and sub-base which has resulted in the concrete raft cracking and becoming displaced which has, in turn, resulted in the cracks to the external masonry. While it may be possible to repair the cracks and arrest the movement it is considered likely that further cracks will occur and that the existing cracks may reopen.

We understand that you may wish to consider converting the stable block to alternative accommodation in the medium term. It is considered unlikely that this will be possible without significant underpinning works to the existing structure.

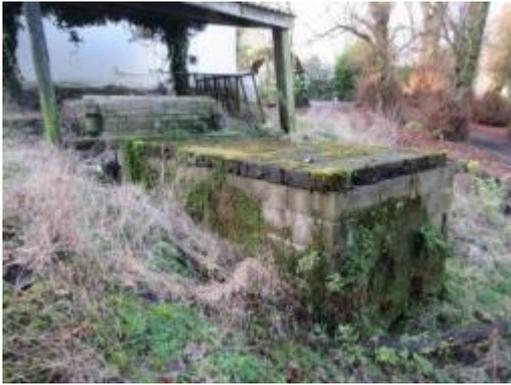
The building is connected to a cesspit. The cesspit is located immediately adjacent to the rear elevation of the property. There appear to be two settlement tanks for the cesspit with an outfall that discharges onto the adjacent ground. The settlement tanks are provided with a combination of precast concrete lintels and timber sleepers to cover the tanks. The tanks appear to have been crudely constructed and are in fair condition only.

This installation does not appear to comply with current Building Regulation requirements. As noted above, the Building Regulations are not applied retrospectively, but the cess pit installation is in poor condition and significant maintenance and repair works are required.

If it is intended to convert the stable buildings to an alternative use, it will be necessary to provide a new drainage installation in the form of a septic tank.

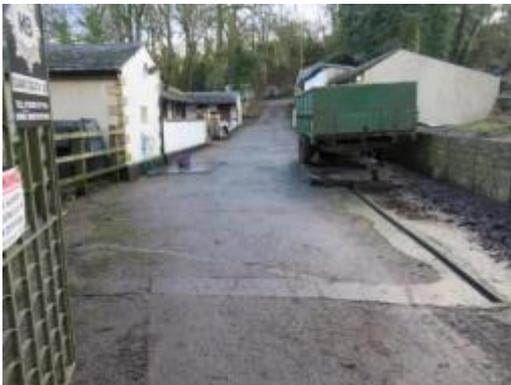
There is an access roadway that runs between the two stable block buildings. This is surfaced in asphalt. The surface of the asphalt is uneven, out of level, and degraded in places, but is serviceable. It is anticipated that some local repairs will be required in the short to medium term.

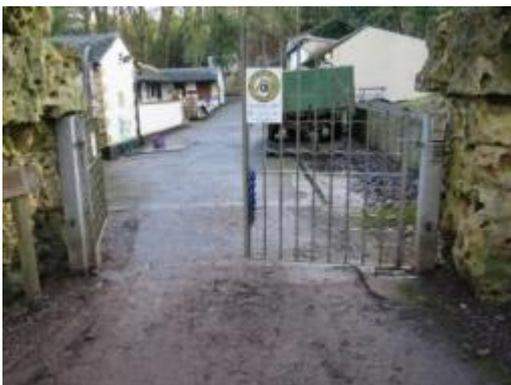
A pair of decorative galvanised metal vehicular gates are provided to the entrance. The gates are soiled and weather stained and, although previously electrically operated, are not working presently.

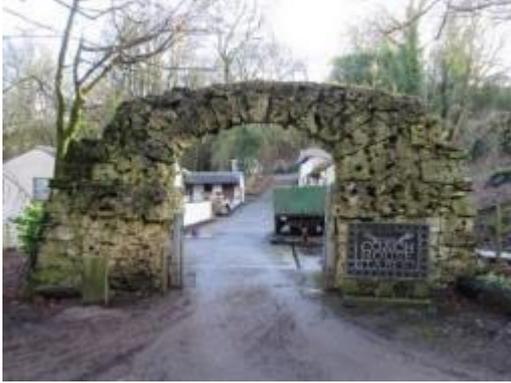
There is a stone archway at the front entrance to the property. The arch is Listed Grade II. The List Entry Number is XXXX.
